FY2016 Ex-Post Evaluation of Japanese Grant Aid Project

“The Project for the Improvement of Water Supply Condition in Ndola City”

External Evaluator: Tomoyuki Sho, IC Net Limited

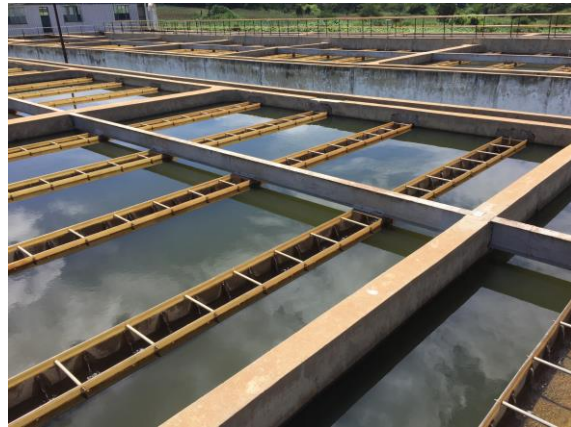
Collecting Trough in Sedimentation Tank at Kafubu Water Treatment Plant

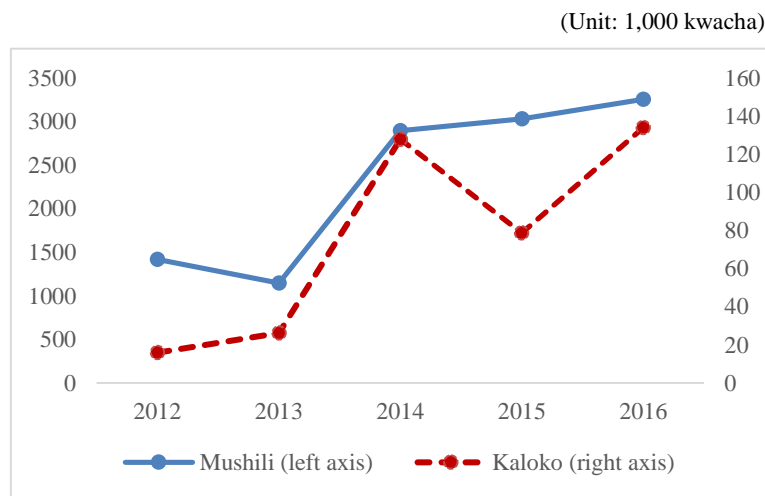
Figure 2: Collections in the Areas with Severe Water Supply Problems over Time: 2012–2016

problems, increased explosively 2.5 times and nearly 5 times, respectively, from 2013 when the Project was completed to 2014 (see Figure 2). This is likely to be explained, to not a small extent, by an increase in the population served with water, in addition to other factors such as a rise in billing amounts due to increased hours of water supply, an improvement in collection efficiency due to enhanced satisfaction, and the repayment of the public sector's outstanding debt, which to be discussed below¹². Therefore, despite the leakage taking place in the downstream of the water distribution network, it is certain that the population served with water in the areas with severe water supply problems, all in all, increased substantially due to the Project.

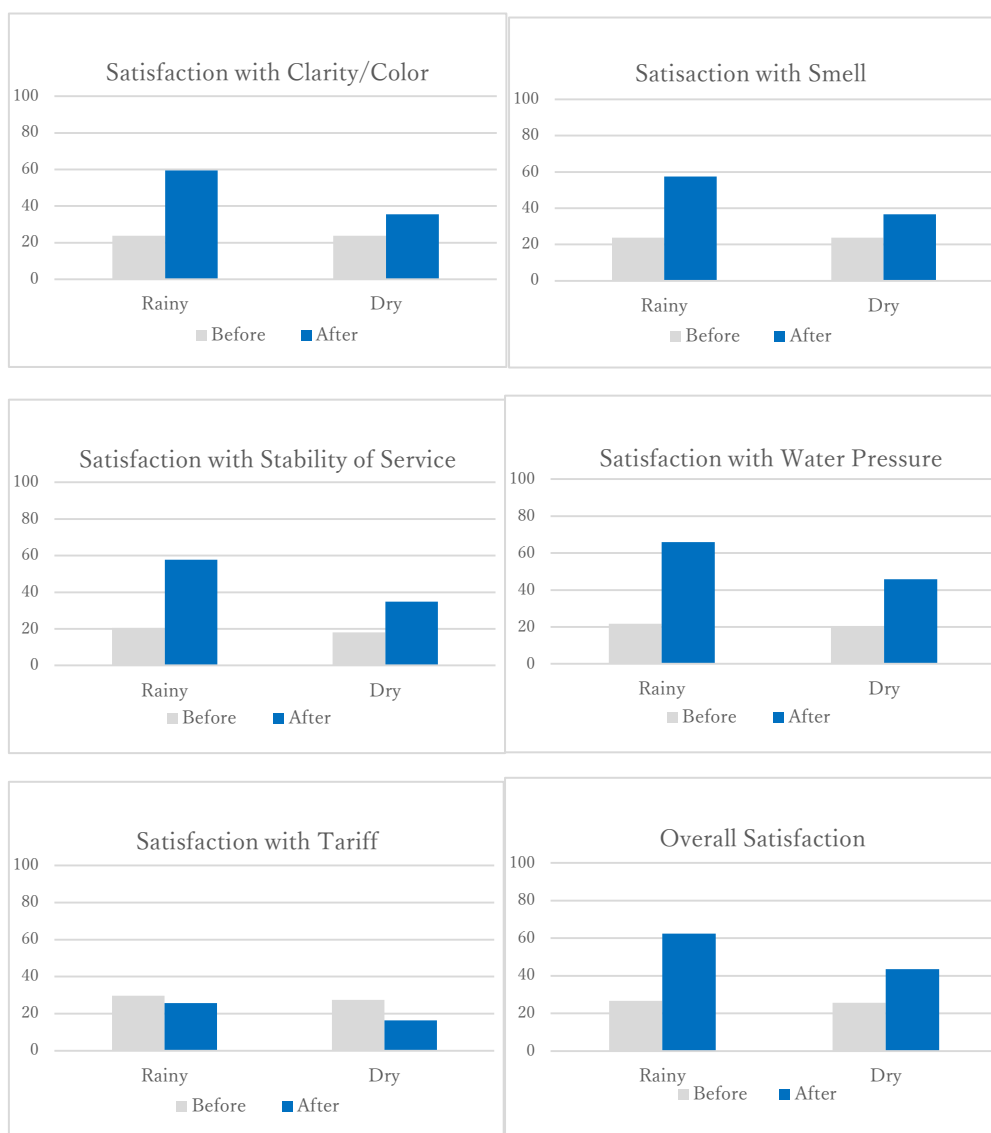
Figure 4: Beneficiary Survey Results: Levels of Satisfaction with Services

water supply conditions, as indicated by their increases of 35–40 percentage points in the rainy season, for example. (See Figure 4) Although this Project was primarily concerned with the improvement of water supply conditions, it is also recognized that the Project contributed, to a certain extent, to the improvement of water quality and other aspects through replacing chemical feeding facilities and installing water quality analyzers, among others.¹⁷

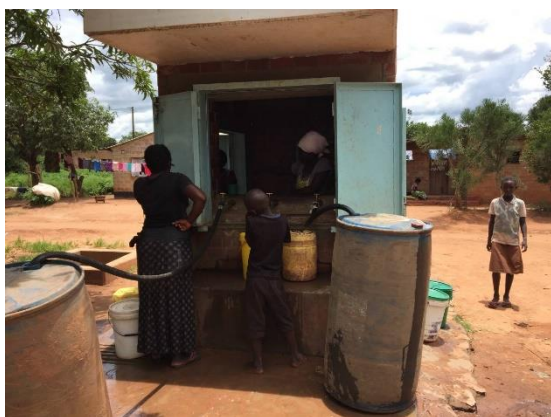
Photo 1: Public Water Kiosk (1)

At the time of ex-post evaluation, the number of customers per day at each kiosk was about 200 persons, and the volume of water sold reached roughly between 200,000 liters to 350,000 liters on a monthly average basis. The monthly average sales per kiosk ranged from about 1,000 kwacha to 2,000 kwacha at maximum, and 60% of sales have been paid to KWSC and the remaining 40% have been the vendor's share. All the six public water kiosks turned profits, and the public water kiosks were largely managed properly by local residents.²² (See Photos 1 and 2) Consequently, the vandalization of distribution pipelines by some neighbors has not been witnessed any more, and it has become unnecessary for the local residents to go to remote sources to fetch water. (For the details on the alleviation of water-fetching labor by women and children, see the "Impacts" section.)
