FY 2016 External Ex-Post Evaluation of Japanese Grant Aid Project

“The Project for Landslide Prevention in the Tegucigalpa Metropolitan Area”

External Evaluator¹: Hajime Sonoda, Global Group 21 Japan, Inc.

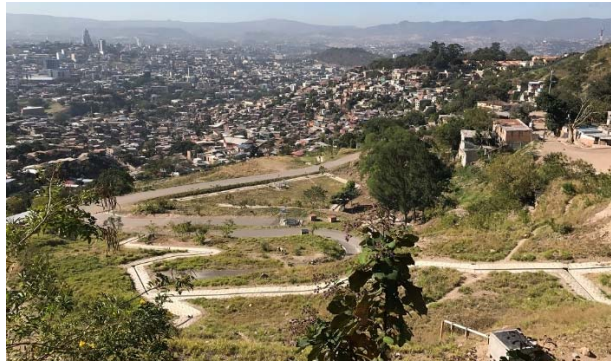
Complete view of El Reparto (After the implementation of countermeasures)

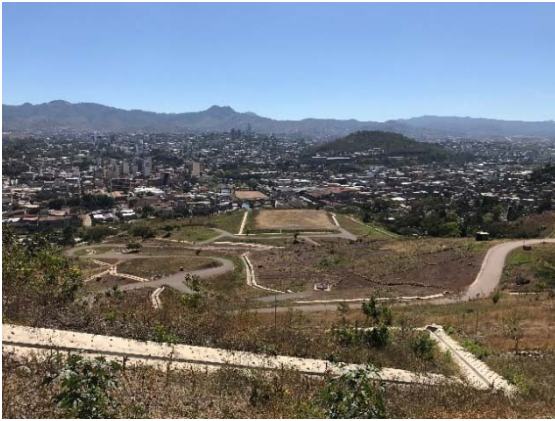
Complete view of El Berrinche

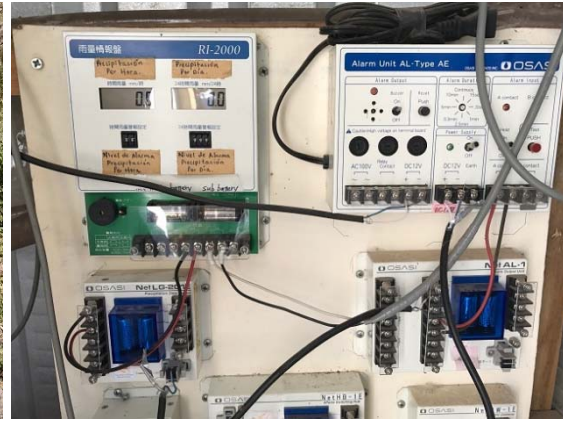
Inside of the observation station (El Reparto)
