FY 2016 External Ex-Post Evaluation of Japanese Grant Aid Project

“The Project for the Improvement of Water Supply System in Concepcion and Pilar Cities”

External Evaluator: Hiromi Suzuki S., IC Net Limited

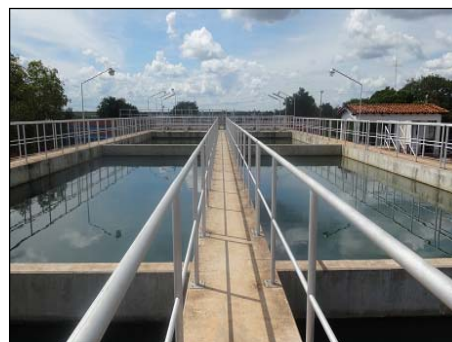
Concepcion Water Treatment Plant: Chemical Sedimentation Tank

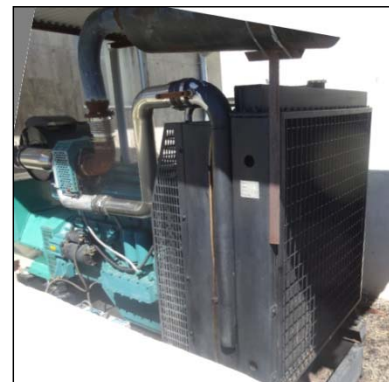
Private power generator at  
Pilar Water Treatment Plant

WTP) in 2015 as the unstable power supply in Paraguay meant a series of power cuts which caused cutting off of the water supply in the early days of the operation of the new WTPs.

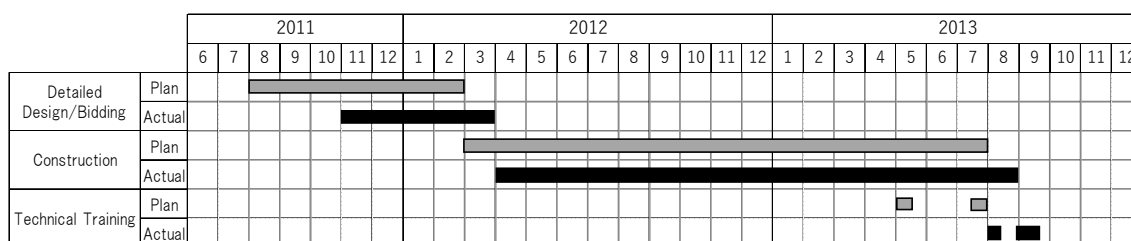
Fig. 1 Planned and Actual Project Periods

The planned project period was from August 2011 to July 2013 (24 months). The actual project period was from November 2011 to September 2013 (23 months) which was 96% of the planned period.<sup>13</sup>

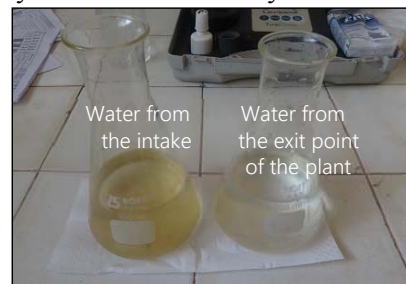
The target for (4) quality of the treated water (color and turbidity) was achieved at both WTPs where the recommended standard water quality in Paraguay has been constantly met. Water quality data for the Paraguay River (source of raw water) for 2016 shows a maximum color value of 100 to 120 in the dry season (April to November) and 120 to 140 in the wet season (December to March) but the color of the treated water is constantly 3. Similarly, the turbidity of the raw water widely fluctuates between 9.6 NTU and 75 NTU irrespective of season while the turbidity of the treated water by the WTP is stable at 0.1 to 0.4 NTU.

Concepcion Water Treatment Plant: Water from the intake and the exit point of the plant

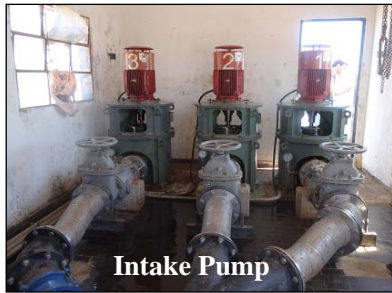
- Status of operation and maintenance: Generally good
- Problem with the intake: Because the gate at the intake<sup>26</sup> has worn out and it is not fulfilling its role anymore, small fish and sand are sucked into the intake pump. Despite the standard service life of 12-15 years with proper maintenance, the bearings have required replacement three times in four years, causing a much high maintenance work volume compared to that originally required.

- Repair of the flow meter at the rapid filtration tank: The flow meter of the rapid filtration tank is out of order due to a lightning strike and the coordination of its repair with the ESSAP Headquarters is necessary.
- Repair of access road to the WTP: Part of the road from the site entrance to the WTP property has been damaged by flooding of the river and has not been repaired, making it difficult to access the WTP in the rainy season.

- Regarding the water intake gate for the Pilar WTP, as it is described in Table 7, it has worn out and it is not fulfilling its role anymore. This has resulted in heavy abrasion of the intake pump bearings, necessitating the replacement of the bearings more frequently than assumed. The urgent construction of this gate is desirable.
