FY2016 Ex-Post Evaluation of Japanese Grant Aid Project

“The Project for Urgent Improvement of Water Supply Facilities at Kassala City” and  
“The Project for Improvement of Water Supply System at Kassala City”

External Evaluator: Mayumi Hamada and Chiho Ikeda,

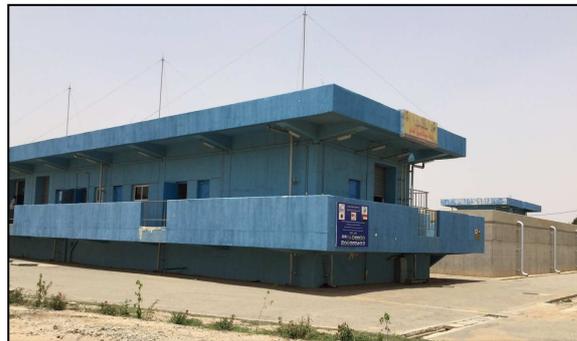
Mahta Water Treatment Plant<sup>1</sup>

<sup>1</sup> Front building is a distribution pump building and the back one is a reservoir. Three WTPs have the same design though the capacities of the facilities are different.

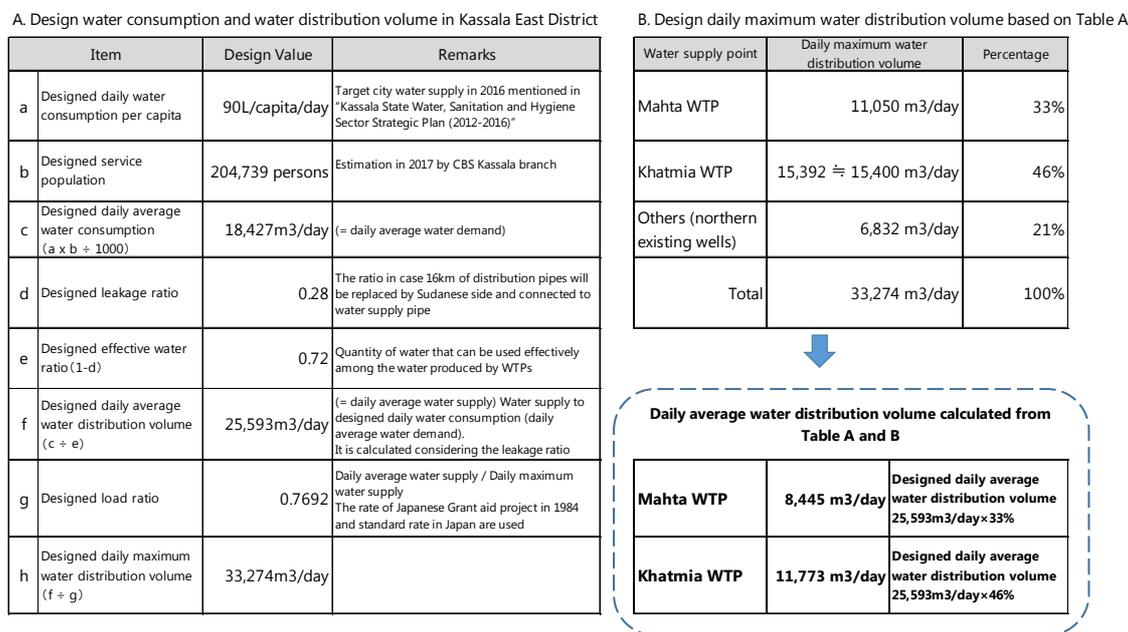
Figure 1 Calculation of the designed daily maximum water distribution volume and daily average water distribution volume calculated from Table A and B<sup>19</sup>

Daily average water distribution volume was calculated based on the daily maximum water distribution volume of East District (Refer to Figure 1, A and B) that was calculated at the planning.

- ♦ Mahta WTP 【Daily maximum water distribution volume: Baseline 9,200 m<sup>3</sup>/day (2010) → Target 11,050 m<sup>3</sup>/day (2014)】

District (27,270 m<sup>3</sup>), that is, the average daily water distribution from Mahta WTP (9,163 m<sup>3</sup>) + from Khatmia WTP (8,747 m<sup>3</sup>) + from others (9,360 m<sup>3</sup>), minus the same water leakage rate as planned (28%). Others refers to the estimated water production of the wells connected directly to the distribution pipe network according to the interview with Kassala SWC. As for the water leakage rate, the same water leakage rate as planned, as shown in Figure 1, was applied since the exact leakage rate was unknown.

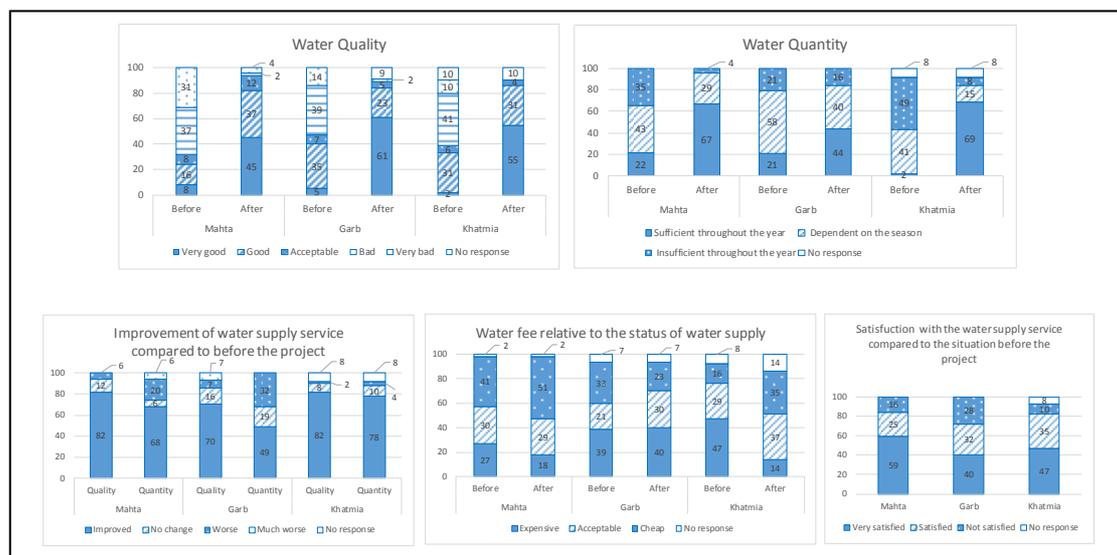
Figure 2 Results of the beneficiary survey in relation to the project's effectiveness

before. Especially, most of the residents in the East District, where the rehabilitation of the existing WTP and the construction of the new WTP were carried out, responded that they are “very satisfied” or “satisfied.” Thus, it is supposed that the reliability of the water supply service of the residents who has been receiving water supply service has been generally improved as compared with before the project. In addition, the survey results show that the residents of the Khatmia WTP covered area, where the water supply situation was not good before this project, think that the water supply service has been improved greatly with respect to the amount of water<sup>27</sup>. On the other hand, in the West District (covered area of Garb WTP), where the project implemented only the rehabilitation of the existing WTP, many residents felt that the quality of water has been improved, but about half of the respondents responded that the amount of water was “not changed” or “worse.” Thus, the satisfaction of the residents in the West District is not as high as in the East District<sup>28</sup>.

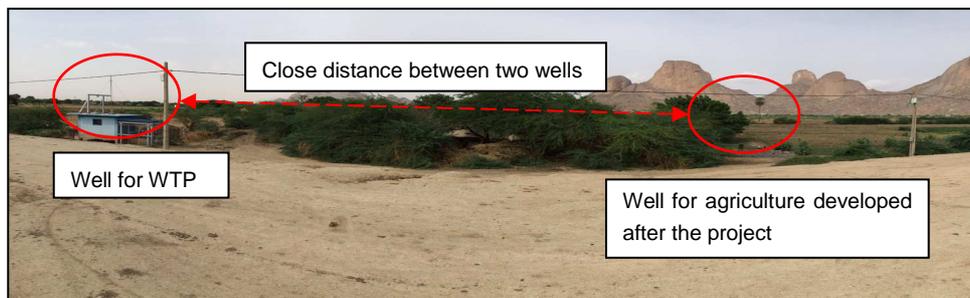
As stated in the section on effectiveness, the water distribution volume and water pumping volume of each WTP tend to decrease. According to the director of the Groundwater and Wadis Kassala branch, it is assumed that over pumping as well as the overdevelopment of agriculture wells due to the expansion of the agriculture lands, mutual interference of wells located within a close distance, and effect of the plant called mesquite (\*1), are causes of the decrease of the groundwater level. However, a clear reason has not been specified at the moment, as the detailed investigation has not been conducted. Kassala SWC has begun periodic monitoring of several wells in the city since November 2016 in order to grasp the current situation of the decline of the groundwater level. A block meeting with the residents to discuss effective water use has also started. (\*2) In addition, new wells for drinking water are being developed by Kassala SWC to increase the water distribution volume. But those efforts require time to take effect, and it is unknown how much they can mitigate the decrease in water distribution due to the decline of the groundwater level.

(Example of close interval between the well of WTP and agricultural well)
