FY2016 Ex-Post Evaluation of Japanese ODA Loan Project

“Urgent Disaster Reduction Project for Mt. Merapi/Progo River Basin and Mt. Bawakaraeng”

External Evaluator: Masami Sugimoto, SHINKO Overseas Management Consulting Inc.

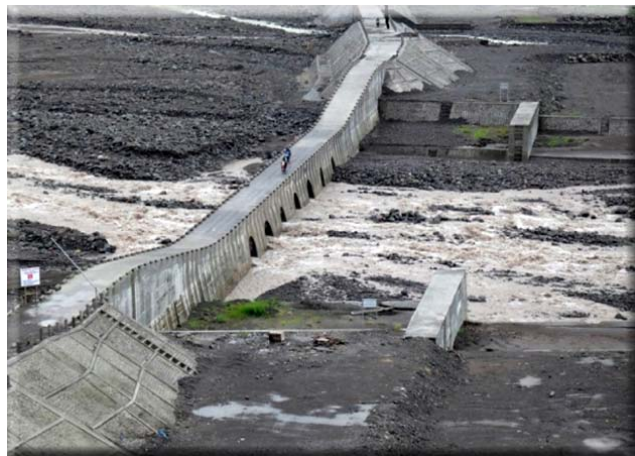
(Consolidation Dam : Mt. Bawakaraeng Component)

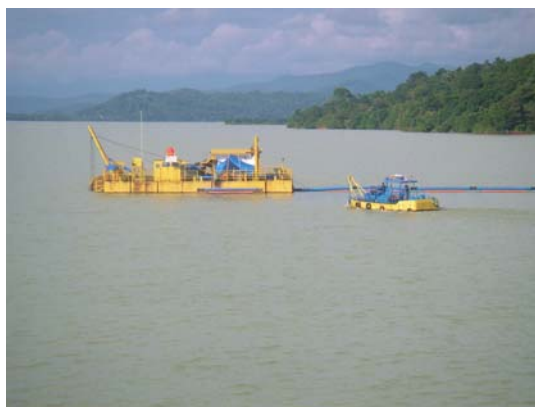
Fine debris naturally flows into the Bili-Bili Reservoir because the complete blocking by the sabo facilities is not possible, additionally it is not taken either in business sand mining. Therefore, continuous dredging at the both sites became necessary to maintain the dam functions: at the reservoir edge for flood control, and near the water intake for smooth water intake. Unused project fund saved by minimized riverbed excavation due to the local residents' appeal not to affect the irrigation intake was transferred to the necessitated reservoir edge dredging. The construction of consolidation dams were added based on the necessity identified in the new facility design reviewed in the project. The main objectives of this component are prevention of the debris inflow into the Bili-Bili Dam and regional socio-economic development for the local residents at the Jeneberang river basin. Regional infrastructure development was added for the latter purpose.

Dredging Works near the Water Intake of Bili-Bili Dam

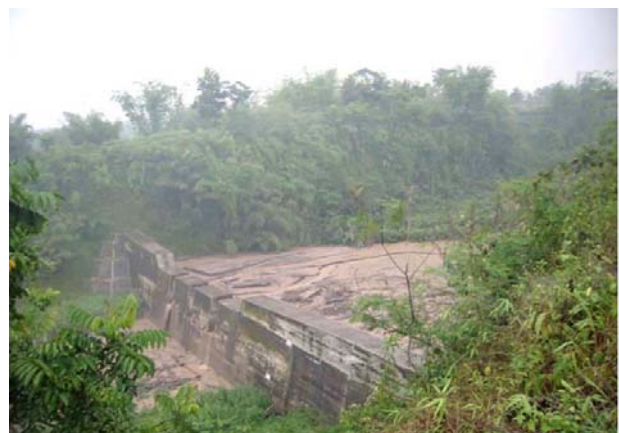
The damage mitigation effect of the sabo facilities during the large scale eruption in 2010 is recognized in various literatures. Only four out of fifteen rivers suffered from the debris flow caused by this eruption. Even in Putih River where the greatest damage occurred and occurrence of debris flow reached for eleven days, the sabo facilities arrested the flow until flood of the debris flowed over the sabo facilities more than a month later, which contributed to secure time for evacuation and

Arrested Debris Flow by Sabo Dam at Krasak River
(Source: Material provided by Executing Agency)

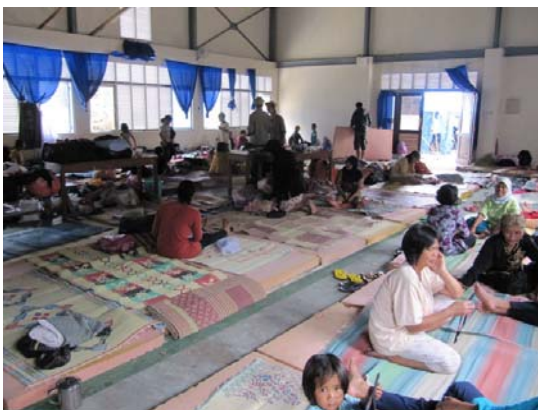
Evacuees in the Shelter Installed in this Project

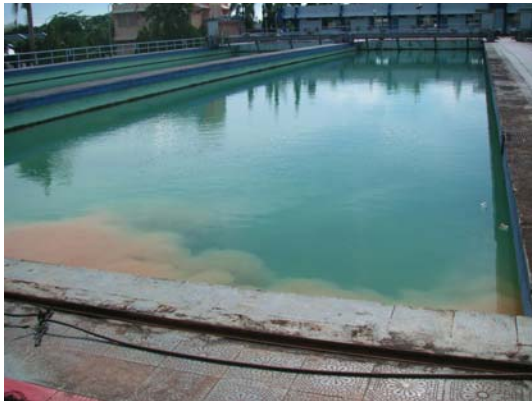
Functional disorder brought by the sedimentation inflow is on both "quantity of water intake" and "water quality," but it is not seriously affecting both of the aspects maintaining smooth operation being protected by the controlled sediment inflow by the sabo facilities as well as the constant dredging works near the water intake meeting 60% of the total water supply demand of Makassar City without a hitch. The raw water from the reservoir which used to be transparent before the collapse has become muddy, but the quality of the processed clean water is maintained due to the effort of strengthened purification and a close water quality monitoring by the water supply institution; Penjernih Air V Somba Opu Water Treatment Plant.

Sedimentation Basin:
Raw water is on this side

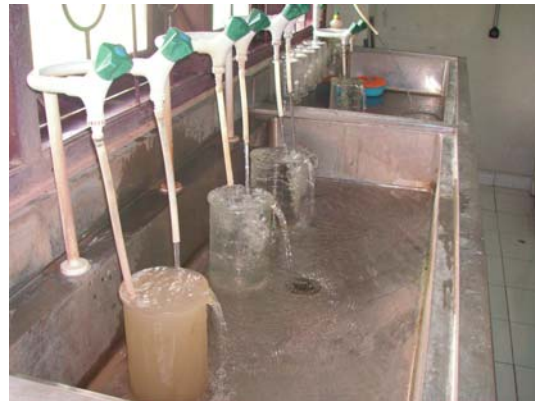
Water Quality Monitoring:
From raw water front side to clean water inner side

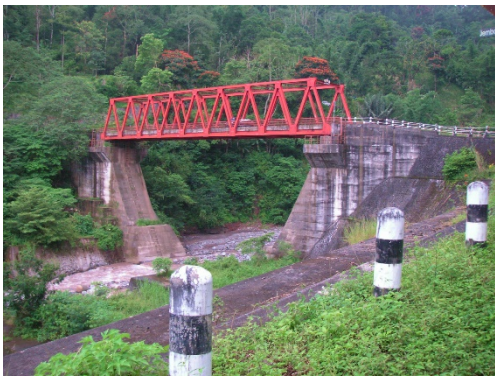
Roads improvement was performed in disaster-damaged Lengkesa Village. In addition to the bridge function prepared by the sabo facilities themselves, a new iron bridge was installed at Daraha area. Those transport infrastructures have been producing remarkable effect for regional economic activation as the Mt. Merapi component also did.

Daraha Bridge

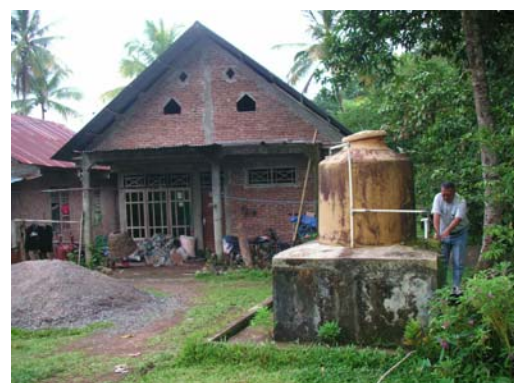
Simple Water-Supply System
