FY2017 Ex-Post Evaluation of Japanese Grant Aid Project

“The Project for Widening of New Bagamoyo Road”

External Evaluator: Tomoyuki Sho, IC Net Limited

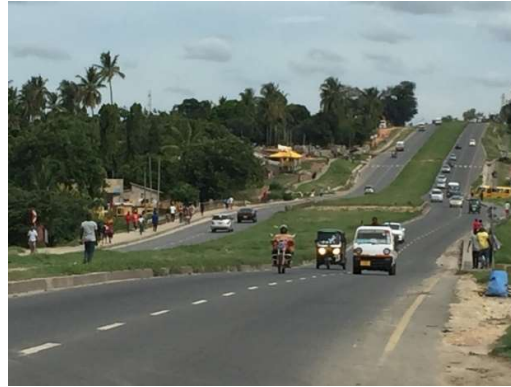
Road Improved by the Project

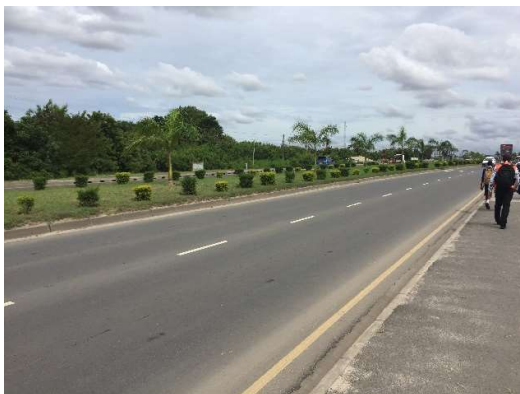
Photo 3. Well-Maintained Median Strip

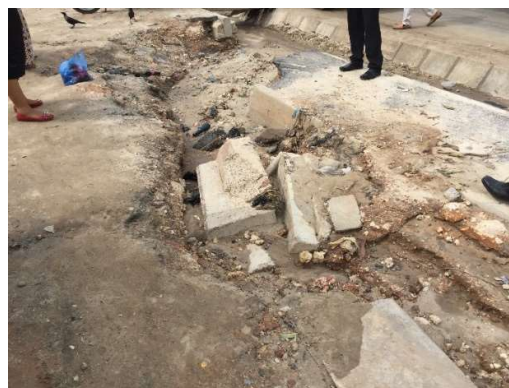
Through the site visits and interviews with the officials concerned, it was confirmed that the recommendations made by the Japanese side during the defect liability period, such as removing weeds, cleaning road surface, and monitoring road pavement surface, have been mostly being carried out. The beauty of the road and its median strip is well-maintained particularly around the Lugalo barracks, as students from neighboring schools also participate to remove weeds and clean along the road (see Photo 3). When it comes to road drainage facilities, however, it was observed during the site visits that partially collapsed side ditches and laterally eroded road embankment had been left abandoned (see Photo 4). As mentioned, road flooding has become worse than before in some sections of the road, because the capacities of road crossing culverts and side ditches turned out not to be up to par to handle flow volume during the rainy season. Moreover, after the project completion, surface ponding due to water flowing from the road toward roadside houses has been posing a problem in residents' daily life in relatively widespread areas. During the interviews, a large number of residents voiced complaints against the road flooding and surface ponding during the rainy season in the areas along the road<sup>29</sup>.

Photo 4. Collapsed Side Ditch and Side Walk  
Due to Heavy Rain

The probable fundamental causes of the problem are disorderly residential land development and deforestation in the upstream areas of the road, as well as drainage connections without considering downstream capacities. Yet, the capacities of the drainage facilities, such as road crossing culverts and side ditches, constructed by the project also turned out not to be up to par to handle flow volume during the rainy season, and it affected the problem. The facts that drainage facilities outside the road construction site became out of the scope of this project and that a sediment basin at the upstream of the road and the existing drainage facilities had not been rehabilitated at the timing of the implementation of this project due to budget constraints have led to the problem as well.
