FY2017 Ex-Post Evaluation of Japanese Grant Aid Project

“The Project for the Improvement of the Living Environment in the Southern Area of Lusaka”

External Evaluator: Satoshi Nagashima, INTEM Consulting Inc.

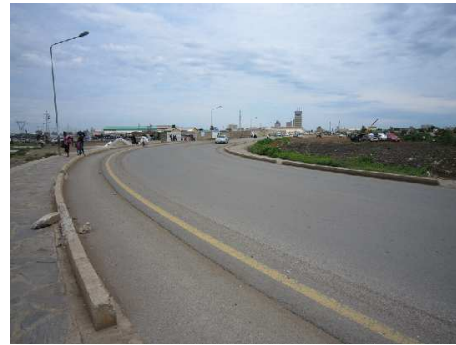
Part of constructed road

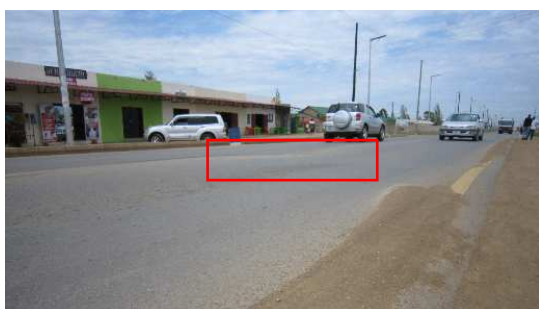
After the rainy season in 2016-2017, road unevenness occurred in a part of the road constructed in this project. Further, as of November 2017, a new surface layer gap etc. has been confirmed. As of January 2018, repair by the Zambian side has not been done.

According to a material provided by JICA, it is analysed that there is a high possibility that it is caused by gaps between existing roads or rocks in the road floor, water stagnant due to heavy rain, erosion of existing top soil due to groundwater flow, softening and vibration due to traffic, etc.

Photo: One of part of road unevenness  
(The part surrounded by the red frame is sinking)

Some of the road unevenness that occurred during the rainy season in 2016-2017 is extremely dangerous, especially it is hard to see it during night time driving. Although LCC and RDA are conducting surveys to investigate the cause, it is necessary to identify the cause as soon as possible. In addition, it is desirable to allocate the budget for repairing the road at the earliest possible stage after the survey and repair the road unevenness sections as soon as possible.

Although LCC and RDA are conducting surveys to investigate the cause of the road unevenness that occurred during the rainy season in 2016-2017, it is currently difficult to secure even the cost of the surveys due to the severe financial circumstances. In case it is judged that repairs by LCC and RDA are difficult, it is desirable to consider examining the follow-up cooperation for the repair of the road unevenness parts as one of the solutions.

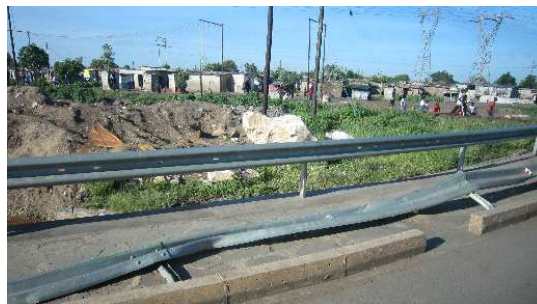
According to the interview survey at LCC, they have already dispatched engineers, conducted on-site surveys, and reported to Ministry of Local Government, but there is no prospect of securing budget for repair. In addition, it was observed during the on-site survey that there were several places where the guardrails along the road were also left damaged.

Photo: Damaged guardrails
