Republic of Djibouti

2017 External Ex-Post Evaluation of Japanese Grant Aid Project
“The Project for the Provision of Waste Management Equipment”

External Evaluator: Shima Hayase, IC Net Limited

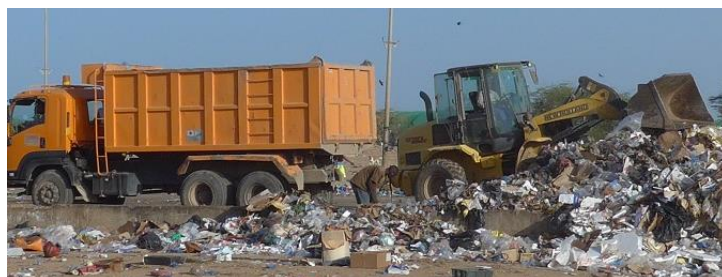
At the waste management site, operation with the sanitation landfill method was carried out following the instructions. However, waste pickers came and went freely to the site. They came into a waste segregation station to collect waste while dump trucks and wheel loaders were in operation.

It seemed that there is a safety control issue in both waste collection equipment and equipment at the waste management site. In order to prevent unexpected accidents, it is necessary to give safety guidance to the staff and to safety awareness to the residents.

Waste pickers collect wastes at the segregation station

OVD's safety control measurement needs to be reviewed. Some assistants collected waste with their bare hands, wearing neither gloves nor boots. Also some residents and children climbed into trucks in operation. Waste pickers came and went freely to the waste management site. They came into a waste segregation station to collect waste while dump trucks and wheel loaders were in operation. These risky behaviours may cause unexpected accidents. Thus it is assumed that OVD needs to give safety guidance to waste collection staff, and safety awareness to the residents.

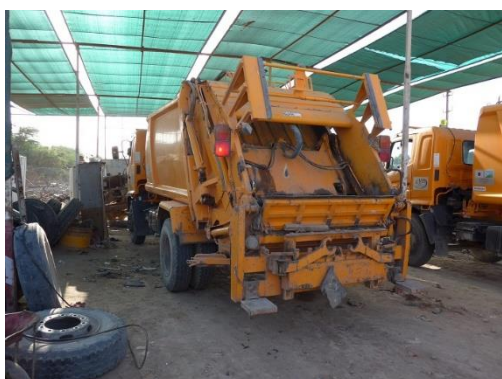
Startup checks (cleaning, oil, tires and radiator), closing checks and cleaning were carried out daily by drivers. In the cases when minor faults were found such as those in tiers and batteries, OVD's maintenance department handled them. Otherwise an agent in the city responded to other issues. Regular check-ups were conducted by the agent as a rule. They were carried out every 5,000 km. Along with mileages, these were recorded in a log book for each vehicle and in a computer.

Changing tiers at a temporary parking space

At the time of the ex-post evaluation (2018), OVD's maintenance department was working at the corner of a temporary storage site because the construction of AFD's workshop has not yet completed. At the work space, there were neither a pit nor crane which were necessary for vehicle maintenance and their equipment and tools were very basic. Manuals and spare parts were stored in a temporary storage on the site of AFD's workshop. Manuals were lent according to request.

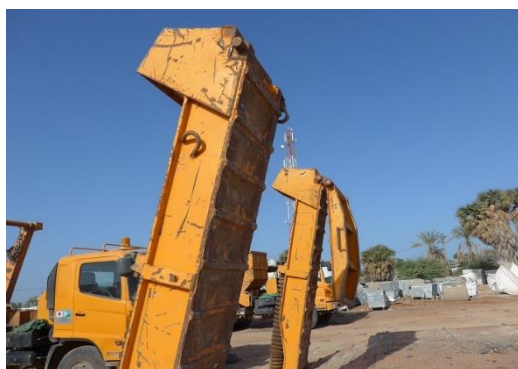
A trailer truck with a missing rail

There were neither faults nor damages. They were stored in a roofed parking space. A trailer truck was stored at the same temporal storage site as waste collection equipment, and it corroded substantially. The vehicle with a sidebar was left, and has not been repaired.

serious issues for operation. However, it is necessary to be washed with water and to be cleaned it after use. Damages and scratches are needed to be retouched for corrosion prevention. OVD needs to review the maintenance system in order to conduct a sustainable operations and maintenance. Its maintenance department needs to work thoroughly.

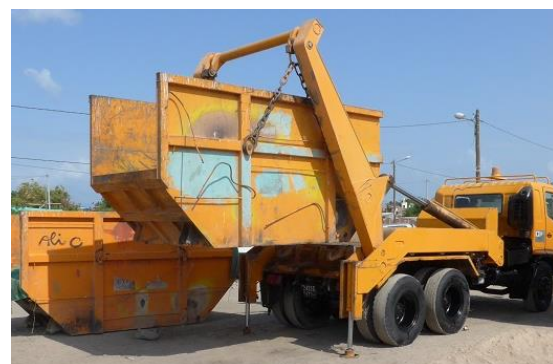
Due to accidents in operation, damages on windshields and fenders, and scratches on the bodies were often observed on compactor trucks, container trucks and towing trucks. In the

interviews, the necessity of repairs was acknowledged, but they were used without being repaired unless there were serious problems in operation. According to the officer in charge, damaged parts such as broken windshields were to be repaired when the parts arrived.

A container truck (10 m³) with broken sidebars
