FY2018 Ex-Post Evaluation of Japanese Grant Aid Project

“The Project for Rehabilitation of Trunk Road (Phase IV)”

External Evaluator: Maki Hamaoka

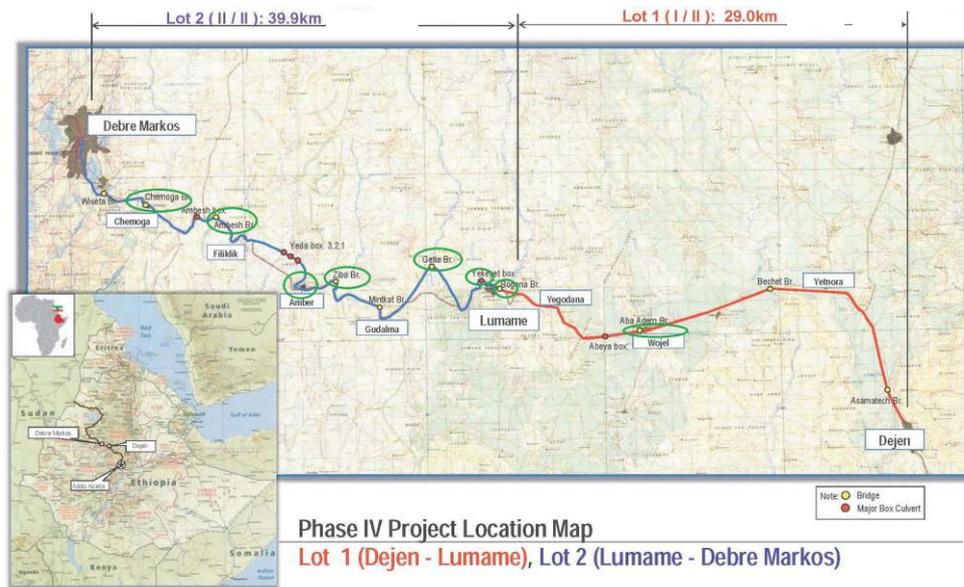
Figure 1 Frequently Accidents Occurred Points (circled with green)

Improvements in traffic comfort led to excessive driving speeds for drivers, and an increase in traffic accidents has been observed, mainly on downward curves. In this ex-post evaluation, the effectiveness and impact of the project were evaluated, taking into account that risk-hedging against excessive speed was undertaken sufficiently.

comfort of the target section improved, traffic accidents mainly caused by excessive speed have increased. For instance, as traffic accidents frequently occur on downward curves, it is recommended to paint slanted lines on the road to guide vehicles to drive in the middle of the lane before the curve. We recommended that the ERA Debre Markos Directorate identify locations where accidents occur frequently and investigate whether signs and guideposts are properly installed in the fiscal year 2019, then include the necessary budget for taking preventive measures against traffic accidents in the fiscal year 2020 budget plan. These measures include painting road markings within the year, replacing damaged guardrails with new ones and attaching reflectors to the guardrails.

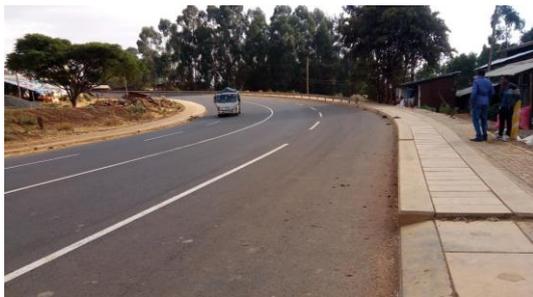
Place where accidents occur frequently (Amber)

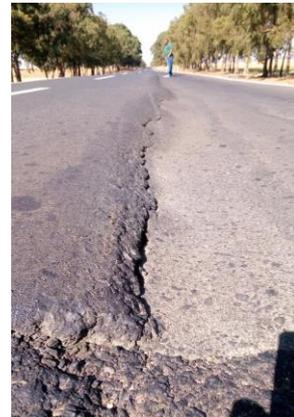
Particularly, in the section near Yet Nora (around 10km from Dejen), which is susceptible to black cotton soil, the road surface was damaged (cracks and settlement) over about 600m at the end of 2014. In May 2015, before the final inspection, the contractor repaired this section using the overlay (patching) method. At the time of the ex-post evaluation, road surface damage (deformation, cracks and settlement) due to black cotton soil was confirmed at the same location. Although no accidents caused by road surface damage have occurred, it has been pointed out by road users that it has hindered driving comfort. From December 2018 to May 2019, the road research center of ERA investigated the causes of road surface damage in this section.

According to the results of the ERA's investigation, causes of damage in this section are (1) softening of the subgrade by moisture, (2) clogging of cross-drainage structures, (3) low-quality construction materials and (4) differential movement between box culvert and pavement.

Settlement of the road surface partly due to influence of black cotton soil

ERA headquarters asked the Debre Markos Directorate to repair the concerned section. In the near future, the Debre Markos Directorate is repairing damaged road surfaces with higher-quality construction materials.

(2) Immediate Repair of the Road Surface damaged due to the Influence of Black Cotton Soil and Future Reinforcement of Preventive Maintenance

Although the road surface damaged partially by the influence of black cotton soil has not led to a serious accident at the moment, it is recommended to conduct repair work on damaged parts within the fiscal year 2019: Road users point out that the damaged portion influences driving comfort.
