FY2018 Ex-post Evaluation of Japanese Grant Aid Project

“The Flood Prevention Project of East Side of the Pasak River in Ayutthaya”

External Evaluator: Nobuyuki Kobayashi, OPMAC Corporation

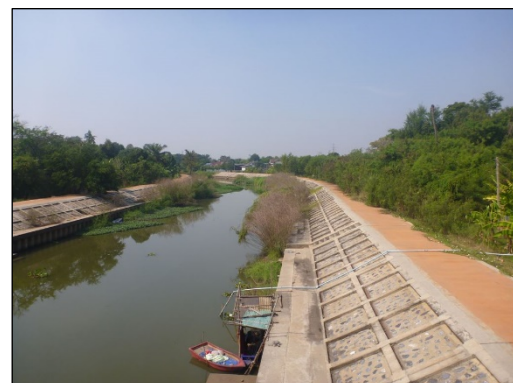
Photo 1: Revetment on Han Tra Canal

In this project, major changes to the technical specification included (1) addition of gabion<sup>7</sup> removal/installment, (2) extension of pile depth, and (3) replacement to concrete ground. The addition of gabion removal/installment was necessary because other (unrelated) construction work affected the site conditions of the Kra Mang canal. Extending the pile depth in both floodgates was necessary because design based on existing works and test results

suggested that it was necessary to drive the pile deeper than the original estimates. Soft ground was also replaced to concrete ground in a part of the construction site of the Han Tra floodgate. Neither change; however, brought about a significant change in the output.

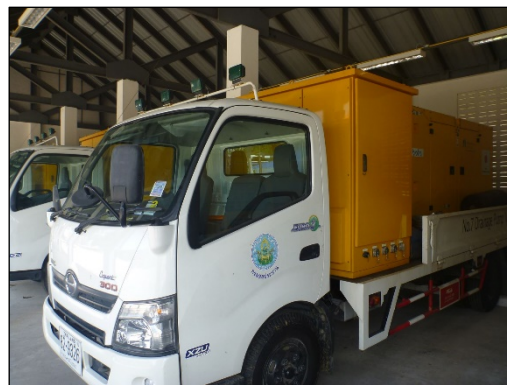
Photo 2: Drainage Pump Vehicle

The frequency and days for use of drainage pump vehicles showed that the drainage pump vehicles provided by this project were used continuously (see the following table). According to interviews with the executing agency staff, the pump vehicles were used across Ayutthaya Province and occasionally used in nearby provinces. On the other hand, the executing agency staff pointed out that it was difficult to operate more than 3-4 vehicles

out of 10 drainage pump vehicles provided by this project at the same time. The purpose of using pump vehicles is to (1) lower the water level in sunken places during rainy seasons, (2) supply water in dry seasons, or (3) release retained water that can cause strong odor in the canals. Moreover, in June 2018, two drainage pump cars provided by the project were used for the rescue mission of the boy football team that had become trapped in the Tham Luang Cave, Chiang Rai Province. JICA officials who cooperated with the rescue mission were awarded medals from the King of Thailand.

Based on the information provided by the executing agency, the drainage pump vehicles were inspected daily, and parts and batteries were replaced as necessary. Out of 10 drainage pump vehicles at the Ayutthaya Irrigation Project Office, all were stored in the garage except one operating outside the office at the time of the site survey. Regular inspections and cleanings were conducted, and all vehicles were ready to operate.

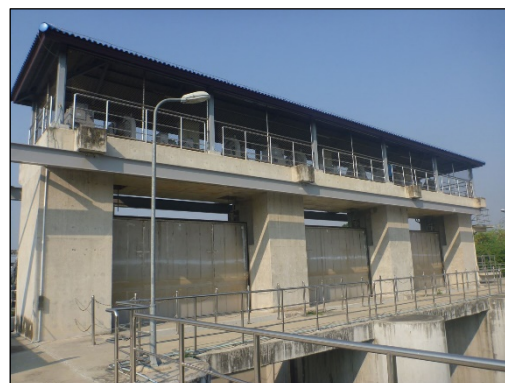
Photo 3: Kra Mang Floodgate

Based on the information provided by the executing agency and the interviews with the staff of Ayutthaya Irrigation Project Office, inspection of the floodgates (testing opening/closing of gates, inspection of hydraulic equipment, etc.) was conducted regularly once a week. It is checked for malfunction every 2 weeks. Moreover, test runs of the stand-by generator was held

once every four weeks and lubrication was carried out once a year. At the time of the site survey, both floodgates remained operational. The gates of both facilities were made of stainless steel and serious rusting had not occurred. Although there were minor cracks on the concrete structure, large cracks and chips which may affect the strength of the structure were not found. Fences were provided for the prevention of equipment theft and hatches for workers were constructed.
