FY2018 Ex-Post Evaluation of Japanese Grant Aid Project

“Reconstruction of Kok-Art River Bridge on Bishkek-Osh Road”

External Evaluator: Mimi Sheikh, International Development Center of Japan, Inc.

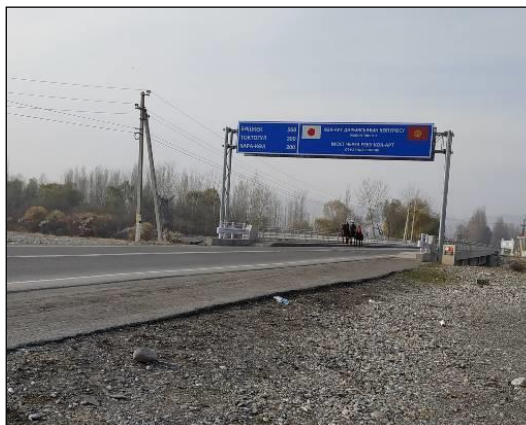
Kok-Art River Bridge and the access road

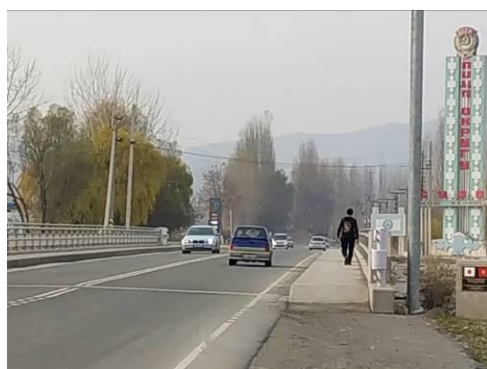
The planned outputs from the Japanese and Kyrgyz sides were carried out as planned. Table 1 shows the planned and actual outputs. The existing bridge was widened from the original 0.75 m to 1.5 m and “a mount-up type” sidewalk was created to increase the safety of pedestrians by making the walkway higher than the road.

A bridge user on the newly enlarged sidewalk

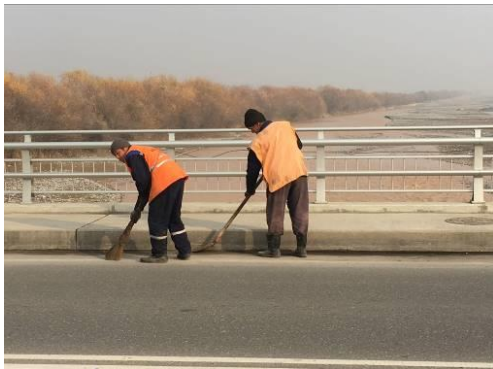
The DEU-22 conducts the following operations once every two weeks on the three bridges under its jurisdiction, including the Kok-Art River Bridge: drainage pipes on the bridge surface and around the bearings, removal and cleaning of sand and dust accumulated in the drainage ditches, and removal of rocks and driftwood.

DEU-22 staff cleaning the bridge

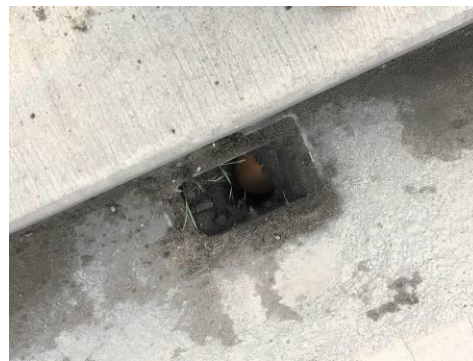
Drainage ditch prior to periodic cleaning

As a result of the site inspection, it was confirmed that the regular cleaning by the staff of the DEU-22 was carried out by using an appropriate number of workers and appropriate cleaning tools. Since the DEU-22 office is located in the immediate vicinity of the bridge,
