FY2018 Ex-Post Evaluation of Japanese Grant Aid Project

“Thakhek Water Supply Development Project”

External Evaluator: Miho Kawahatsu, OPMAC Corporation

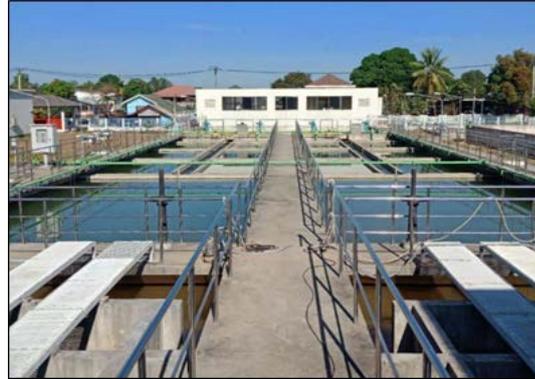
Newly Established Water Treatment Plant

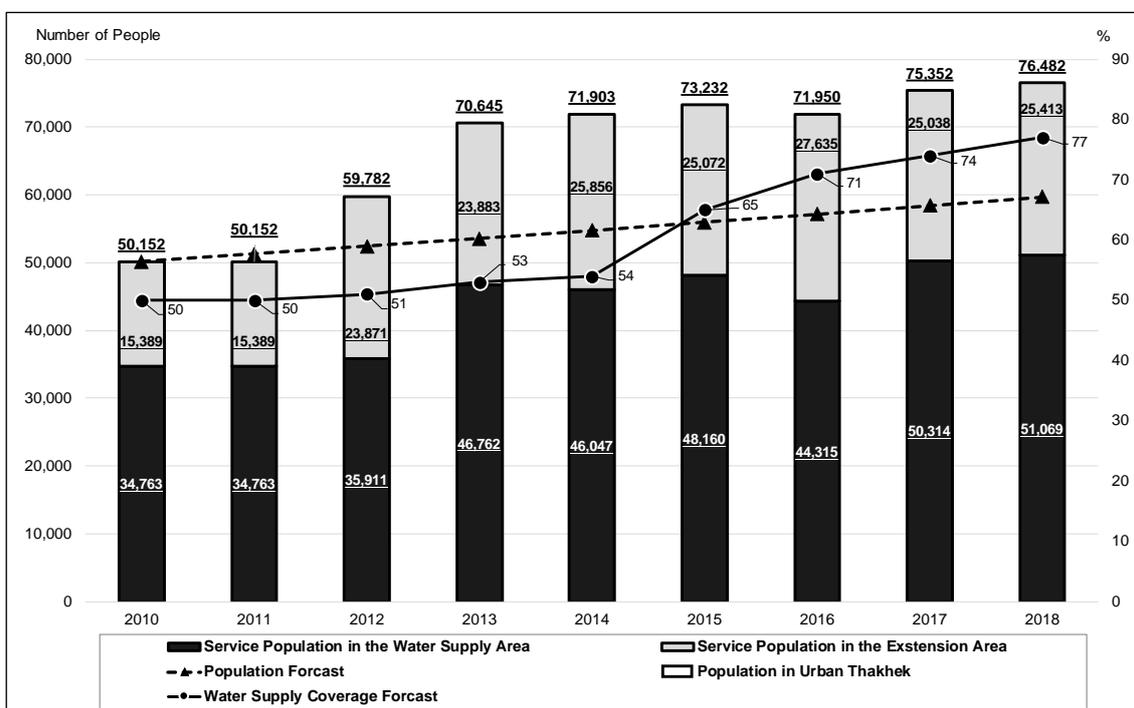
Figure 1: The Comparison between Actual and Forecast Population (Population and Water Supply Coverage rate) in Urban Thakhek

At the time of the ex-post evaluation, the population in 2018 was larger than the forecast by approximately 17,000, suggesting a parallel increase in the water supply and demand. Furthermore, with the developing ASEAN regional economy, cement factories, and a motel with a large parking area for numbers of heavy trucks were opened, becoming contracted customers in the extension area. The geographical location of Thakhek meant increases in water demand as a part of public service provision along with construction and the presence of long-distance truck carriers around the urban area.

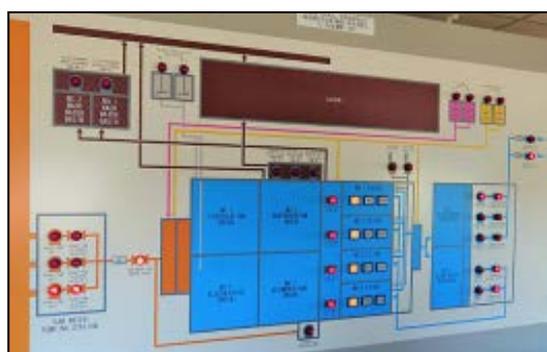
Control panel of the water treatment plant

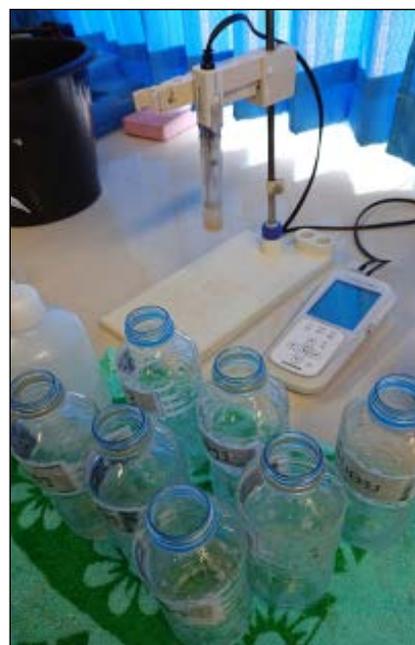
Water quality is examined by taking samples from 6 water tanks in the water treatment plant every hour, 24 times a day in the laboratory in the water treatment compound built by the project. It was reported that when any outlier appears in the inspection, reference is made either refer to the emergency response manual prepared by the capacity-building program of the project, or methods are used that were learned through the relevant JICA technical cooperation project¹⁰.

Testing water quality of samples
