FY2018 Ex-Post Evaluation of Japanese Grant Aid Project
“The Project for Improvement of the Equipment for Road Maintenance
in Osh, Jalal-Abad, and Talas Oblasts”

External Evaluator: Mimi Sheikh, International Development Center of Japan

0. Summary

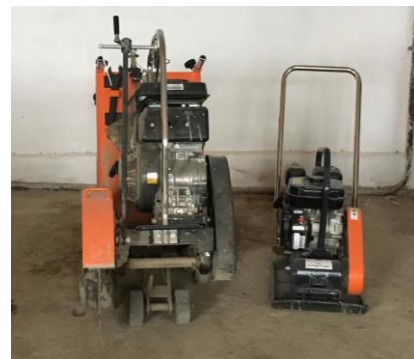
An asphalt cutter (left) and a vibration compactor (right): the most installed equipment

The asphalt cutters, vibrating compactors, and hand breakers required for patching were used frequently; according to DEU staff, this is because patching equipment was provided as a package, and not as single pieces of equipment, and road works, such as the repair of potholes, could be immediately begun with the packaged equipment.

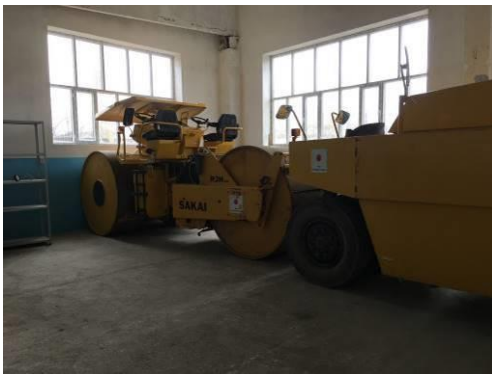
A road roller (left) / a tire roller (right)

A limited number of heavy machines (such as asphalt finishers and road rollers) were installed and required for overlaying and replacing pavement; these were delivered to the

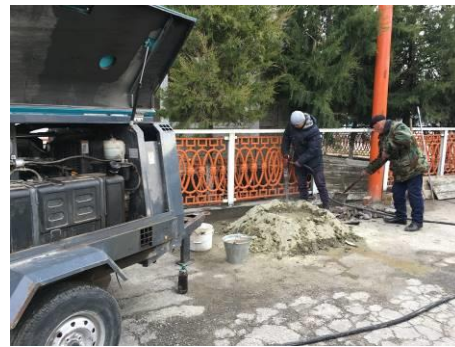
Repairing a road shoulder using an air compressor

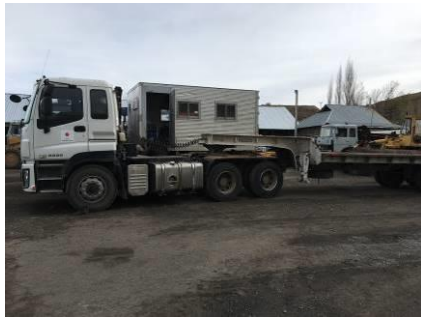
Mobile workshop van

phase, it was assumed that one mobile workshop van⁹ would be installed in each region's road maintenance bureau, so that the repair vehicle could be circulated among the DEUs to carry out on-site maintenance and small-scale repairs of equipment. However, while mobile workshop vans were used frequently by the DEUs in which they were installed, some DEUs did not know of the mobile van's existence if they were located one hour or more from a DEU in which a mobile workshop van was installed. Therefore, the vehicles were less frequently borrowed and lent among DEUs.

⁹ Before the project, the breakdowns that occurred on site were fixed by the operator on site. However, due to the shortage of maintenance equipment in the field, the repair could take several days to a week, which had a significant impact on the construction schedule. The mobile workshop van is a vehicle equipped with maintenance equipment and that was provided to enable prompt on-site repairs.

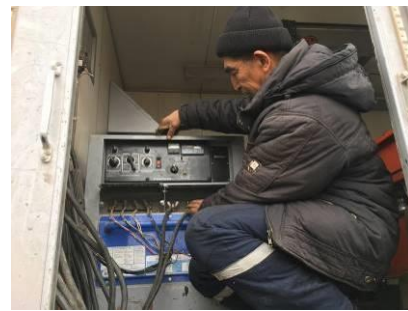
Inside of the mobile workshop van

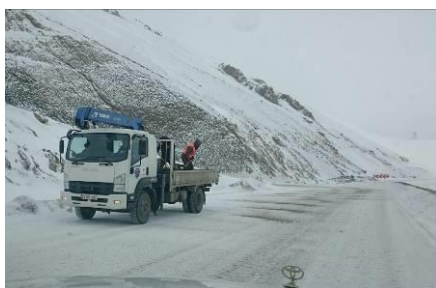
A worker spraying snow-melting salt and sand

In addition, on mountain roads, several workers were frequently observed during this study spraying snow-melting salt and sand from the back of a truck with a crane that had been provided by this project. Before this project was implemented, many DEUs could not take sufficient preventive measures before snowfalls because they did not have trucks with cranes and had to rent them from private companies. However, after the project was implemented, they have been able to take action both before after snowfalls.

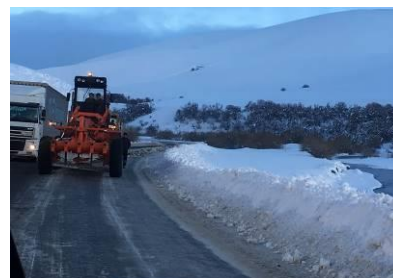
A rotary blower removing snow on a mountainous road

The snow-removing trucks, rotary snowploughs, salt spreaders, and motor graders are essential for getting through passes smoothly and safely. The number of days that the studied roads were closed due to snowfall, and the number of days required for restoration, were not monitored quantitatively. According to the DEUs for which snow removal equipment was provided, they can now dispatch workers immediately to the affected areas to conduct snow removal operations; before this project, the equipment frequently failed due to deterioration, and they sometimes had to rent equipment from private companies depending on the condition of their equipment. In addition, according to DEU-17, before this project, they sometimes had to close roads for three days or more due to snowfall; however, by the time of the ex-post evaluation, it became possible for them to immediately dispatch workers and equipment to affected areas using trucks with cranes, and they could open the roads within a day. Thus, the high performance of the equipment provided in this project contributed to shortening road closure periods.

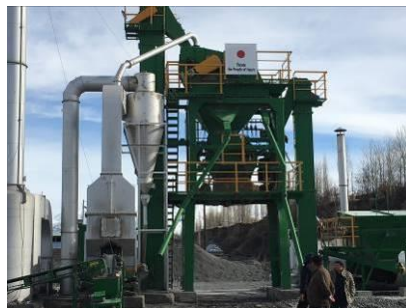
An asphalt plant

All four asphalt and aggregate plants have been operating smoothly, and it was confirmed that they are operating approximately 10 hours a day, 6 months a year, thus producing approximately 300 tons of asphalt a day.

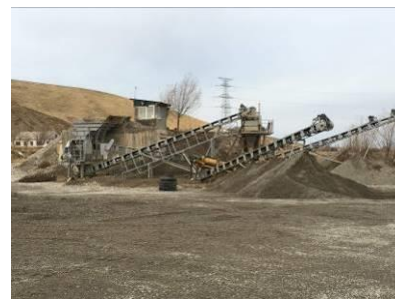
An aggregate plant
