FY2018 Ex-post Evaluation of Japanese Grant Aid Project
“Project for Improvement of Blantyre City Roads (Phase I, II, III)”

External Evaluator: Kazuko Shirai
Kaihatsu Management Consulting, Inc.

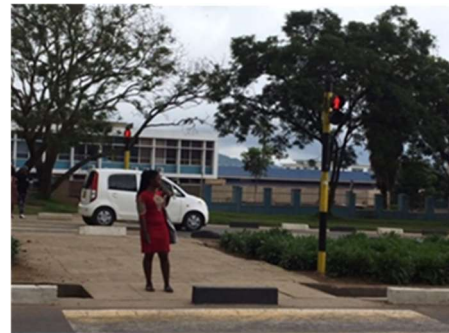
As indicated in Table 7, the number of annual traffic accidents decreased by more than a half from the pre-project (533) to the post-project completion time (203, 173 and 244). Most facilities, such as zebra pads and traffic signs, which were constructed under this project, are appropriately used. Therefore, it can be assumed that the project contributed to a decrease in traffic accidents to some extent. In addition, in recent years, fatal accidents tend to decrease according to the results presented in Table 7. According to the explanation of the Southern Province Police Headquarters, the space between curbstones placed by the project contributed to the mitigation of shock that vehicles would receive during an accident and reduced the seriousness of accidents. Therefore, it can be considered that the project's specifications have contributed to reducing the seriousness of traffic accidents.

Zebra Pad Constructed During the Project (section 2)

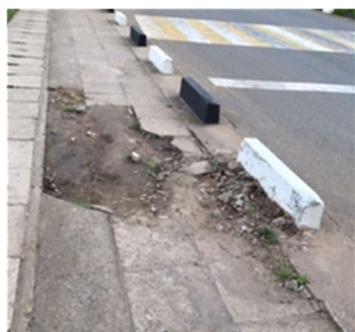
On the other hand, according to the observation by the evaluator at the time of the ex-post evaluation, damages to the sidewalk of the targeted roads were noted. According to BCC, the reasons for the damages are (i) leakage from underlying water pipes, (ii) settling of subgrade material, and (iii) dislodging or cracking of weakly compacted material. On the other hand, BCC also recognizes that the budget is insufficient, and they cannot repair points that they cannot judge clearly by observation as dangerous to pedestrians and drivers. Some plates, which indicate that the Japanese supported the rehabilitation of the road, were stolen³⁰. It cannot help but say that careful maintenance by BCC has been lacking for this reason.

Footpath near a large shopping mall (section 2)

Notable damage was not observed on the roads rehabilitated by the project. Environmental safeguarding measures including planting in the safety zone are in place, and the roads are maintained to some extent. However, some heavy damage was observed particularly on sidewalks. According to BCC, even though the damage of the sidewalks is found, BCC restores it only after that damage causes accidents. BCC should identify all the damaged points on the sidewalks of the targeted roads, secure the budget in advance and restore them before the actual harm is caused. In addition, BCC is recommended to conduct maintenance by setting restoration priorities based on appropriate monitoring of roads in consideration of the City's unstable financial status. Furthermore, BCC should consider taking preventive measures such as stocking spare materials (standardized illumination pillars in particular) before provision and building awareness of facility users.

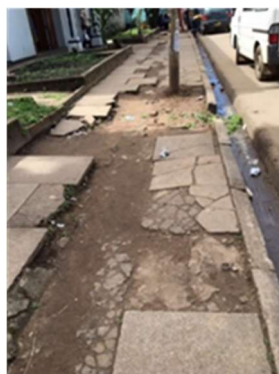
Footpath in Livingstone Av. (section 5)

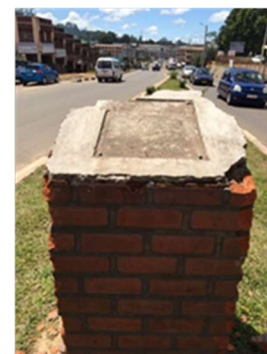
Stolen plate at Yainakis Av. (section 3)

³⁰ BCC explained that these plates were damaged when many people gather for meetings.
