FY2018 Ex-Post Evaluation of Japanese ODA Loan Project

“Pinatubo Hazard Urgent Mitigation Project (Phase III)”

External Evaluator: Miho Sakuma, International Development Center of Japan, Inc.

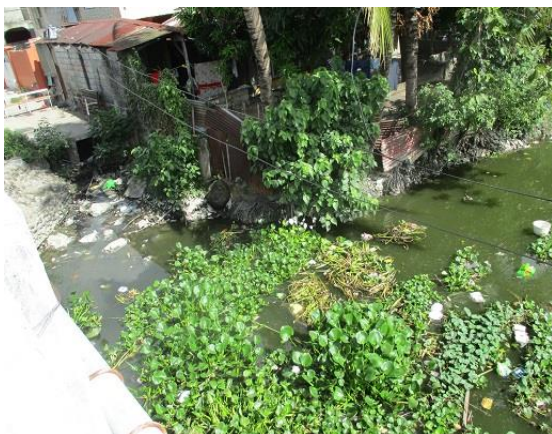
A local drainage channel adjoining the project site, necessary to remove silting accumulated on the riverbed and plants on the river surface

On the other hand, although the effects of this project have been recognized, there are many drainage channels and waterways in the target area, including the Pampanga River and its tributaries, which are not covered by this project. In addition to volcanic ash, weeds and garbage have accumulated on the river beds and surfaces, causing poor drainage. Therefore, it was pointed out that these might be the cause of flooding.

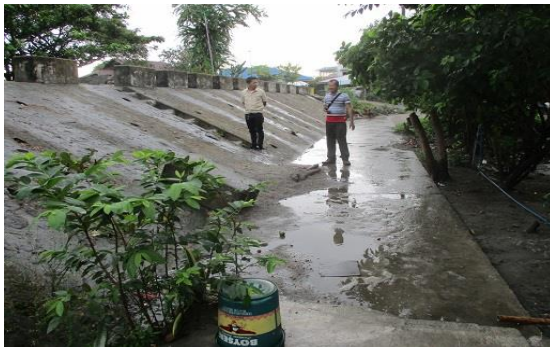
The old road (Center in the photo) and the new road raised by the project (Upper left in the photo)

In this project, road dikes and raised roads were designed to secure vertical evacuation and evacuation routes in the event of flooding from the initial design stage. As a result of the F/S, it has been confirmed that it is difficult to completely eliminate floods in delta areas such as the target river basins. Therefore, from the viewpoint of how to mitigate flood damage, not only

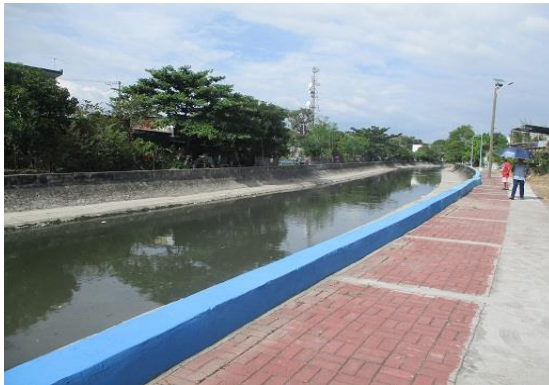
Dredged and widened local drainage channel
