Republic of Senegal

FY2019 Ex-Post Evaluation of Japanese Grant Aid Project

“The Program for Emergency Water Supply for Addressing Climate Change  
for the Republic of Senegal”

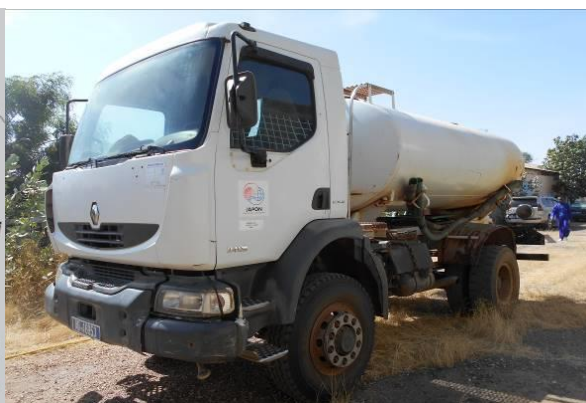
Equipment for emergency water supply  
(Water tanker) procured through the project
