FY2019 Ex-Post Evaluation of Japanese Grant Aid Project

The Project for Rehabilitation of Baluchaung No.2 Hydropower Plant

External Evaluator: Hajime Sonoda, Global Group 21 Japan, Inc.

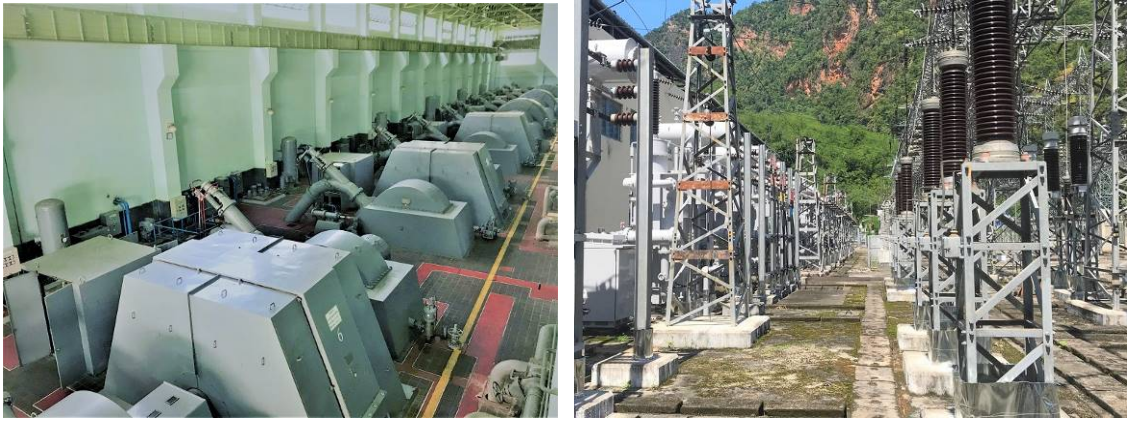
Baluchaung No.2 Hydropower Plant: generating equipment (left), substation equipment (right)
