Country Name	The Project for Water Supply to Small Cities in Southern Part of Amhara Regional State
Federal Democratic Republic of Ethiopia

I. Project Outline

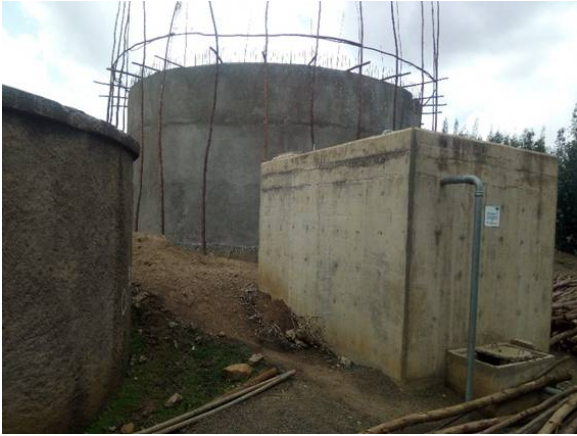
Water reservoirs (left: existing, right: newly constructed in this project, behind: newly constructed by TWU for the use by an additional community)

There were some negative impacts caused by construction of the pipelines according to the interviews at 4 project sites in 2 towns. There were some claims from landowners to the constructed pipes, which pass through their land, and from the communities who were not able to be benefited from the pipes though they pass through the communities. The claims were successfully settled, because WWO applied the regional land use management and regulation guidelines to respond to most of the claims from the landowners and local communities. (For the latter case, TWU decided to build a new reservoir tank at their own cost and supplied the water to the communities.)

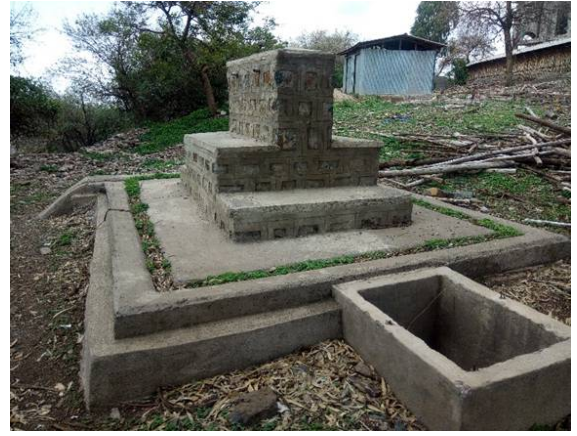
No negative impacts on surface environment have been observed, according to WWO and TWUs. However, there is a sign of negative impacts on the subsurface environment (groundwater). It was reported that water discharge from both some of the newly constructed wells and existing nearby wells had decreased. These phenomena indicate that groundwater may be at a risk of depletion.

Public faucets abandoned because of no groundwater produced

- Consider carefully the impacts on the groundwater conditions for sustainable production of water: Some water supply wells constructed in this project did not yield groundwater as planned. Furthermore, operation of the newly constructed wells reduced the groundwater production rates at some existing neighbor wells. These phenomena clearly indicate overestimation of groundwater production in this project and a potential risk to depletion of groundwater resource in the region, which may cause water conflicts. A similar future project would need to put a more premium on the impacts to the subsurface environment (groundwater conditions). The preliminary field survey should focus on not only water production but also drawdowns (changes in groundwater head) during pumping tests, which indicate the sustainability of groundwater resource and the impacts on other users of the resource. The project requires careful consideration of the regional groundwater balance and should be planned with a viewpoint of comprehensive water

resources management. As a result of these in-depth preliminary studies, it may be concluded, for example, that the project requires an enhanced groundwater recharge (water harvesting) to sustain the groundwater production at design rates while maintaining the groundwater reserve.
