Independent State of Samoa

FY2019 Ex-Post Evaluation of Japanese Grant Aid Project

“The Project for Improvement of Urban Untreated Water Supply Schemes”

External Evaluator: Keisuke Nishikawa / Juri Ishimoto, Japan Economic Research Institute Inc.

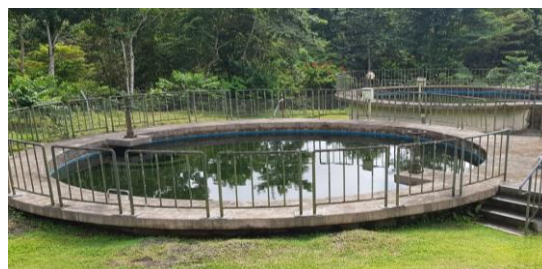
Vailima Water Treatment Plant

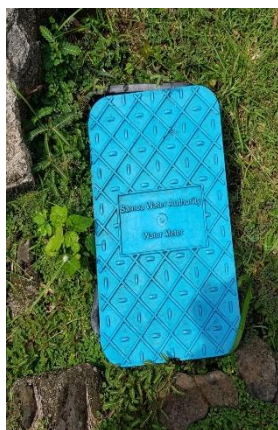
Water Supply Equipment (Water meter)

The number of water supply equipment installed was changed during the project implementation. The connection of the water supply equipment (public service pipes, meter boxes, and water meters) procured under the project to each property was a Samoan responsibility, and the beneficiaries needed to register their water use with SWA for the connection. Although the connection to Vailima WSS was completed as initially planned, Tapatapao and Vaivase Uta WSSs were unable to register a total of 353 units because of absent and unregistered households due to overseas residence and the ongoing development of residential areas. For this reason, the number of equipment to be connected to the three WSSs until the completion of the project was changed from the originally planned 1,280 units to 927 units, and the target year for the completion of the remaining connections was changed to 2025. According to SWA, as of May 2021, Tapatapao WSS connected 734 houses against the planned 293 houses, and Vaivase Uta WSS connected 363 houses against the planned 440 houses.⁶ In the case of Vaivase Uta WSS, although it is below the plan, the progress is good (about 83% of installations are completed) and it is considered that the installation will be able to be completed by the target year. Through interviews with SWA, it was confirmed that other Samoan obligations were implemented as planned.

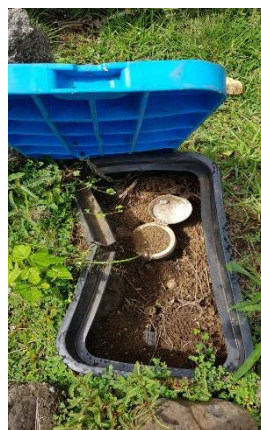
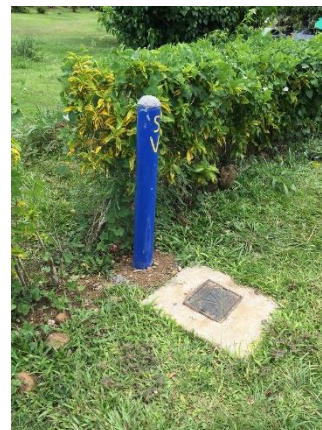
Valve Post

The outputs that were not envisioned at the time of planning were as follows. In Vailima WSS, since there were many incidents of leakage from the existing distribution pipes, additional distribution pipes were laid on three important and urgent routes to ensure a stable water supply to the citizens. In addition, during the project period, a large fire (January 2016)

and a fire at an oil storage facility (April 2016) occurred in areas of Apia that were not covered by the project. The location of the fire hydrant could not be detected at the time, resulting in delays in firefighting operations. As a result, it was recognized that it would be necessary to determine the locations of fire hydrants from the perspective of saving lives, and valve posts were installed at a total of 288 additional locations to make it easier to check the location of fire hydrants and valves. In Samoa, water pipelines and fire hydrants were located together on the side of paved roads, and therefore it was difficult to locate fire hydrants before the installation of valve posts. Currently they can be easily found. The above additional work was the result of a flexible response to the local conditions after the detailed plan was formulated, and is considered appropriate because it was aimed at ensuring a stable water supply and the safety of the residents of the target area.
