“The Project for Construction of Paso Real Bridge” (hereinafter referred to as “the Project”) was implemented with the aim of achieving safe and smooth river-crossing traffic over Matagalpa River on National Route 21 by replacing the existing Paso Real Bridge (temporary bridge) located in Matagalpa Department of Nicaragua with a permanent one, thereby contributing to the facilitation of the smooth flow of goods. At the time of both planning and ex-post evaluation, the Project is highly consistent with the development policy/plan and development needs of Nicaragua. As the Project is also consistent with Japan’s assistance policy for Nicaragua at the time of appraisal, the relevance of the Project is high. The outputs of the Project are as planned with both the project cost and project period being within the planned ranges. Therefore, the efficiency of the Project is high. Since the implementation of the Project, there has been no traffic suspensions due to an increased river water level or other reasons at Paso Real Bridge, and the river-crossing time has been shortened. Moreover, the danger posed by over-loaded vehicles above the weight limit crossing the bridge and the number of

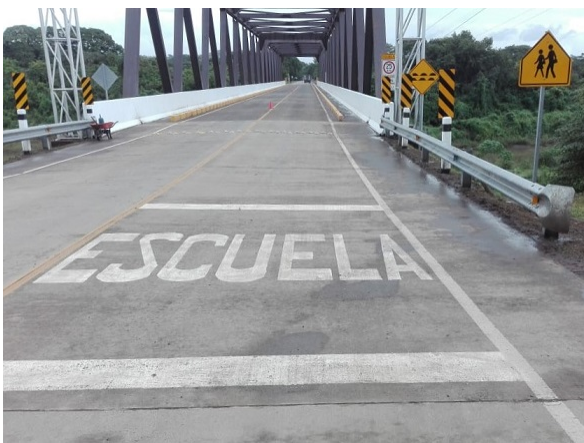
The existence of a primary school at the side of Paso Real Bridge makes the nearby road section, including the bridge, a school zone where the maximum speed is restricted to 25 km/hr. Because of this, the target average travelling speed across the bridge site was set at 25 km/hr at the time of planning and road signs and speed cushions were introduced. In Nicaragua, however, such speed limit for a school zone is routinely ignored and the actual average travelling speed exceeds 25 km/hr. According to local residents living near the bridge, no uniformed policeman is present most of the time. Based on the actual measurement results described above, it is concluded that most vehicles using Paso Real Bridge travel at a speed above the design speed.

Traffic sign for the school zone

- There is a need for the introduction of speed bump to ensure the safety of children using Paso Real Bridge to go to school and to reduce the number of speeding vehicles above the design speed limit of 40 km/hr under the Project. The preferable design of the speed bump is to achieve a sufficient deceleration effect even for large vehicles while limiting damage to passing vehicles (smooth surface of 2 – 3 m in width and 0.1 – 0.2 m in height). These zones should be painted yellow or black, etc. to ensure sufficient visibility. In view of the possibility of vehicles rapidly accelerating after passing the deceleration zone, the introduction of four such bumps is recommended, consisting of two bumps at two entry points of the bridge and on both access road at the some 70 – 100 m point from the bridge.

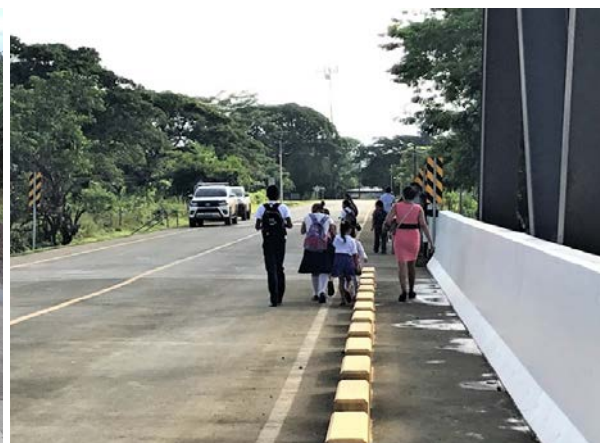
While, most vehicles do not observe the speed limit (25 km/hr) in the school zone during commuting to and from a primary school located at the side of Paso Real Bridge (to be described later in more detail). In addition, the local topography necessitated that the access road on the west side has a steep, sharp bend with poor visibility and a likelihood of natural acceleration for vehicles. Road tacks were put near the bridge under the Project to decelerate the vehicle speed, but their small size means that larger vehicles can pass over them without decelerating. During commuting to the school, pupils (almost all walk on the south side) are overtaken by vehicles from behind. Although the traffic volume at this time is not high, some pupils can be seen walking on the roadway, stepping off the sidewalk of the bridge. For the above reasons, the evaluator believes there is a danger of accidents around the bridge.

Pupils walking to the school
