Country Name	The Project for Selected Market Centres and Rural Water Supply in Mchinji and Kasungu District
Republic of Malawi

I. Project Outline

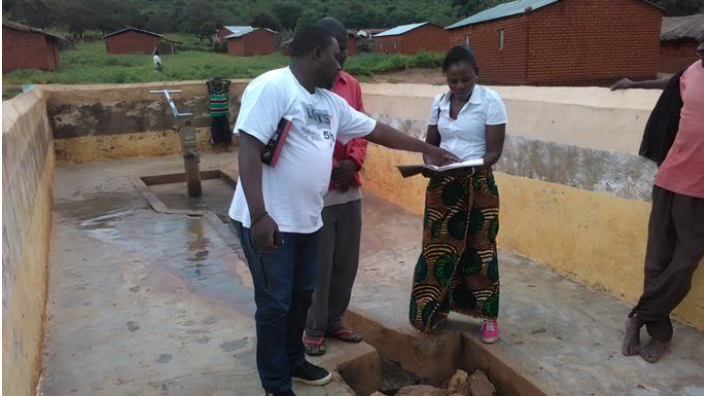
Molosiyo No. 2 Water Point in Mchinji, one of the boreholes constructed by the project. WPC has benefitted from the O&M training during the project.

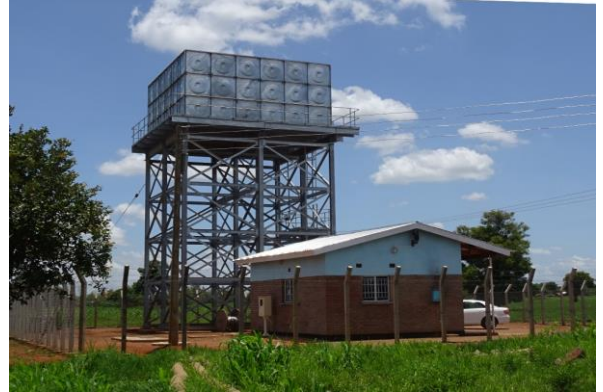
Water tank at Santhe market centre in Kasungu constructed by the project
