FY2020 Ex-Post Evaluation of Japanese ODA Loan Projects

“Karnaphuli Water Supply Project” and

“Project for Institutional Improvement and Advancing NRW Reduction Initiative of
Chittagong WASA”

External Evaluator: Hideyuki Takagi, Ernst & Young ShinNihon LLC

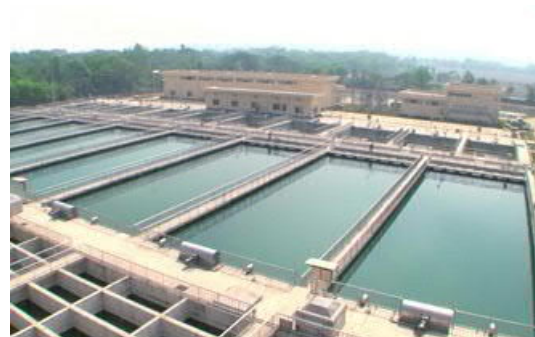
Photo 1. Karnaphuri water treatment plant constructed by the Project (a photo from JICA's project documents)

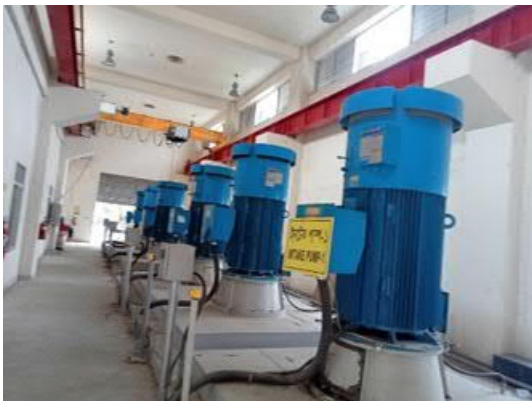
Photo 2. Pump station at Karnaphuli water intake facility (photographed by a local assistant in June 2021)

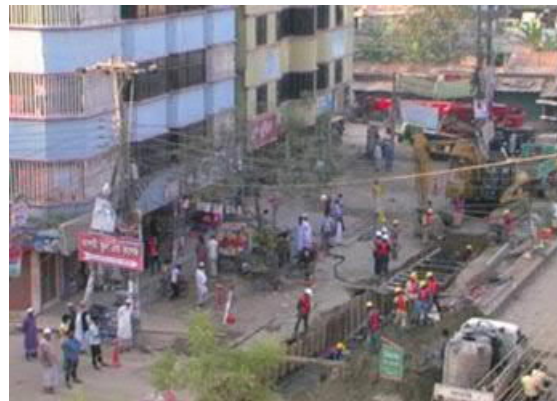
Photo 3. Work to lay distribution pipes (photo from JICA's project documents)

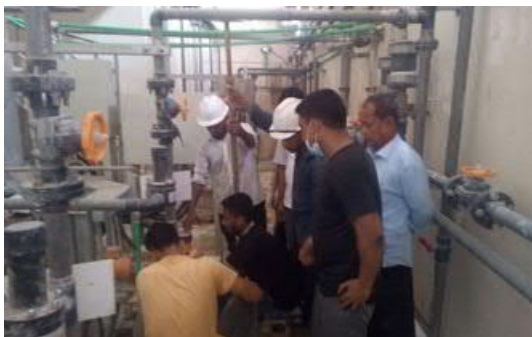
Photo 4. Training on chlorine injection equipment at the Karnaphuli water treatment plant (photo in March 2020, provided by the executing agency)
