Country Name	The Project for Reconstruction of Bridges on New Britain Highway
Independent State of Papua New Guinea

The bridges reconstructed under this project:
Aum Bridge (above) and Kapiura Bridge (below)
(Source: External Evaluator)

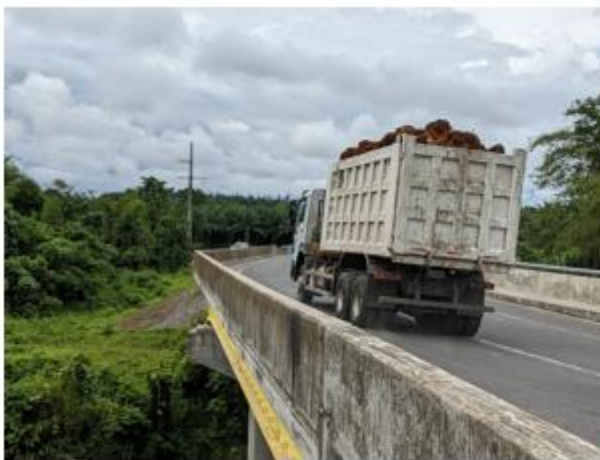
A truck with full of palms is passing through the Aum Bridge (Source: External Evaluator)

The Aum and Kapiura bridges replaced in the project were observed to be in use for traffic without any major problems. According to DOW, the bridge load carrying capacity (Indicator 1) for both bridges satisfied the target value of 88 tonnes, and it was observed that some 45-tonne trucks fully loaded with palm oil and logs passed through the bridges during the field survey. The average driving speed on each bridge (Indicator 2) was set at the target value of 60 km/h. It was confirmed that the speed of vehicles passing on both bridges were generally above 60 km/h by visually checking at the field survey although the actual speed was not measured according to DOW. Therefore, it is considered that Indicator 2 has been achieved. The annual average daily traffic volume (Indicator 3) refers to the number of vehicles per day between Kimbe and Bialla. According to DOW, the target of 772 vehicles/day has been achieved. In addition, all vehicles were observed to be passing smoothly during the field survey though it should be noted that the traffic volume survey has not been conducted after the completion of the project and it is DOW's estimate of traffic volume.

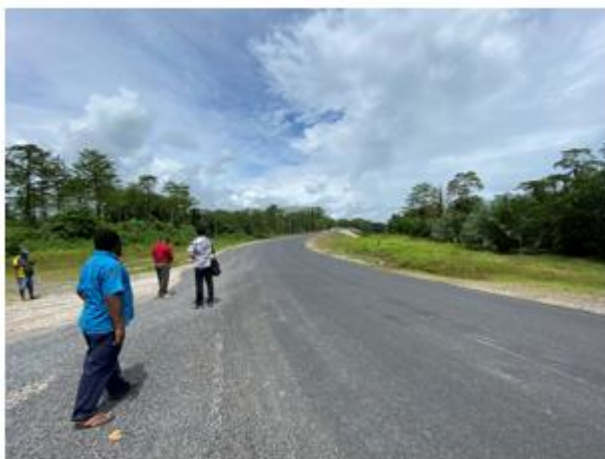
An approach road leading to the Kapiura Bridge has been constructed (Source: External Evaluator)

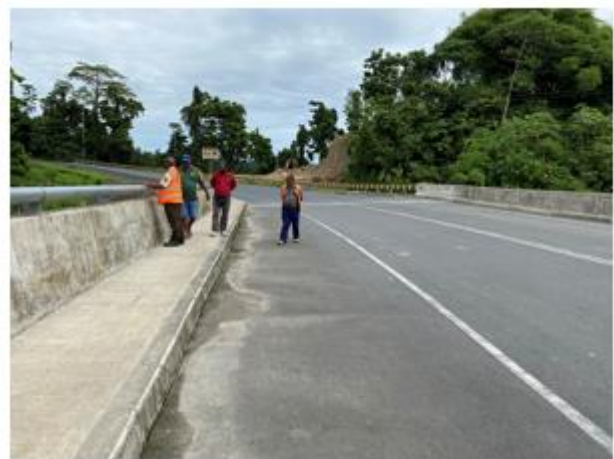
Curbside walkway has been installed on the Aum Bridge (Source: External Evaluator)

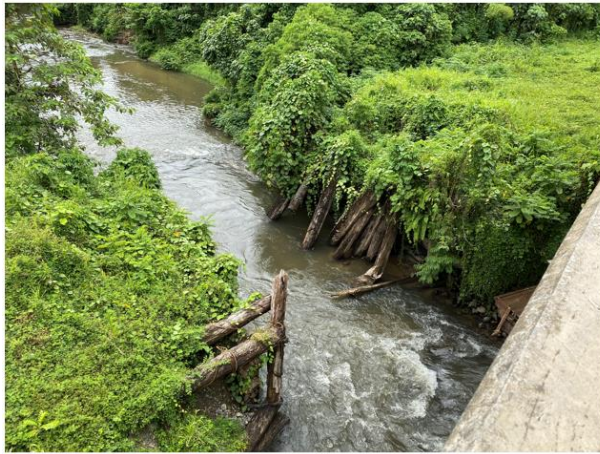
Log bridge incompletely demolished near the Aum Bridge
(Source: External Evaluator)

In addition, in order to ensure the long-term structural stability of the abutment, it is necessary to complete the revetment works and the demolition of the log bridge which have not yet been completed by the Papua New Guinea side.

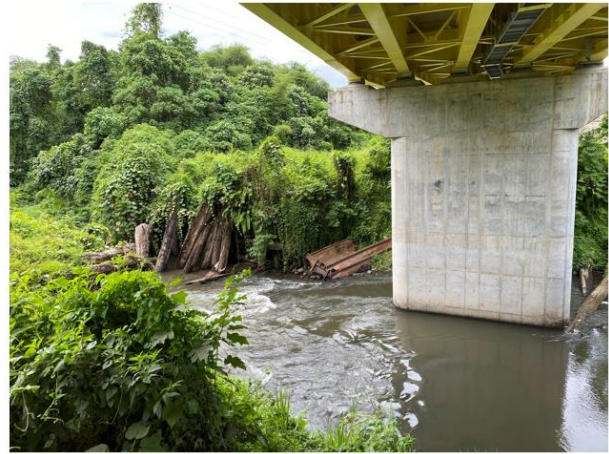
The revetment construction, which was to be carried by the Papua New Guinea side, has not yet been started. It may have a negative impact on the structural stability of the piers of the bridges in the long-term. According to the project consultant, the piers of the bridges have been built to the depth of the river bedrock in accordance with regulations of river management structures in Japan. Therefore, there is no immediate risk of the piers flowing out and the bridges falling due to floods in normal scale. However, depending on the magnitude of the flood, the stability of the piers may be affected by scouring due to levee sediment runoff near the piers.

Unimplemented revetment works of the Aum Bridge
(Source: External Evaluator)

No particular risks which had been estimated at the time of planning have occurred. Similarly, no particular risks against the sustainability of the project effects generated can be assumed. However, it is critical to carry out the revetment works to ensure the long-term stability of the abutment structure.
