FY 2021 Ex-Post Evaluation Report of
Japanese Grant Aid Project

“The Project for Reconstruction of Bridges on Primary National Highway No. 1”

External Evaluator: Keiko Watanabe, Mitsubishi UFJ Research and Consulting Co., Ltd.

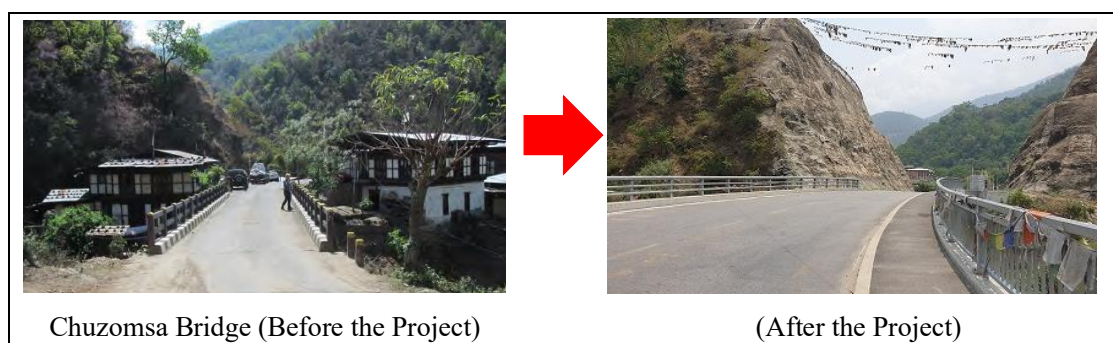
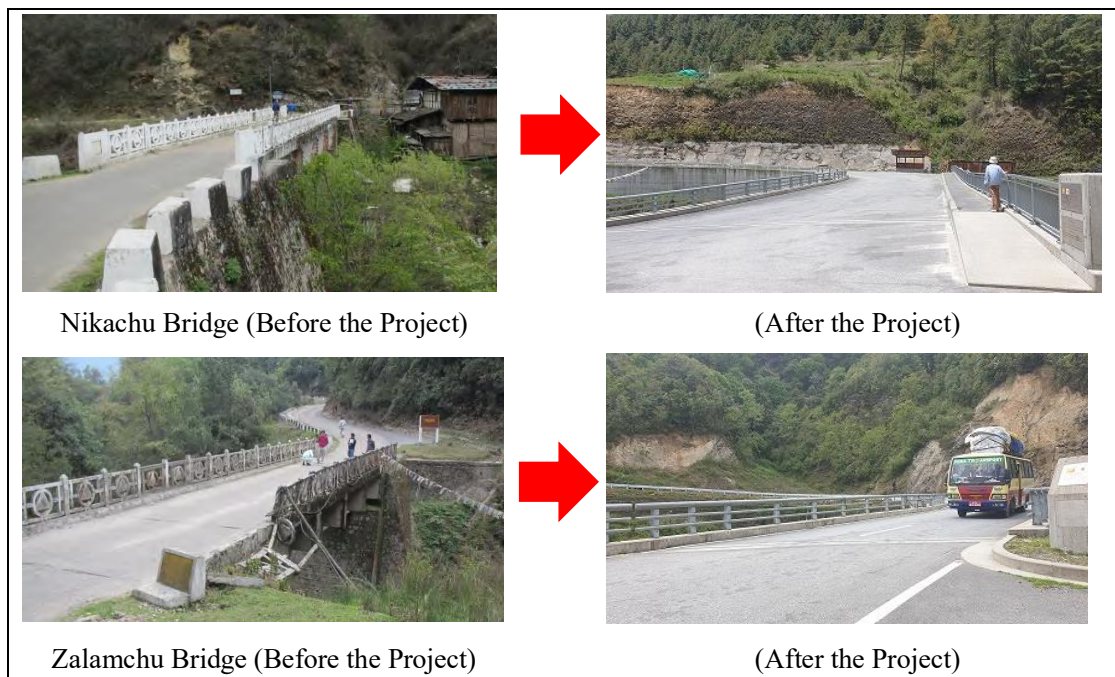
Below pictures are three bridges before and after the project.

Source: Photos before the project are provided by JICA. Photos after the project are taken by the local consultant at the time of ex-post evaluation field survey.

The project is to reconstruct three bridges, Chuzomsa Bridge, Nikachu Bridge and Zalamchu Bridge; to construct approach roads; and construct revetments and install sidewalks for Chuzomsa Bridge and Nikachu Bridge. Table 1 and 2 show the actual results of major outputs. Although there were minor design changes of about 1 m each in the overall width of the bridge and the length of the revetment, according to the executing agency and the implementing consultant, the alignment was changed in order to smoothly connect with the existing road adjacent to the approach road. It was found that the change was made appropriately. Therefore, there were no major changes in the outputs and the project was almost as planned.

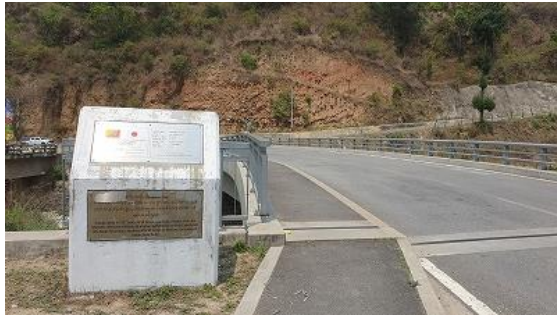
Sidewalk of Chuzomsa Bridge

As for Chuzomsa Bridge and Nikachu Bridge, sidewalks were installed because there were settlements and frequent pedestrian traffic around the bridges. This was at the request of the executing agency, but this project provided the first bridges with sidewalks on the national highway in Bhutan. Even the bridges that were reconstructed with grant aid in the past did not have sidewalks. It has been confirmed that the presence of sidewalks increases the sense of safety and security for both pedestrians and drivers. In particular, the fact that children, people with disabilities, and the elderly, who are vulnerable to traffic accidents, can cross the bridge with peace of mind is an added value that enhances the effects of this project. In this respect, it was shown that this project can be a good example of future bridge construction in Bhutan.

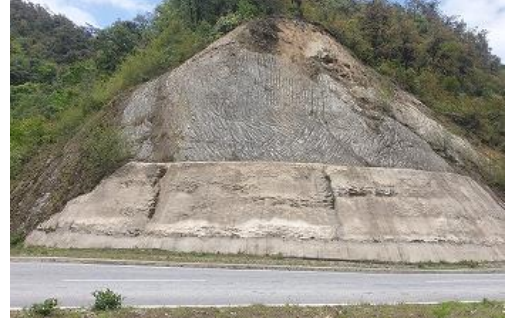
Slope mortar spraying along the access road to Zalamchu Bridge

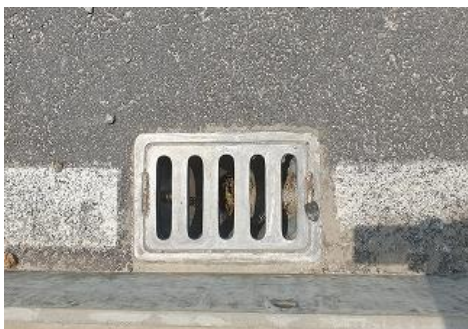
It was confirmed by inspection that there were no major damages on any of the three bridges, and the drainage outlets on the bridges surface, which are important for maintenance, had been thoroughly cleaned. Interviews with local residents also confirmed that the bridges and the roads leading to the bridges are being cleaned regularly (almost every week). According to the regional offices in charge, routine inspections are carried out at least once a week, and periodic inspections are carried out at least once a year. In addition, there was an answer that inspections were always carried out after the monsoon. Therefore, the maintenance status is considered to be good.

Drainage Outlet of Chuzomsa Bridge

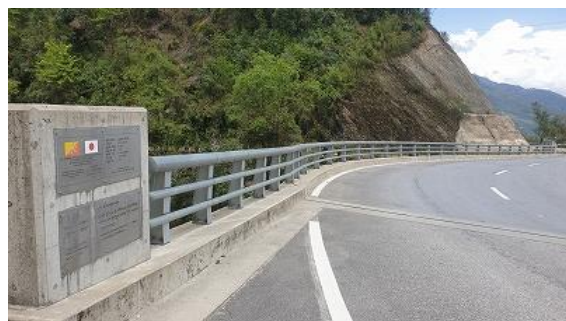
Well-cleaned Zalamchu Bridge

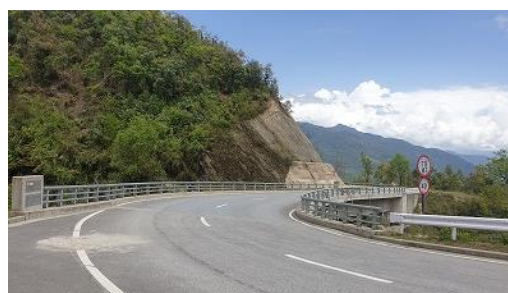
In addition, this project adopted a curved bridge design for the first time in Bhutan. Including past grant aid projects, Bhutan usually uses the design of straight bridges that span rivers at right angles, which sometimes causes vehicles to collide with railings on both sides of the bridges, and there

Curving Zalamchu Bridge

were many bridges which do not have railings to avoid accidents. In this project, there was a risk that a straight bridge would cause such danger due to its location, so it was decided to design the front and rear of the bridge in a curved line rather than at right angles (straight lines) to the river
