FY2021 Ex-post Evaluation Report of
Japanese ODA Loan Project

“Project for the Construction of Major Bridges on National Road Network”

External Evaluator: Tomoko Tamura, Kaihatsu Management Consulting, Inc.

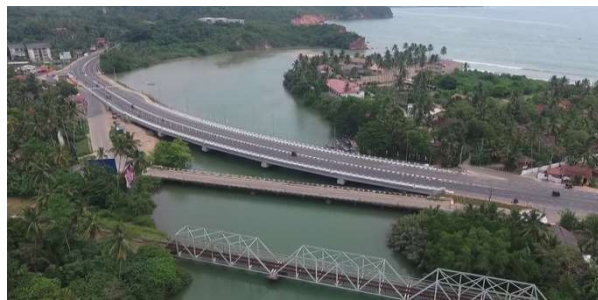
Polwathumodara Bridge, Matara District, Southern Province

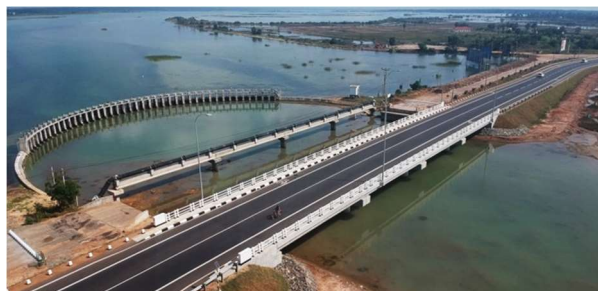
Navatkuli Bridge, Jaffna District, Northern Province

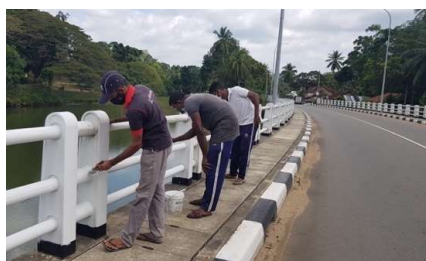
During the first field survey of the ex-post evaluation, minor cracks on the paint of the handrails, minor corrosion on the underside of the beams, partial damage to the lid of the sidewalk section, and lack of lighting due to problems in bulbs or power distribution, were found on some of the bridges. At the time of the second field survey, it was found that these defects had already been addressed or were being worked on, and those that were less urgent were scheduled to be addressed in the next periodic maintenance.

Re-painting of handrails
(Denagama bridge)

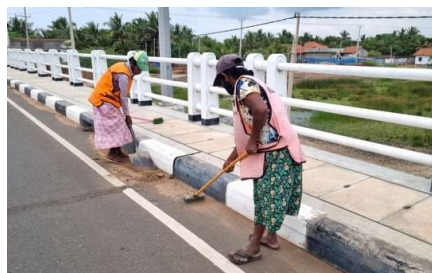
Cleaning of bridge surface
(Aru Kuli bridge)
