| Country Name | <b>the Programme for Community-based Flood Disaster Management to Adapt to Climate Change in the Nyando River Basin</b> |
| Republic of Kenya | |

**I. Project Outline**

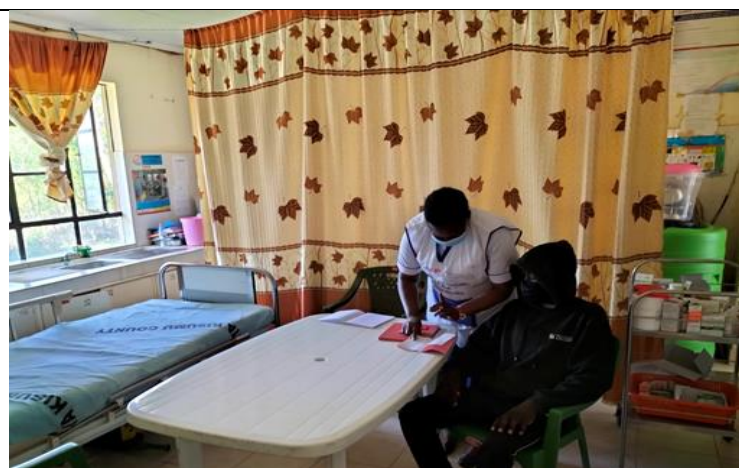
Nurse treating a patient at Komwaga Evacuation/Health Centre.

- The evacuation centres established under the project have been used not only for disaster management but also for multiple purposes, such as providing basic medical services to the community as required. This has led to a positive impact that was not initially envisaged, such as improved access to medical services, as well as improved disaster management. In addition, the evacuation centres, that also served as health centres, were able to receive financial support for O&M of the facilities from the County Government's health sector budget and donor health projects. Therefore, from the perspective of sustainable maintenance of facilities, it is important for JICA to closely collaborate and share information with stakeholders (National and County Governments, local authorities, NGOs, donors, etc.) who are interested/involved in solving development issues of local communities in future similar projects, right from the project formulation stage. It is also advisable to consider the possibility of effective utilization and multi-purpose use of project facilities.

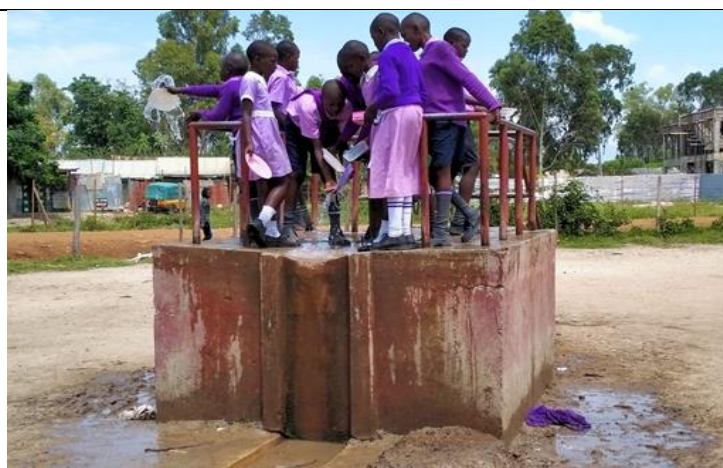
Pupils using a borehole and washing their lunch dishes at Rae-Kanyaika Primary School in Mowlem.

Most of the facilities established through the project have been maintained and continuously utilized. it was confirmed that primary schools in Mowlem and Achuodho have planned maintenance activities and regularly procured spare parts and consumables for boreholes in a timely manner. However, appropriate implementation of procurement of boreholes’ spare parts is dependent on the social and natural conditions in each community. For example, Kisumu water company has provided piped water in Kamuga, so the community has very little incentive to contribute to the maintenance of the borehole. Also, at Kanyilum, the water gradually turned very saline to the extent that the borehole is no longer utilized at all although the reasons for this are not clear.
