FY2023 Simplified Ex-Post Evaluation Report of Japanese Grant Aid Project

Country Name
Republic of Angola**The Project for Improvement of Namibe Port**

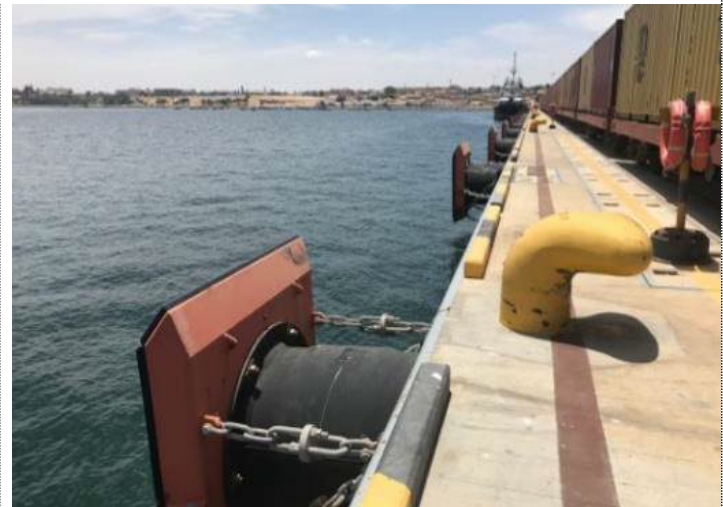
Cell-type fenders and mooring bollard installed at Namibe Port (source: photographed by the evaluator)

The fenders installed in the previous grant aid project (The Project for Emergency Rehabilitation of Port Facilities 2008-2010) were damaged within a year, so the EPN was concerned about the durability of the fenders from the time it commenced the design of this project. As the fenders installed in this project were highly durable, they were in good condition at the time of the ex-post evaluation. It will be important to continue using them appropriately, in order to keep them good condition going forward. The EPN will need to instruct and manage the private concessionaire to ensure that the facilities are used within the appropriate cargo ship weight and berthing speed ranges. The method of operation was indicated by the project implementation consultant as a notable point of operation, and it will be important to clearly state it as an operation rule if necessary.

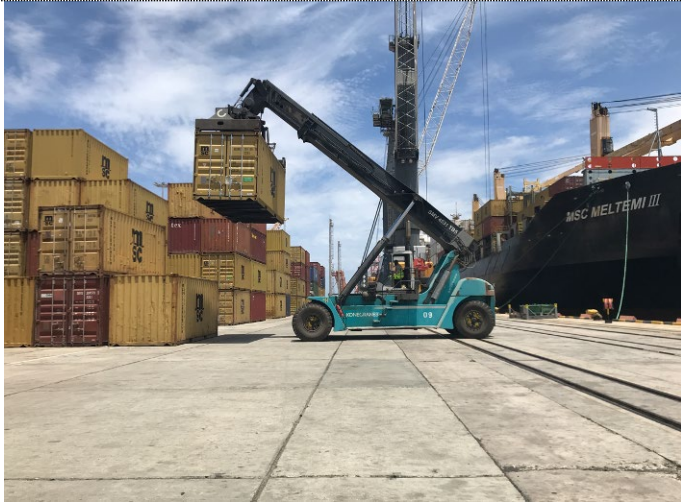
Concrete paved apron/yard (source: photographed by the evaluator)

Although some parts of the renovated facilities were found to be in need of repairs during the project, they had already been repaired by the time of the evaluation, and the facilities were maintained and operated without problems. There was no major damage to the pavement of the apron/yard, but one spot was found to have sunk by about 5cm. The defect inspection confirmed that the sunk spot had been repaired, and the repair of the spot was later confirmed in the repair inspection conducted by the project implementation consultant on March 7, 2023. Further, during the field survey, the executing agency pointed out that the surface finish of the apron pavement was different from that of the adjacent panels. The surface paved in this project was finished by “broom finishing,” a standard surface finish recognized internationally, in order to reduce the risk that machines or workers would slip when water collected on the surface. While this surface may lead to tire wear of the working machines, the consultant allayed the EPN’s concerns on this point during the defect repair inspection by explaining the anti-slippage benefit. The container storage location markings on the yard still remained during the evaluation. There were no problems with the renovation to the concrete for the superstructure of Namibe Port 3B quay, car stop blocks, mooring bollards, and fenders. Parts of the fender that had rusted or were missing nuts were judged to be in need of repair in the defect inspection, and the corresponding defects were subsequently repaired.

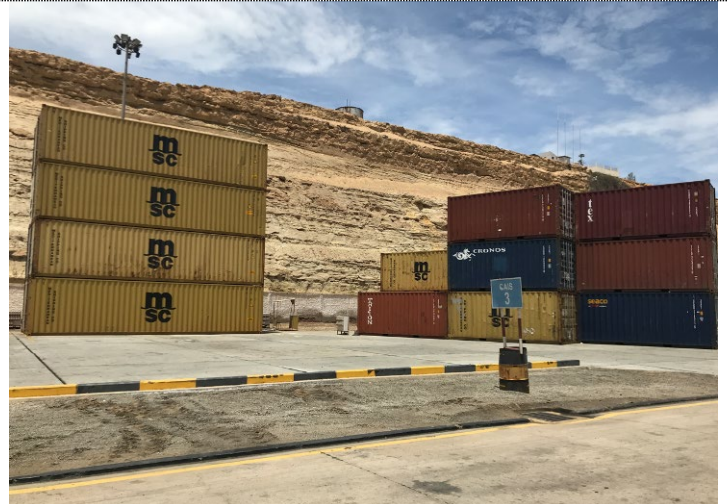
Concrete paved reefer container yard (source: photographed by the evaluator)
