FY2022 Ex-Post Evaluation of Grant Aid Project

Grant Aid “The Program for Rehabilitation and Recovery from Nepal Earthquake”

External Evaluator: Mitsue Mishima, Ryo Matsumaru<sup>1</sup>, OPMAC Corporation

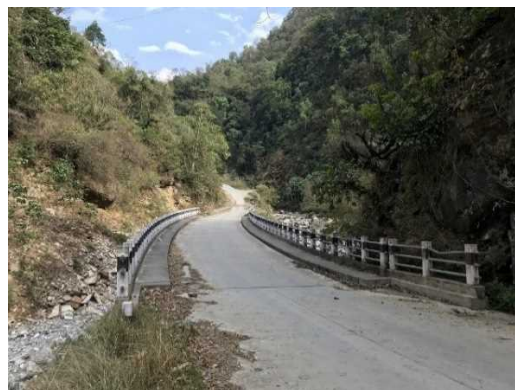
The Rangrung River Bridge  
Subject to Barhakilo-Barpak Road Bridge Project

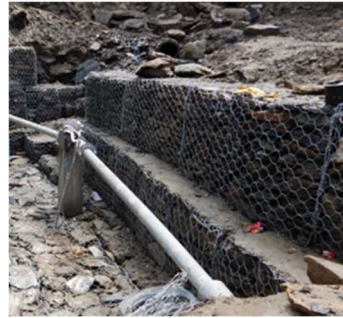
Photo 4: Holche system water pipeline  
(At the time of the post-evaluation,  
source: external evaluator)

The field survey at the time of the post-evaluation did not reveal any particular areas in need of immediate repair, except for the water pipe of the Holche system, which is already being repaired by WUC.

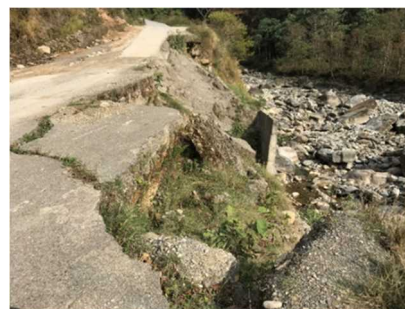
Photo 7: Location of collapsed approach road and a portion of the retaining wall at the Rangrung Khola Bridge. (Source: external evaluator)

During the field survey at the time of the post-evaluation, it was found that the approach road and part of the retaining wall for the Rangrung Khola Bridge had collapsed (see Photo 7) because of a heavy rainfall in June 2022 that had exceeded the designed water level of the river. At the time of the post-evaluation, there were no problems with vehicle traffic. However, cracks can be seen in the areas where the road collapsed, and there is a high risk of further road collapse if another flood event of the level that caused the collapse were to occur.

In June 2022, there was heavy rainfall that exceeded the designed water level, causing and the approach road and retaining wall of the Rangrung Khola Bridge to partially collapse. This had not been repaired at the time of the post-evaluation. There is a high risk that similar heavy rainfall in the future could cause further road collapse in this area. Therefore, it is recommended that

As mentioned in section "3.4.6 Preventive Measures to Risks", the levee of Rangrung Khola Bridge needs to be repaired as soon as possible, and a budget request has been made for FY2023 for the cost of the work.

repairs are conducted as soon as possible. As planned at the time of the ex-post evaluation (August 2023), a budget should be secured during the 2023 fiscal year to ensure that the measures are implemented.

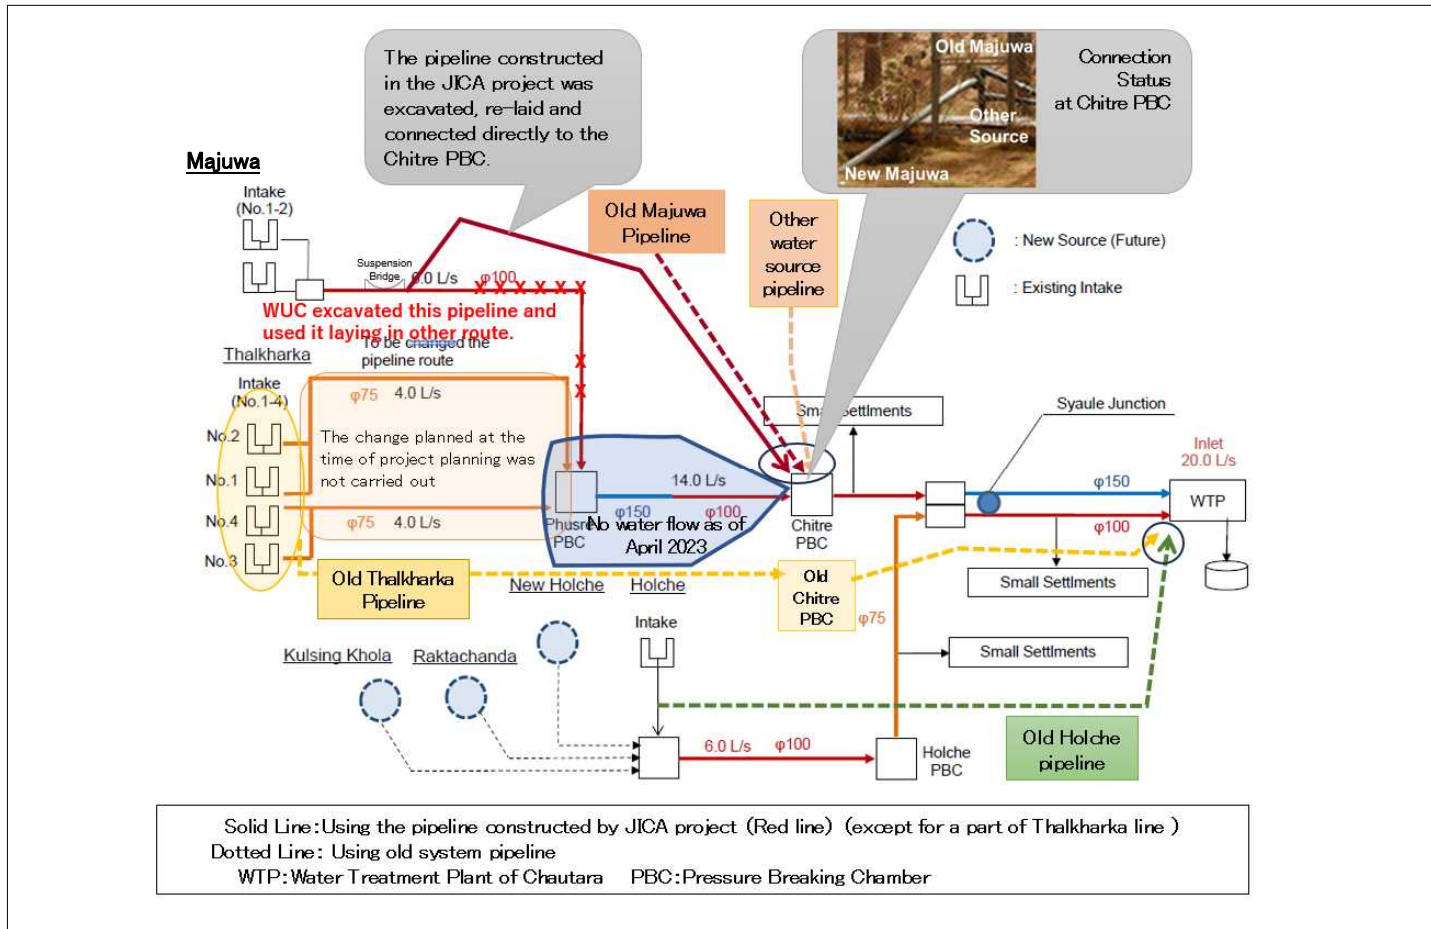
Attached Diagram: Chautara Water Transmission System (as of April 2023)

For the Majuwa water pipe constructed under the project, WUC had re-laid the water pipe route in July 2020, two years after completion in July 2018, changing the connection point from the Phusre PBC to the Chitre PBC. In addition, it was found that the water pipe between Phusre and Chitre was not being used at the time of the post-evaluation.
