| Country Name | Project for Hydro-microbiological Approach for Water Security in Kathmandu Valley, Nepal |

I. Project Outline

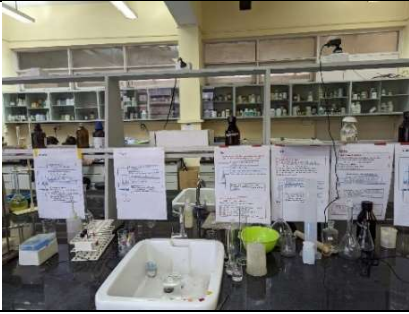
SOPs and manual being utilized in IOE Lab

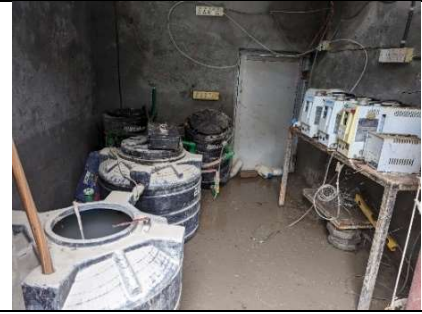
So far, eight LCD water treatment systems have been installed, but it was identified by the study that two of them have not been functioning. The one located in Jwagal UN Park had a problem in the hydrogen gas equipment damaged by floodings and could not be repaired due to the unavailability of the spare parts in the local market.⁶ The other is in Lokanthali with a problem on the transformer, but it is expected to be fixed shortly since KUKL in coordination with KVWSMB is in the process of procurement of a new transformer. One of the hydrogen gas generators of the LCD water treatment system at Chapacho has not been working and has been left unrepaired because of the unavailability of necessary components in the market for replacement.⁷ Several other equipment, such as water purifiers, cover of centrifuge and sand filter, have not been functioning as expected due to the unavailability of spare parts or necessary components for repairment in the local market.

Hydrogen Gas Generator, Jwagal LCD, being damaged due to inundation from flooding

⁶In spite of the efforts made by KVWSMB, LCD water treatment system in Jwagal UN Park is nonfunctioning at present due to the unavailability of spare parts.

- Natural disasters are unpredictable and it is impossible to procure appropriate equipment considering unforeseen disaster. Nonetheless, when selecting equipment to be provided in the project in disaster affected country like Nepal, the availability of spare parts in the domestic market should be confirmed in the ex-ante evaluation phase. If it proves to be impossible to procure locally, and procurement of the appropriate equipment is necessary to achieve the project objectives, then maintenance methods should be considered against any incident such as natural disasters. This is important to avoid abandonment of the equipment that, once malfunctioned or not functional. Some of the equipment used in the project was manufactured in Japan, and its spare parts were not available in the Nepalese domestic market nor in the Indian market. Due to this lack of availability of spare parts, some of the equipment was left non-functional after natural disaster (e.g., hydrogen gas generator).
