FY2023 Ex-Post Evaluation Report of Japanese Grant Aid Project

“The Project for Reconstruction of the Nippon Causeway”

External Evaluator: Keisuke Nishikawa, QUNIE CORPORATION

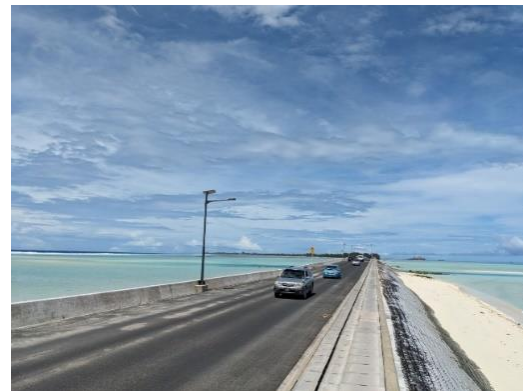
The Nippon Causeway reconstructed in this project (Source: External Evaluator)

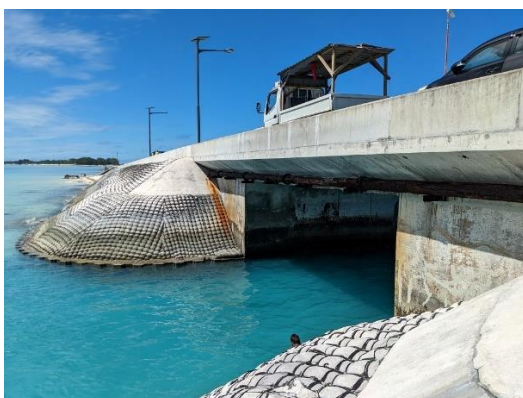
Photo 1: Bridge and waterway  
(Source: Photo taken by the external evaluator)

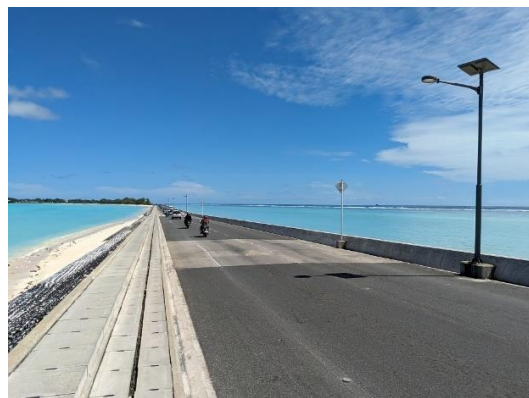
phase of the project, and the area positioned as a sidewalk actually functioned only as a shoulder rather than a sidewalk. In addition, the utility box was installed at a higher level than the road surface, which was linked to safe passage for the elderly who have no difficulty in walking, but did not necessarily ensure a safe sidewalk for the persons with disabilities, as no handrails or step-over ramps were provided.

Photo 2: Utility box, speedhump and streetlight (Source: Photo taken by the external evaluator)

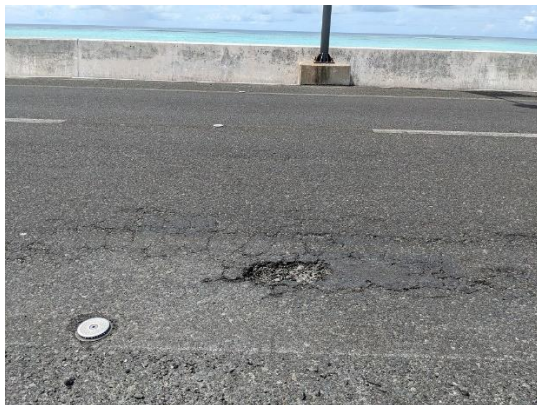
Potholes and cracks began to appear on the surface of the Nippon Causeway within one year after completion of the project. Although they were generally repaired at the time of the defect inspection, they were found in more than 10 locations at the time of the first field visit in November 2023, including recurrence in the same locations. As a result of repairs by CES, the number of potholes was reduced to a few at the time of the second field visit in April 2024, but frequent repair work will likely need to be continued in the future. According to the follow-up status survey in 2023 by the project consultant, although the road base was not damaged and there were no problems with its function as a road, the cause of such frequent potholes was mainly due to the breakdown of the asphalt plant during the project implementation, and the homogeneity of the asphalt mixture quality was not sufficient, and this was due to the fact that the asphalt content was low in some parts.

Photo 5: Pothole on the Nippon Causeway  
(Source: Photo taken by the external evaluator)

In order to ensure smooth and safe traffic between Betio and Bairiki Islands continuously, it is important for MISE to repair potholes and cracks on the Nippon Causeway as soon as they are identified, before they widen. In order to ensure its implementation, it is necessary to have road repair equipment that is properly maintained, and it is important to work on improving the capacity for equipment management as well.

It was revealed in the ex-post evaluation that the pavement quality of some sections of the Nippon Causeway is likely to be low and prone to potholes and cracks, mainly due to the failure of the asphalt plant. Since it remains possible that those potholes and cracks may spread to a scale that cannot be handled by the repair capabilities of the executing agency, it is critical to frequently monitor the status of the situation and provide necessary cooperation, including support for improving the inspection and maintenance capabilities of road maintenance equipment, as necessary.

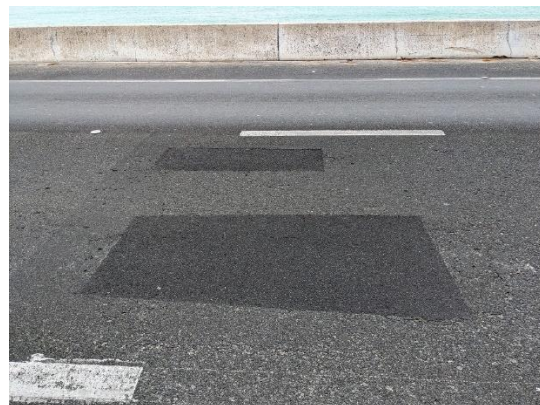
With regard to repair, the executing agency indicated that the maintenance manual on pavement repair prepared under the soft component of the project is referred to by the CES staff as needed<sup>13</sup>. Although the materials needed for rehabilitation (e.g., cold mix asphalt) are purchased from overseas, as mentioned above, there are challenges in maintaining road maintenance equipment in an environment where pavement surfaces are prone to deterioration and damage due to high temperatures and salt damage, and road surface repairs are not always performed at a satisfactory level. In addition, as noted above, spare parts for road maintenance equipment were not procured in a timely manner, and in the ex-post evaluation, some areas were found to have potholes and cracks in the same areas again after repairs.

Photo 6: Road surface repaired by MISE  
(Source: Photo taken by the external evaluator)
