Country Name Kingdom of Bhutan	<b>The Project for Reconstruction of Bridges on Primary National Highway No. 4</b>
-----------------------------------	--

## I. Project Outline

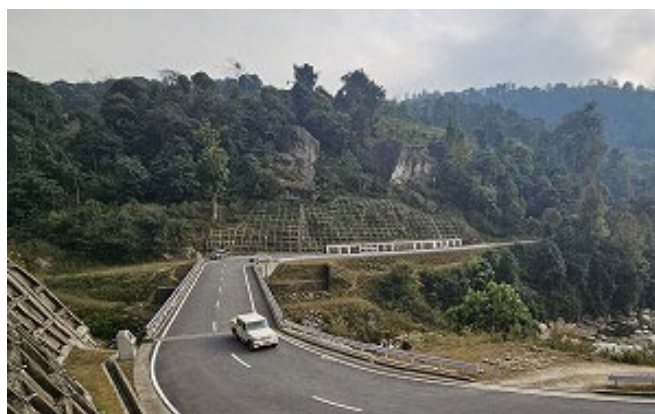
Samkhara Bridge  
(Source: Photo taken by the evaluator)

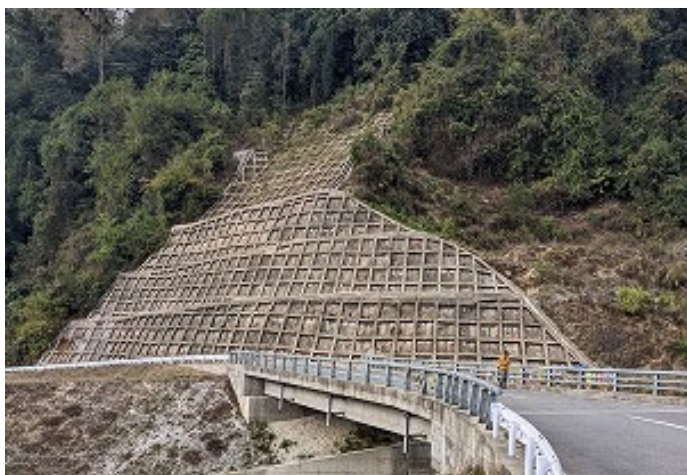
Slope Protection Works at Beteni Bridge  
(Source: Photo taken by the evaluator)

When bridges are constructed with the Japanese grant aid, bridge, approach roads and, if the bridge is located in a mountainous area, measures to prevent slopes on the cut surface on the approach roads, are implemented as a set. On the other hand, in bridge construction usually carried out by the Bhutanese side, due to the budget constraints, measures are taken to keep the slope angle within the specified range depending on the soil type of the slope, but not as extensive as the cutting measures work to be carried out through Japanese grant aid. As a result, even after the construction, rockfalls and landslides can occur during the monsoon season. In comparison, in the vicinity of Teleganchu, Samkhara, Beteni bridges, where cutting measures works were implemented in this project, no such accidents have occurred after the project. The bridge reconstructed project funded by Japanese grant aid is a high value-added project that will not only reconstruct bridges but also implement slope protection works in the surrounding area, thereby further increasing safety and effectiveness of the project.

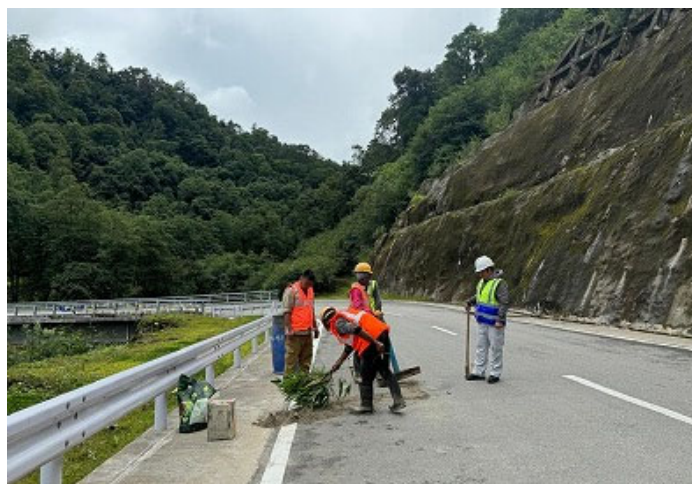
Repair works of potholes of approach road of  
Teleganchu Bridge (Source: DoR)

The maintenance status is considered to be generally good. It was confirmed by inspection that there were no major damages on any of the four bridges, and the drainage outlets on the bridges surface, which are important for maintenance, had been thoroughly cleaned. On the other hand, during the first field survey, several potholes (indentations) were found on the surface of the approach roads of Teleganchu and Beteni bridges. In addition, cracks in the liner plate (earth retaining) of Passang Bridge were observed. The executing agency repaired the damage at these three locations as pointed out by the external evaluator. The completion of repairs was confirmed by photographs of the repaired areas submitted by the executing agency.

Minor damages such as potholes in the approach roads and cracks in the liner plates were identified during the field inspection. Although the repairs have been carried out in response to the finding during the field survey of the ex-post evaluation, even minor damages such as this that does not affect the bridge itself should be addressed as soon as it is discovered, before the damage escalates.
