FY2023 Ex-Post Evaluation Report of Japanese Grant Aid Project

“The Project for the Rehabilitation of Sindhuli Road affected by Earthquake”

External Evaluator: Juri Ishimoto, Metrics Work Consultants Inc.

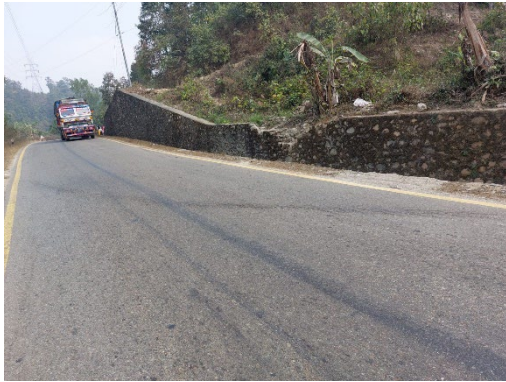
Photo (8) Sidewalk on the Sindhuli Road  
(outside the yellow line)

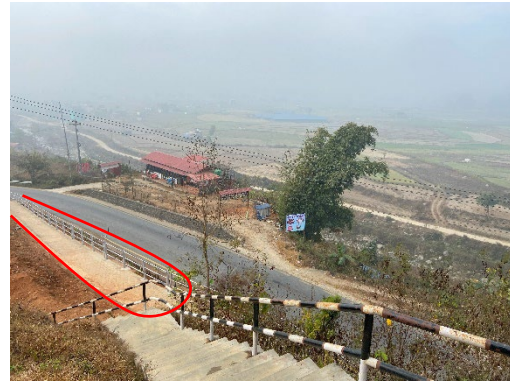
Photo (9) Newly constructed sidewalk  
(red line)
