FY2023 Ex-Post Evaluation Report of Japanese ODA Loan

“Melamchi Water Supply Project”

External Evaluator: Yukiko Sueyoshi, International Development Center of Japan Inc.

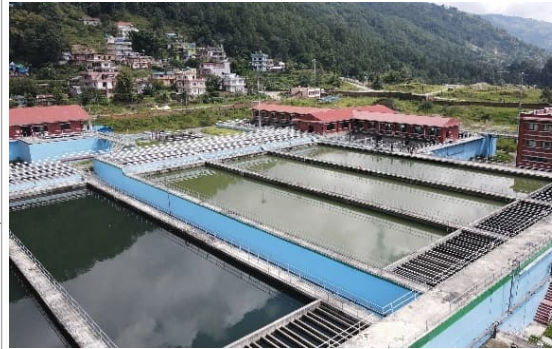
New Sundarijal Water Treatment Plant
(source: Implementing Agency)

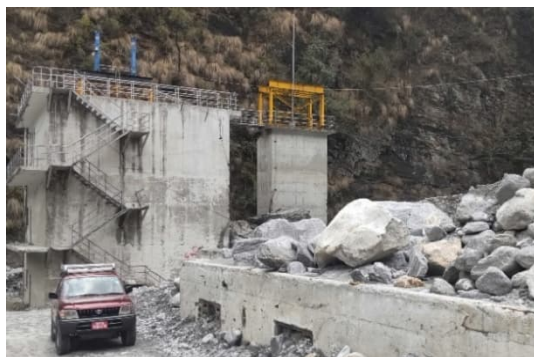
raw water from the Melamchi River commenced. However, within three months, a severe flood and landslide occurred near the intake facility in June 2021, causing extensive damage to the infrastructure. As of the time of the ex-post evaluation, restoration of the intake facility to its original condition was deemed almost impossible (see 3.4.6 Risk Response for future restoration plans).

Photo 7 Part of water intake facility buried by mudslide

The Kathmandu Valley and surrounding watersheds are susceptible to frequent natural disasters, including active seismic activity, floods caused by glacial lake outbursts, and landslides resulting from the fragile ground. Additionally, it has been noted that climate change may lead to more frequent heavy rains and floods during the rainy season, as well as severe water shortages during the dry season²². Furthermore, the upper Melamchi River basin has been identified as particularly vulnerable, with a high potential for recurring floods and landslides²³. These factors present future risks in the relocation and construction of the water intake facilities, and consequently, for the continued operation of the new Sundarijal water treatment plant. In November 2024, the ADB approved the Kathmandu Valley Water Supply Improvement Project (Phase II)²⁴. This phase, in addition to the relocation and construction of water intake facilities, includes the expansion of water treatment plants and the water supply network, the establishment of an early warning system, the strengthening of KUKL's financial management capacity, and support for community rehabilitation in the Melamchi intake area. Detailed design and bidding documents for the relocation and construction of the intake facility will commence in 2025, with two years of construction work set to begin in 2027. The completion of all projects is planned for 2030.

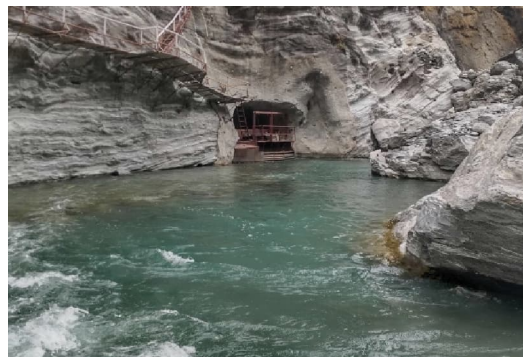
In response, the Nepalese authorities installed a temporary, simplified intake point upstream of the damaged facility. Water intake from the Melamchi River resumed in December 2022, approximately 18 months after the flooding, via a bypass route. Following technical guidance provided by contractors, the water treatment plant facilities were officially handed over to KUKL in March 2023, enabling the commencement of water supply services.

Photo 8 A simple water intake installed as an emergency measure

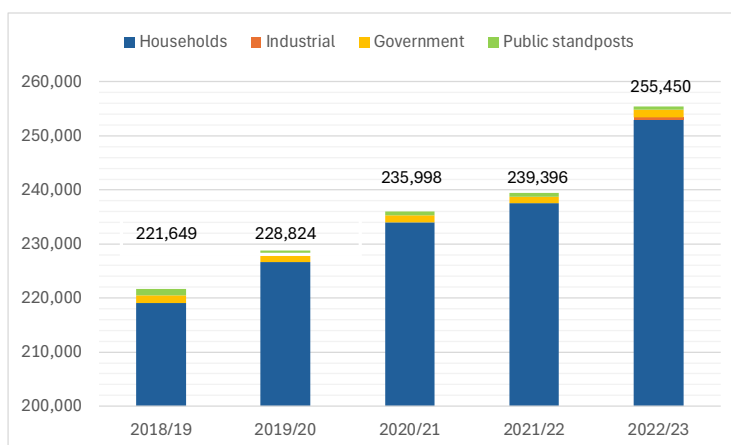
As illustrated in Figure 3, the number of water supply taps has consistently increased, with a notable surge in FY2022/23, reflecting a significant rise compared to the previous year. KUKL attributes this growth primarily to the ongoing improvements in the water distribution network, including the installation of water meters, which are being funded by the ADB loan. Additionally, it can be inferred that the commencement of water supply from the Melamchi River has led to increased demand for KUKL's water services. Therefore, the increase in the number of water supply connections can be regarded as a synergistic outcome of

Figure 3 Changes in KUKL's Connected Water Taps

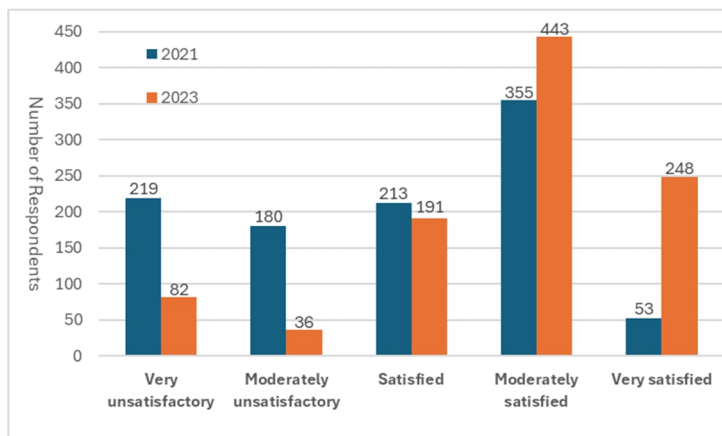
Figure 4 Satisfaction with KUKL's overall services

Figure 4 illustrates the significant improvement in user satisfaction with KUKL. Prior to the commencement of water supply from the Melamchi River, it was not possible to deliver water as notified to customers in advance due to inadequate water availability. However, water is now supplied as planned, although this occurs only during the dry season. Furthermore, the improvement in water quality is considered another contributing factor to the enhanced satisfaction levels.

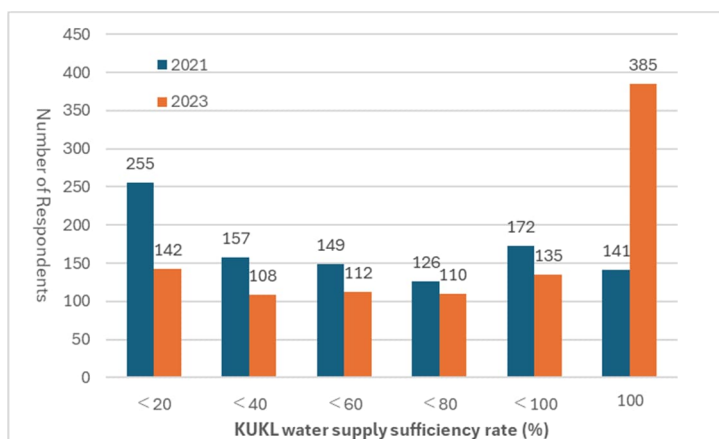
Figure 5 Sufficiency ratio of KUKL water supply to domestic demand
