FY2024 Ex-Post Evaluation Report of  
Japanese Grant Aid Project

“The Project for Reconstruction of Somalia Drive in Monrovia” and “The Project for  
Reconstruction of Somalia Drive in Monrovia (Phase 2)”

External Evaluator: Hiroyo Onozato, Koichi Sato,  
International Development Center of Japan (IDCJ)

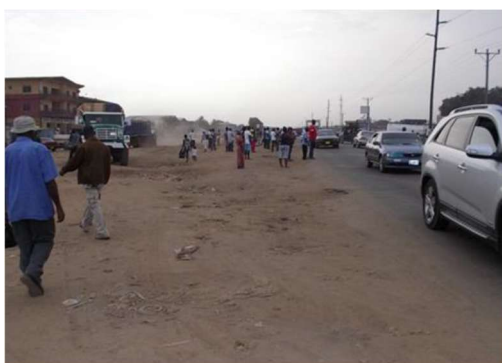
Photo 1: 2km from Freeport before the project commencement (March 2014) (Source: JICA document)

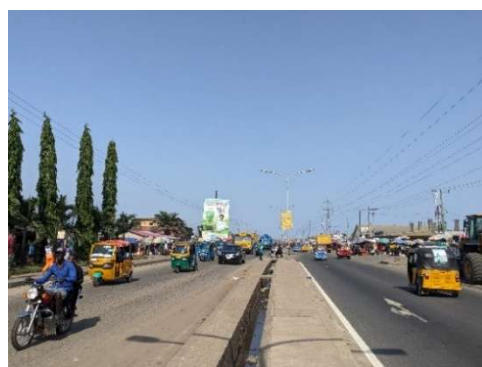
Photo 2: Near the 2km point at the time of the ex-post evaluation (April 2025) (Source: Evaluator)

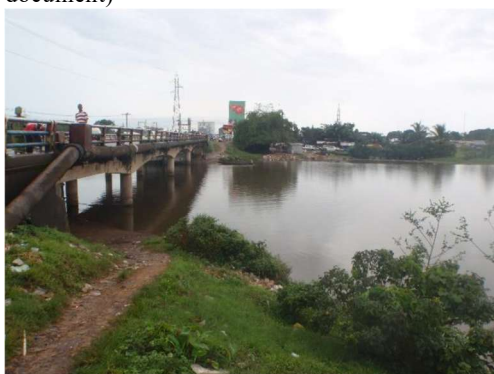
Photo 3: Stockton bridge before the project commencement (February 2013) (Source: JICA document)

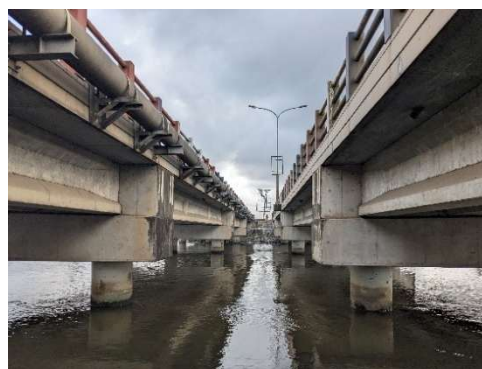
Photo 4: At the time of the ex-post evaluation (November 2024) (Source: Evaluator)

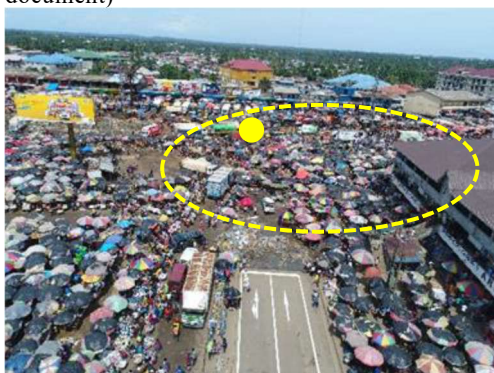
Photo 5: 13.2km point at the time of Phase 2 completion (July 2021) before the rehabilitation of the Red Light Junction (Source: JICA document)

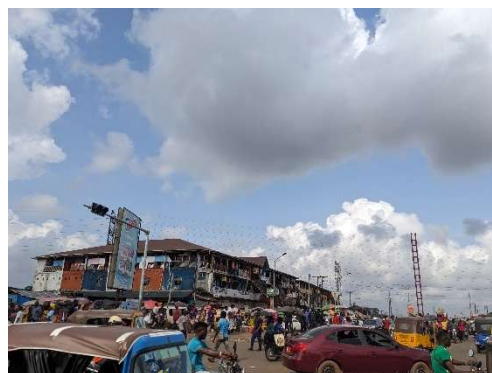
Photo 6: Red Light Junction at the time of ex-post evaluation (November 2024) after the completion of World Bank supported project. Traffic flows into Somalia Drive. The photo of circled area was taken from the ● point indicated on Photo 5. (Source: Evaluator)

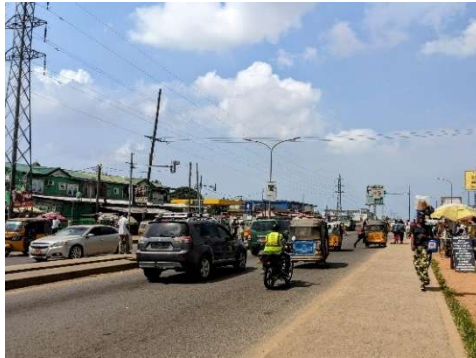
Photo 7: New Georgia Junction. Traffic signals are functioning. Traffic flow is smooth even in peak hours. (Source: Evaluator)

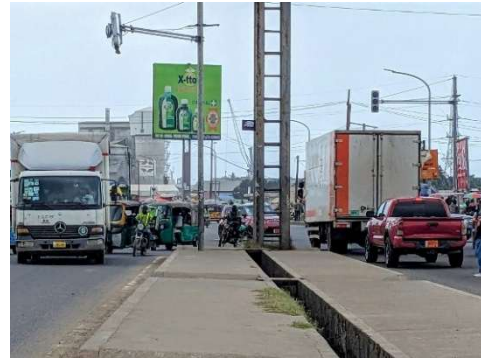
Photo 8: Jamaica Road Junction. Traffic signals are not functioning as a car hit the pole. No traffic congestions were observed during peak hours. (Source: Evaluator)

- c. **Traffic Signal Restoration:** At the Jamaica Road junction, one of the traffic signals has been damaged due to a vehicle collision. Restoration will be carried out with reference to the specifications of traffic signals planned under the Project for Extension of Japan Freeway<sup>57</sup>.

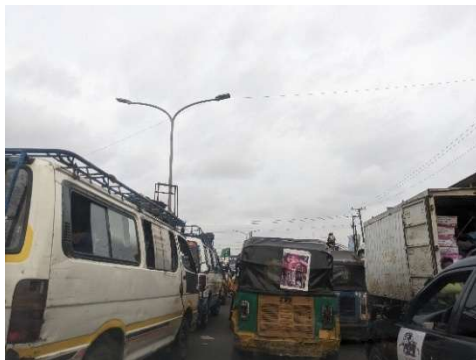
Photo 9: Near Red Light Junction, due to the presence of a market, the area experiences constant congestion, with traffic jams particularly prominent during the evening peak hours. (Source: Evaluator)

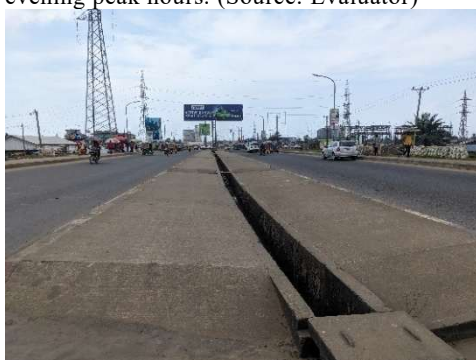
Photo 11: Well-maintained drainage ditches at the median of the road by the industrial area (Source: Evaluator)

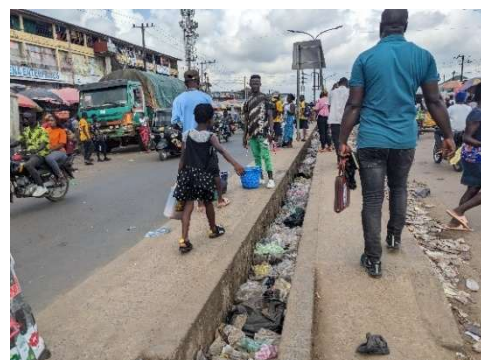
Photo 12: The issue of illegal waste disposal is particularly severe in the area around the Red Light Market. (Source: Evaluator)

During the site visit conducted at the time of the ex-post evaluation, illegal dumping of waste into drainage channels was found to be particularly severe around the Red Light Market, Double Bridge, and Stockton Bridge (see Figure 1). Although MPW conducts quarterly cleaning operations, it is recommended to increase the frequency of cleaning in particularly affected sections to ensure the continued effective use of road facilities. MPW has also been employing local youth for cleaning activities as a means of empowerment. To further strengthen these initiatives, it is recommended for MPW to continue collaborating with the Paynesville City Corporation, Monrovia City Corporation, General Service Agency, and Environmental

Protection Agency<sup>58</sup>. In addition, it is recommended that MPW consider implementing sustained awareness campaigns targeting communities, as well as programs that encourage youth participation in cleaning efforts.

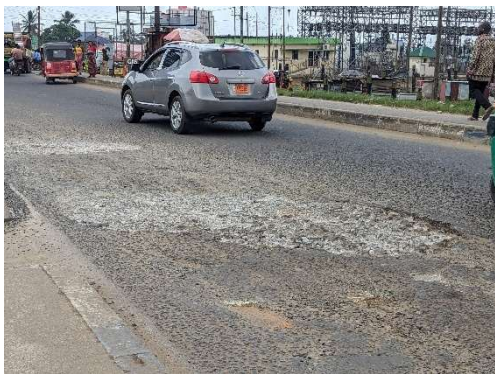
Photo 13: Potholes just before the Jamaica Road junction on Phase 1 road (November 2024) (Source: Evaluator)

- a. **Pavement Repairs:** On the Phase 1 road, potholes were observed to be expanding without proper repair<sup>55</sup>. As five years will have passed since the completion of the Phase 2 road by 2026, it is recommended that the Bureau of Operations carry out timely and appropriate repairs based on periodic inspections.

<sup>55</sup> MPW plans to carry out repair work in April 2025. Source: Assistant Minister of Operation interview (April 2025)

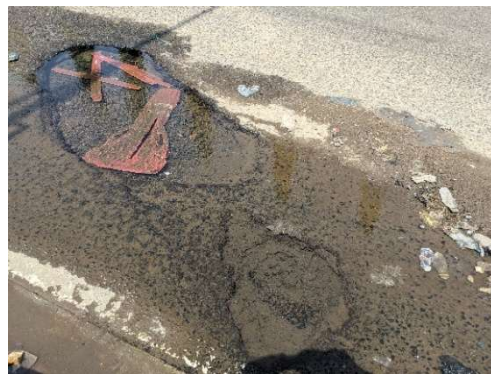
Photo 14: Potholes caused by leaks from sewer pipes (November 2024). Liberia Water and Sewer Authority repaired the leakage in March 2025. (Source: Evaluator)
