FY2024 Ex-Post Evaluation Report of Japanese Grant Aid Project

“The Project for Flood Protection and Drainage Improvement  
in the Phnom Penh Capital City (Phase IV)”

External Evaluator: Keiko Asato

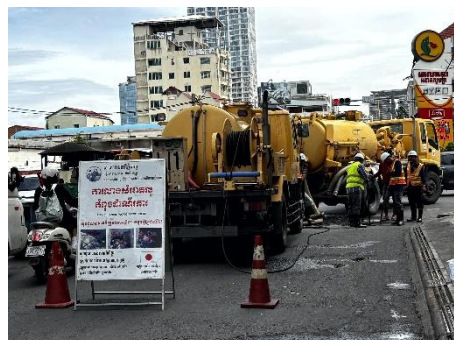
Photo 2: DSO officers cleaning pipes with sign board) (taken by evaluator)

For pipes with a diameter of 60 centimeters or more, workers enter the pipes to carry out cleaning. For the safety of the workers, it is instructed that the manhole should be open for approximately 20 minutes to release the air inside before starting the work (Photo 2).

The length of drainage pipelines cleaned was 20% of the planned length in 2020 but had increased to 50% in fiscal year 2024. Although it is only half of the plan, it has shown improvement. The inundation situation had improved as planned in the target area of this project as well.

Hydrogen sulfide gas may be generated inside sewer pipes, and there is a risk that workers may suffer poisoning. In this project, workers were instructed to start to work after 20 minutes passed since opening the manhole. However, in order to mitigate such risks, the procurement of equipment to measure hydrogen sulfide concentration is proposed. This would make it possible to start cleaning after confirming the gas-generation conditions, thereby ensuring the working safety of the workers.

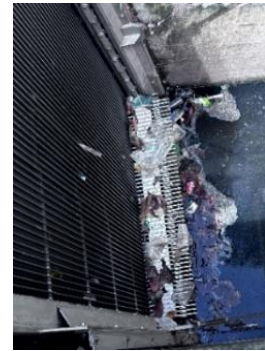
Photo 3: Wastes collected by mechanical screen (taken by evaluator)

the DSO. The DSO regularly monitors the working conditions, and no problems have been reported. During the rainy season, the mechanical screens are operated every day and collect a large amount of waste (Photo 3). Before the installation of the mechanical screens, workers collected waste by hand; however, they were unable to collect all of it, and the remaining waste hindered drainage. According to the DPWT, after the installation of these machines, such situations have been avoided, and efficient drainage has become possible.

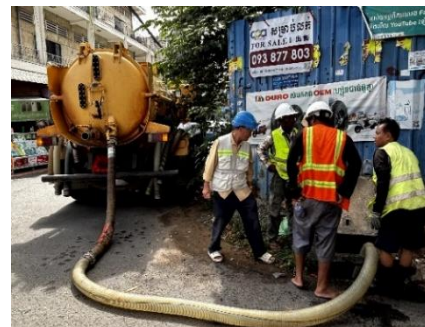
Photo 4: Cleaning workers in operation (taken by evaluator)

In accordance with the prescribed monitoring sheet, the maintenance is carried out using pre-use checks (such as the condition of engine oil, drainage hoses, belts, and others) and post-use checks (such as the condition of drainage hoses and the removal status of waste and sludge suctioned during drainage, and others) are conducted.
