## 【Ex-Post Monitoring of Completed ODA Loan Project】

### “Samanalawewa Hydroelectric Power Plant (I) (II) (III) and Samanalawewa Hydroelectric Project (Reservoir Remedial Works)”

External Evaluator: Jun Kuwabara,  
(International Development Center of Japan Incorporated)

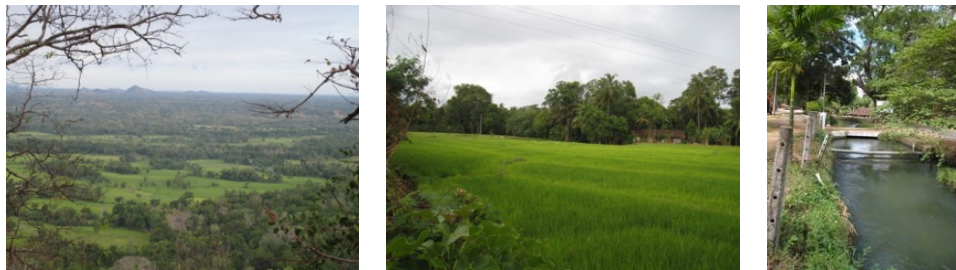
Management Board. The water coming from the leakage on the right bank of the Dam is regarded as part of the water outflow from the Dam. Some interviewees replied that their paddy yields have increased since the Samanalawewa Dam Reservoir started operation, along with the innovation of agricultural technology.

Picture 1 Kaltota Agricultural Area (overview, close-up view and canal)
