## Drin River Hydropower Stations Rehabilitation Project

External Evaluator: Kenichi Inazawa, Office Mikage, LLC

### 1. Project Description

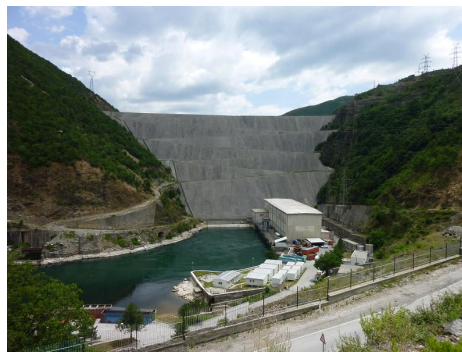
Fierza Hydropower Station  
(Power Generation Building and Dam)

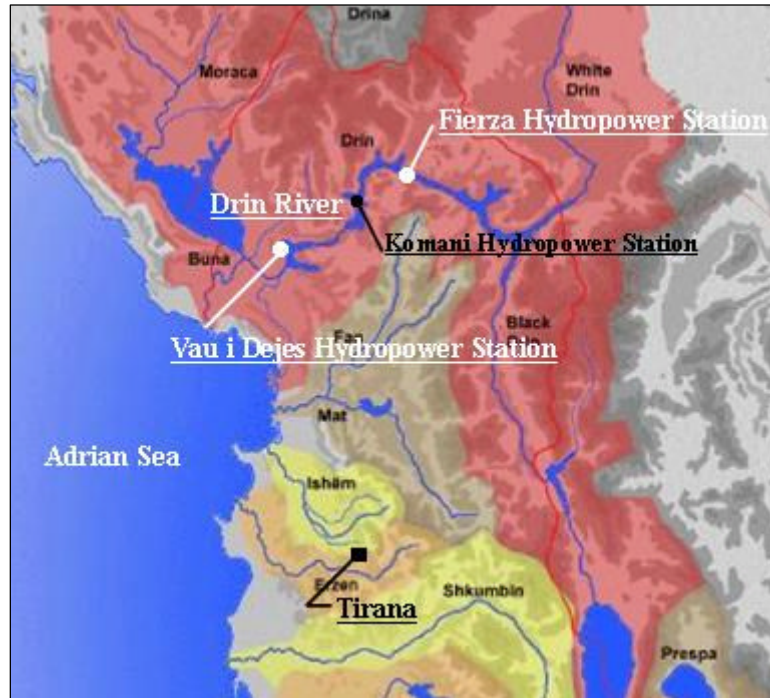
Figure 1: Project Site<sup>6</sup>  
 (Fierza Hydropower Station and Vau i Dejes Hydropower Station)

Table 2 shows planned and actual outputs regarding the JICA loan portion, across the entire project. The project was almost implemented as planned at the time of the appraisal: rehabilitation of power generation units (four units of Fierza Hydropower Station and five units of Vau i Dejes Hydropower Station) and replacement of electrical equipment installed in the power generation chambers and substation facilities.

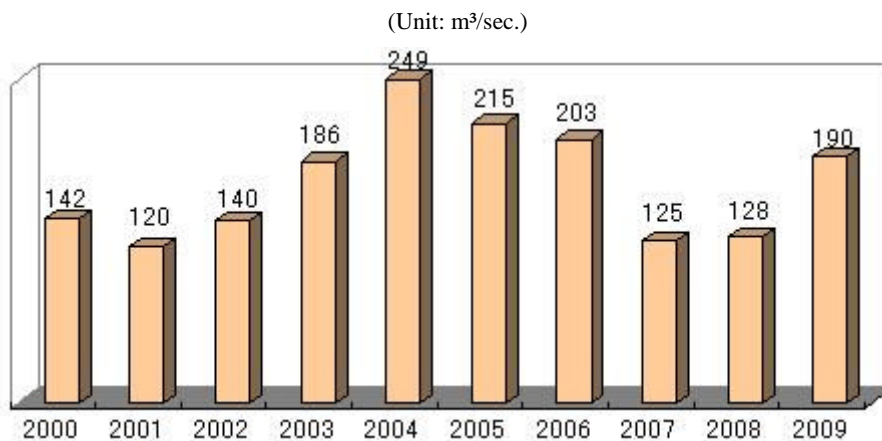
Table 5: Annual Average Water Inflow from the Reservoir Dam to Fierza Hydropower Station

installed in the step-up transformer of the No. 4 generator unit as well as by a decrease in average flow rate per year (see Table 5).

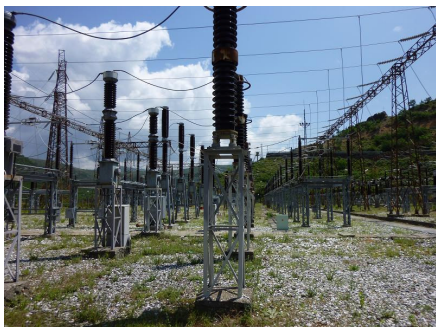
Figure 2: 220KV Isolator Switches (Fierza Hydropower Station)

For both power stations, substation facilities are located adjacent to the power generation building. Instruments such as disconnecting switches, which were the targets of rehabilitation, have been working normally, and no particular problems have been observed. (Regarding the substation facilities, rehabilitation of the electric devices was funded by the JICA loan and construction of the ground facilities was funded by the EBRD loan.)

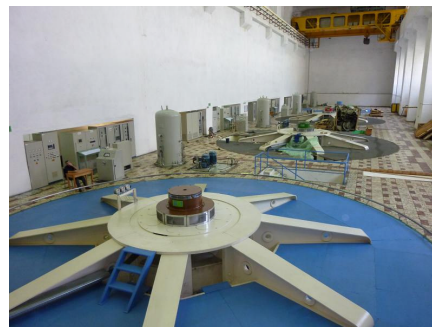
Figure 3: Generator Units (Fierza Hydropower Station)

The generator units have been working normally thanks to the full-scale inspection and maintenance that take place once a year. According to the staff working at the power stations, the generator units suffered from frequent failures/malfunctions and prolonged abeyance in operation due to the aged instruments before the completion of the rehabilitation. However, no mechanical problems resulting in abeyance in operation have been reported since then. (Rehabilitation of the generator units was implemented with the help of Swiss and Austrian grant aids and JICA loan. Rehabilitation of the electrical devices in the generator chamber and test for the generator units were implemented through the JICA loan.)

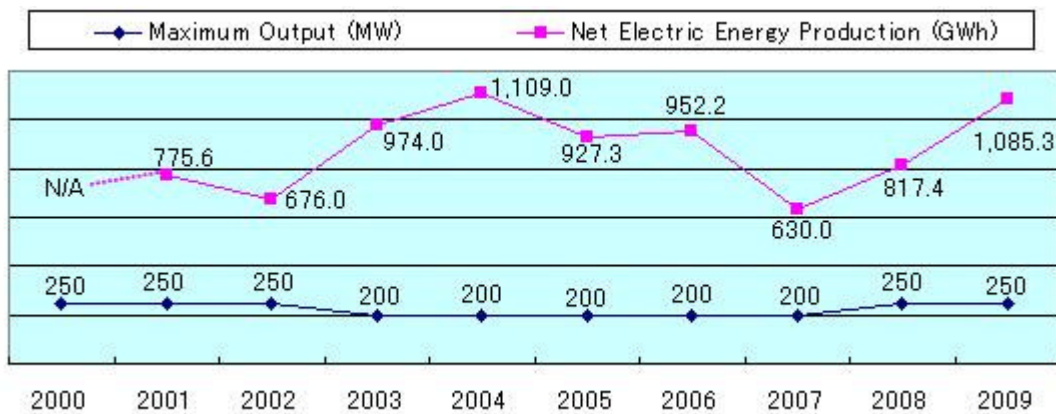
Table 7: Maximum Output and Actual Net Electric Energy Production Regarding Vau i Dejes Hydropower Station

implementation, actual power generation was 878GWh (annual average of power generation between 1981 and 1991). Therefore, assuming the planned value as the total of those figures, 1,056GWh, the planned value was achieved in 2009<sup>14</sup> after the project completion in 2007. Nonetheless, it should be kept in mind that the above result does not necessarily show the actual effect of rehabilitation due to some fluctuant parameters, such as amount of rainfall and dam flow (discharge) and occurrence of instrument malfunction, that have a major influence on the figures. For instance, the 2005–2006 figure shows decrease in power generation (see Table 7) despite virtual completion of the rehabilitation project. This can be explained by the breakdown<sup>15</sup> of the generator unit caused by the malfunction of the aged wall tube insulator installed in the step-up transformer of the No. 2 generator unit, as well as by a decrease in average flow rate per year (see Table 8). Particularly during 2007–2008, a decrease in average flow rate per year (see Table 8) can be considered the sole cause.

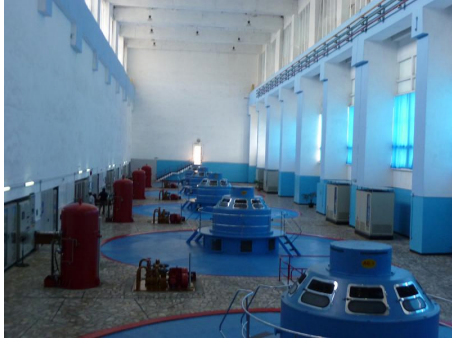
Figure 4: Generator Units  
(Vau i Dejes Hydropower Station)

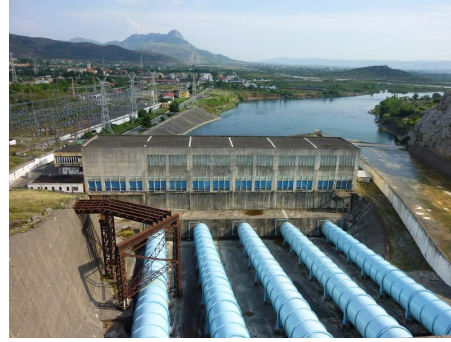
Figure 5: Pipelines (bottom), Power  
Generation Building (center), and  
Substation Facilities (upper left)  
(Vau i Dejes Hydropower Station)

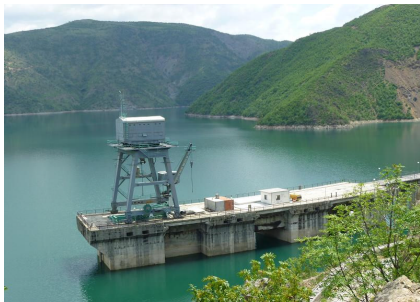
Figure 6: Intake  
(Reservoir Dam at Fierza Hydropower Station)

Since no malfunctions in opening/closing or the control system of the intake gate were found, it can be deemed that there are no mechanical problems<sup>22</sup> at this facility. (Rehabilitation of the control unit and other instruments installed within the intake facility

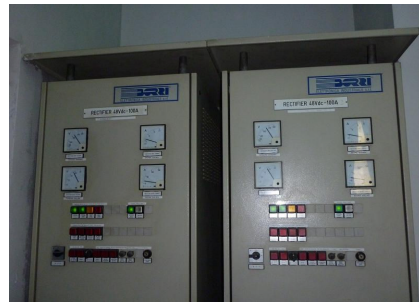
Figure 7: Electrical Equipment Rehabilitated by  
JICA Loan (Vau i Dejes Hydropower Station)

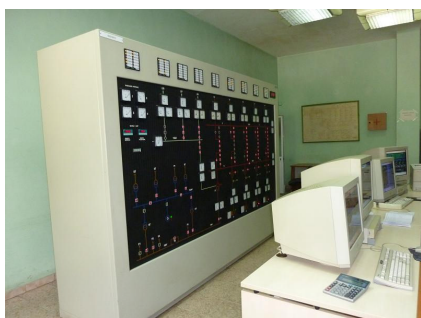
Figure 8: Control Room  
(Fierza Hydropower Station)

Compared to the situation before the completion of the rehabilitation project, performance of the control/monitoring systems has been improved and the generator/substation and water intake, etc. has been controlled/managed more smoothly. The staff works on a three-shift system around the clock. After the completion of the rehabilitation, no failure/malfunction of the control panel or other instruments including computers has been reported. (Rehabilitation of the control and monitoring systems and instruments was implemented mainly with the help of the EBRD loan.)

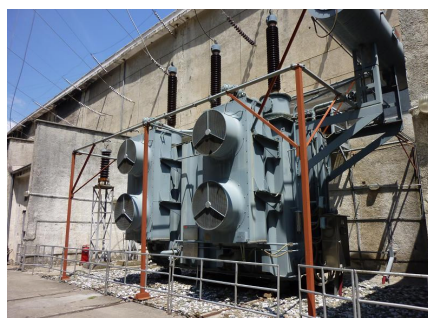
Figure 9: Generator Step-up Transformer<sup>23</sup>  
(Adjacent to Power Generation Building at  
Fierza Hydropower Station)

<sup>23</sup> As described on page 9, a wall tube insulator of the step-up transformer failed in 2007 and was repaired. As of now, the insulator is working properly.
