## Ex-Post Evaluation of Japanese Grant Aid Project “Water System Improvement Project for Ibarra”

External Evaluator: Takeshi Yoshida  
Global Group 21 Japan, Inc.

### 0. Summary

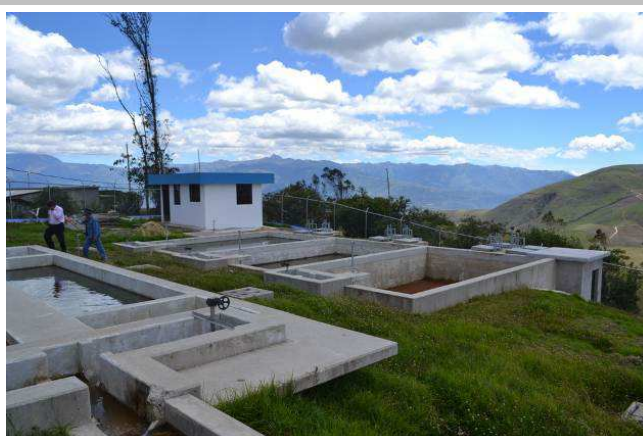
Purifying plant in Aloburo

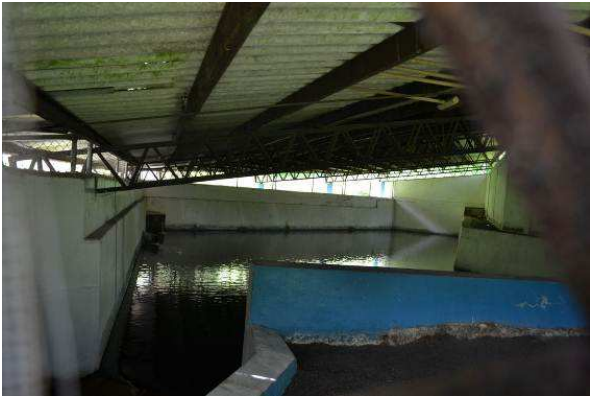
Water intake at Guaraczapas

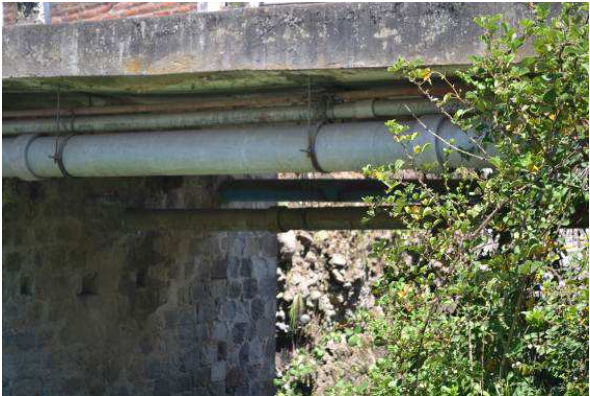
Conveyance pipe at Esperanza

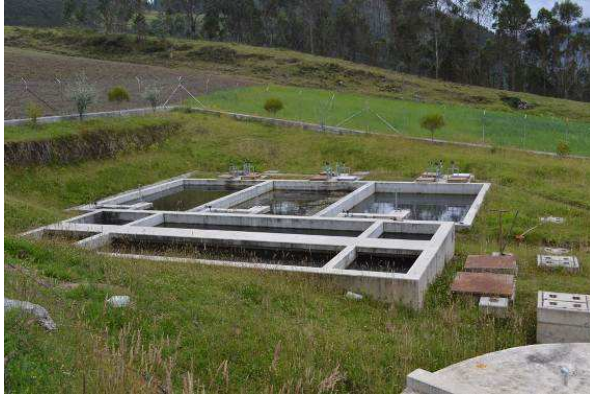
Purifying plant at Zuleta

During the rainy season, the quality of raw water gets worse, deteriorating the quality of supply water in rural areas. In order to solve this problem, two water purifying plants were repaired in the project to strengthen the water purifying capacity. As a result, settling reservoir and slow filter were added, enabling the treatment of high-turbid raw water during the rainy season. According to EMAPA-I data, the highest turbidity of supply water in target areas improved from 16.0NTU before the project (2006) to 3.7 NTU at the best after the project (2010) at Zuleta purifying plant<sup>10</sup>. However,

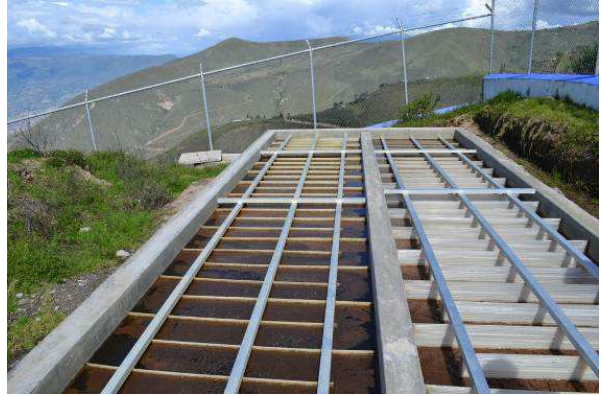
Rapid Filtration installed at Aloburo Purifying plant

at Aloburo purifying plant, during the rainy season, earth and sand mixed in raw water when raining could not be completely treated, and such water were distributed. Because the average turbidity was 5.6 NTU in 2010, being worse than the target of 5.0 NTU, rapid filtration was installed upstream by EMAPA-I's budget in 2011. Since then, supply water has not been overly deteriorated (the highest turbidity in 2012 is 4.3 NTU).

purifying plant through this project seems to contribute to the improvement of water quality and the elimination of water shortage which used to be caused by the increased turbidity during the rainy season.

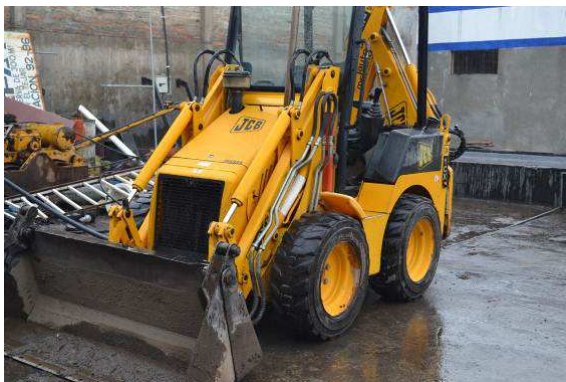
Equipment provided by the project  
(small power shovel)

As a result of the field survey, operation and maintenance of the facilities constructed by the project are fairly managed with no considerable issue. The covers of Azaya reservoir, which were reported as stolen in the defect inspection, were replaced by new ones. Fences for reservoirs, whose necessity was pointed in the inspection, were also set by EMAPA-I's finance. In Aloburo purifying plant, when it rained, earth and sand mixed in raw water could not be completely filtered and distributed as water supply. Thus, EMAPA-I installed rapid filtration equipment upstream by its own budget (about US\$ 8,000) in 2011. Since then, distributing water has not been deteriorated. Among the procured equipment, leakage detectors are not utilized because non-revenue water reduction activities have been slowed. A compactor, a roadroller, drain pumps, a dump truck, and a backhoe are properly managed and utilized for various maintenance activities because they can be used for multiple purposes.

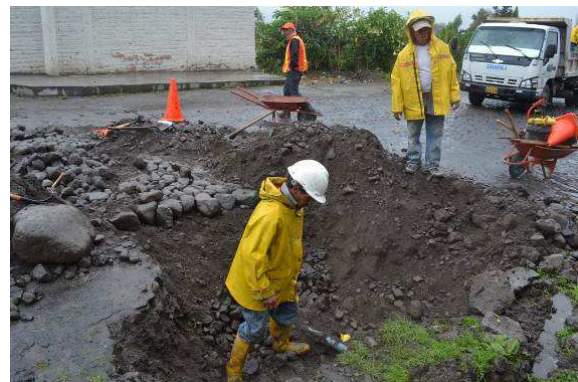
Works for water leakage prevention

Equipment for reducing leakage was provided to non-revenue water prevention office, a new office established as a division of engineering department. Such equipment was utilized for inspecting and repairing underground leakage points that had used to be difficult to detect. Together with the improvement of the skills of EMAPA-I's technical staff through technical assistance, the equipment contributed to the reduction in water leakage rate<sup>8</sup>.
