Ex-post Evaluation of Japanese Grant Aid Project  
“The Project for Improvement of Port Vila Main Wharf”

External Evaluator: Keisuke Nishikawa  
Japan Economic Research Institute Inc.

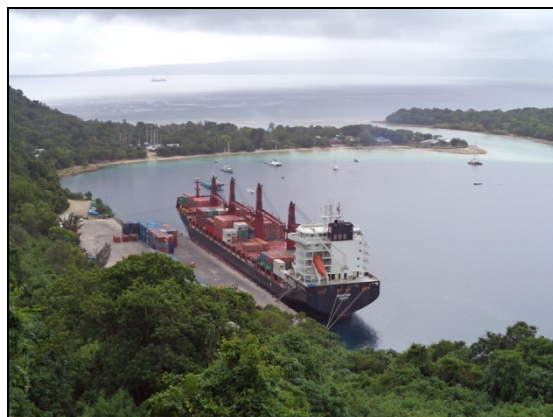
Main Wharf rehabilitated in this project and a cargo ship calling at the port

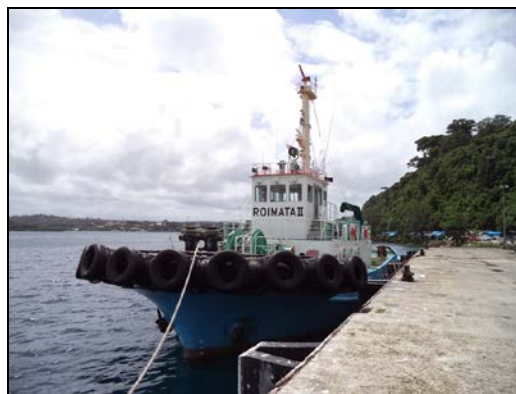
Photo 2: Tugboat provided under this project

A fire extinguishing device for other boats was installed on a tugboat to deal with fire accidents at sea and on land facilities. While there have been no cases where firefighting actions were required using the tugboat, port service functions are considered to have improved as it became possible to respond to fires with the procurement of the tugboat though there were no equipment to respond to the occurrence of fires on a boat in the harbour and near the wharf. According to the implementing agency, fire drills are implemented by the crew on a quarterly basis.

fire-fighting facilities via the tugboat, and eliminating the need to handle cargo-handling operations on public roads were realised. There were no specific negative impacts during and after the project implementation in terms of the impact on the natural environment, nor was any land acquisition or resettlement observed. Therefore, the effectiveness and impact of the project is high.

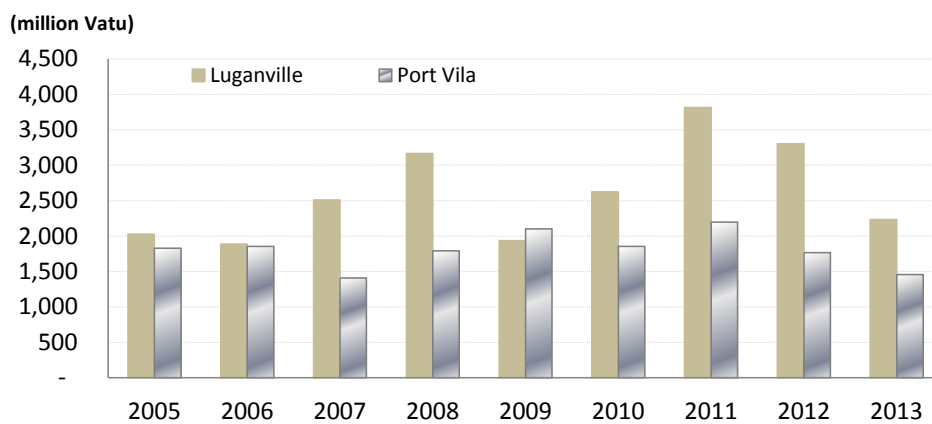
Figure 1: Export Values by Port

Source: Data provided by the Vanuatu National Statistics Office

Export and import values by port in Vanuatu are as shown in Figures 1 and 2.

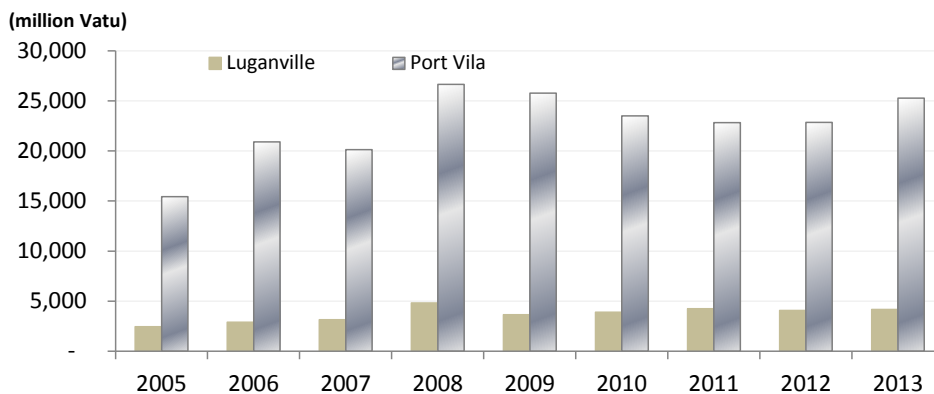
Figure 2: Import Values by Port

Source: Data provided by the Vanuatu National Statistics Office
