Kyrgyz Republic

Bishkek-Osh Road Rehabilitation Projects (I) (II) External Evaluator: KRI International Corp. Nobuko Shimomura Field Survey: September 2008

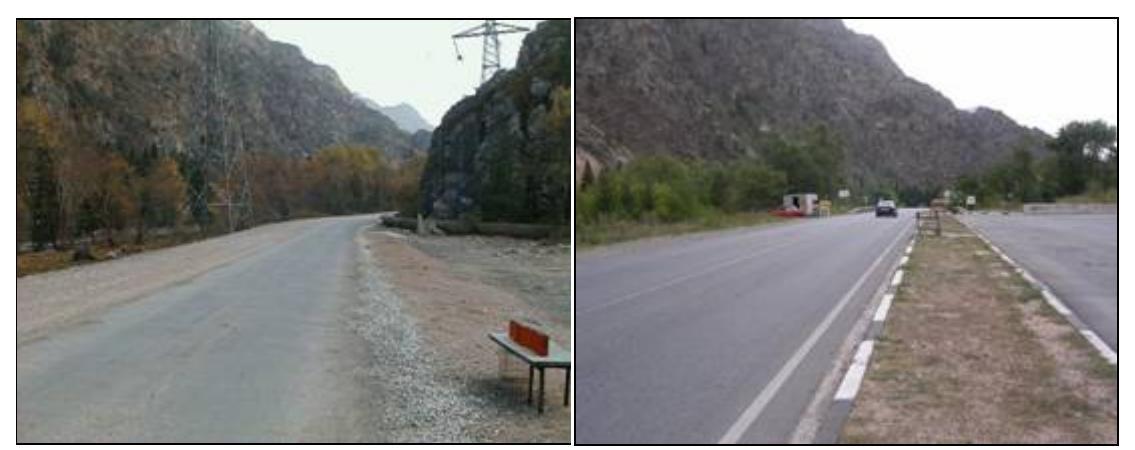
The road before construction rehabilitation (Photo by project consultant)

The road after construction rehabilitation

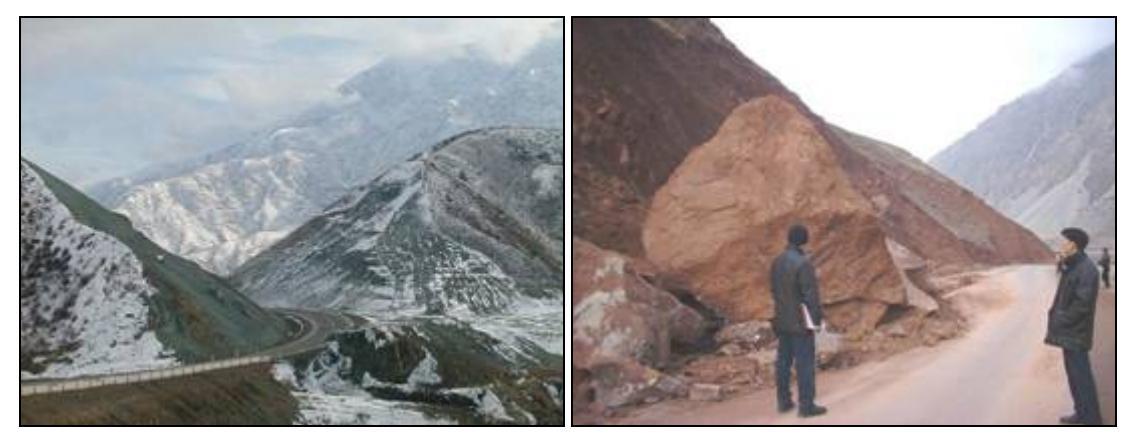
Kok-Bel pass in winter (Photo by project consultant)

Rock fall during construction (Photo by project consultant)

Thirdly, frequent snow avalanches and landslides caused further delays in construction. Even worse, the 2003 winter was extraordinarily severe, causing another one-month delay in construction, which resumed in spring after three-month winter break.

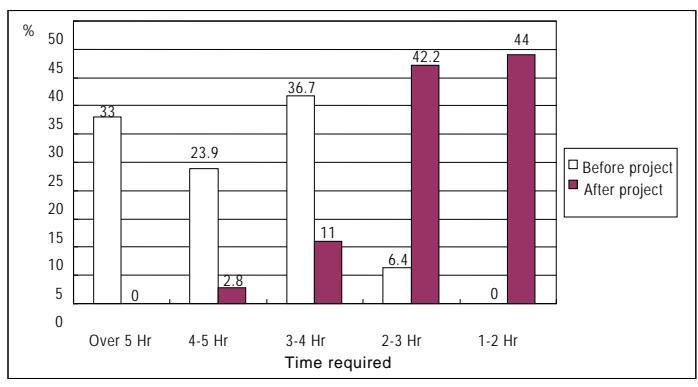
Fig 3 Driving Times from Toktogul to Karakol (approx. 96 kilometers) (Number of respondents: 109, Unit: %)

In these investigations, 50% of drivers responded that they previously needed at least four hours to drive to Karakol from Toktogul (approximately 96km, see figure 3); however, after rehabilitation, nearly half of drivers responded that they need just one or two hours and nearly 90% of drivers responded they can arrive in Korakol within four hours.

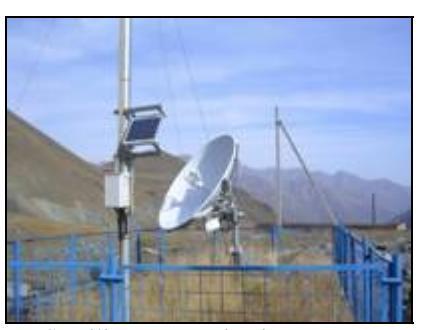
Satellite communication system installed at Thuash tunnel

communication system was installed in Bishkek and four other road maintenance offices on the project road in 2006, after construction was finished. As a result, changes in project outputs—particularly design modification—contributed to improvements in safety operation.

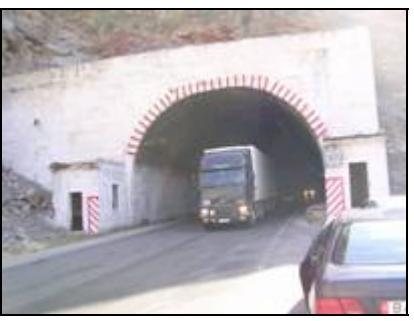
Tunnel constructed at 415km point from Bishkek
