Ex-Post Evaluation of Japanese Grant Aid Project

The Project of Groundwater Development in South-Western Region of Madagascar (Phase II)

(Le Projet d'exploitation des eaux souterraines dans la région sud-ouest de Madagascar (Phase II)) External Evaluator: Satoshi NAGASHIMA, ICONS Inc.

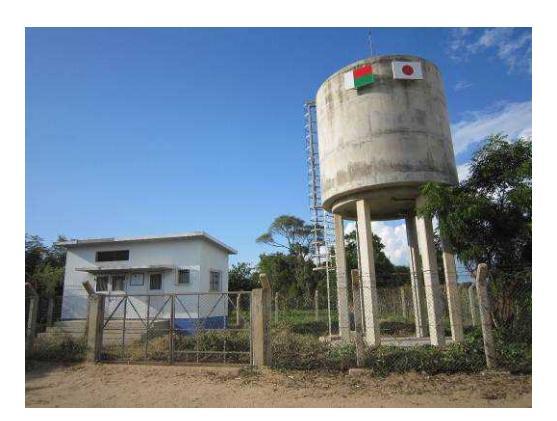
Public fountain type water supply facility

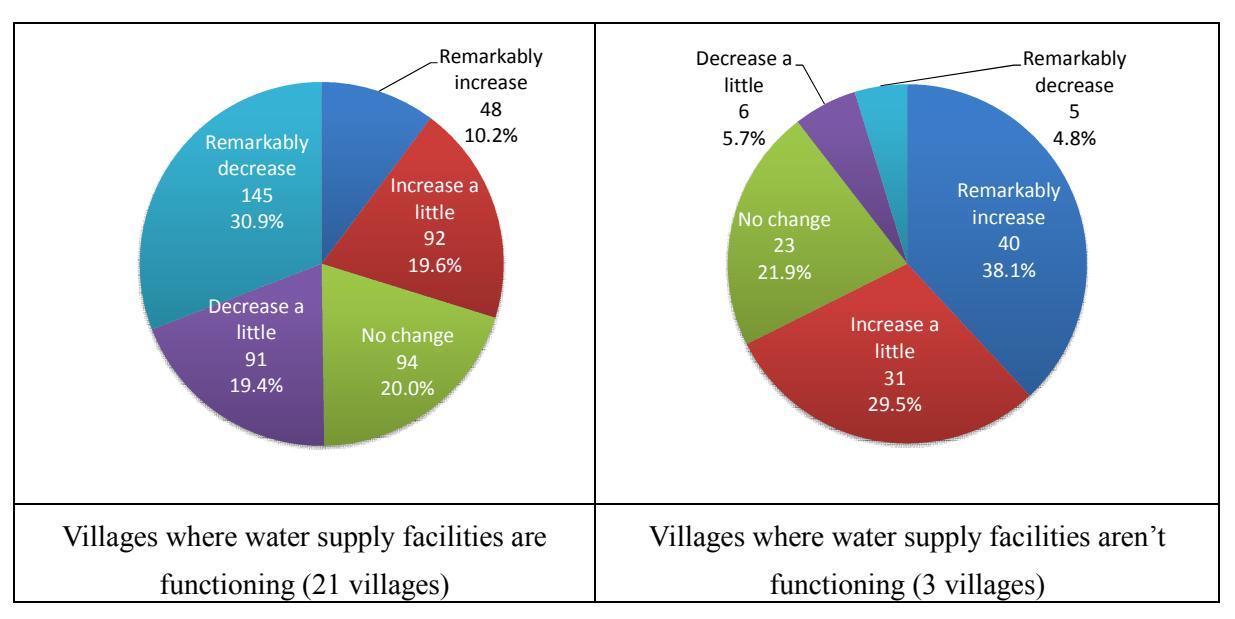
of diarrhoea (children (15 years and under) and adult (16 years or more)) was as follows.

Further, in the beneficiary survey¹³, looking at the infection rate of waterborne disease before and after installation of the water supply facilities in the villages where water supply facility is functioning and not functioning, the result (at the time of ex-post evaluation) of the infection rate

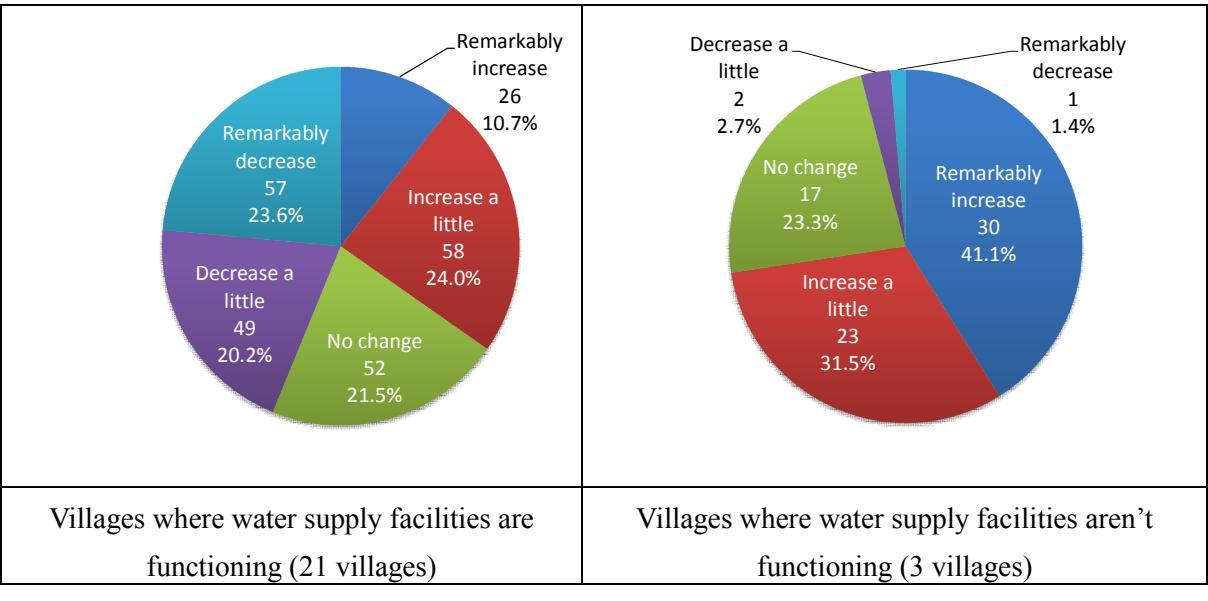
Figure 2: Increase or decrease in the infection rate of diarrhoea for adults (over 16 years old) before and after the installation of water supply facilities

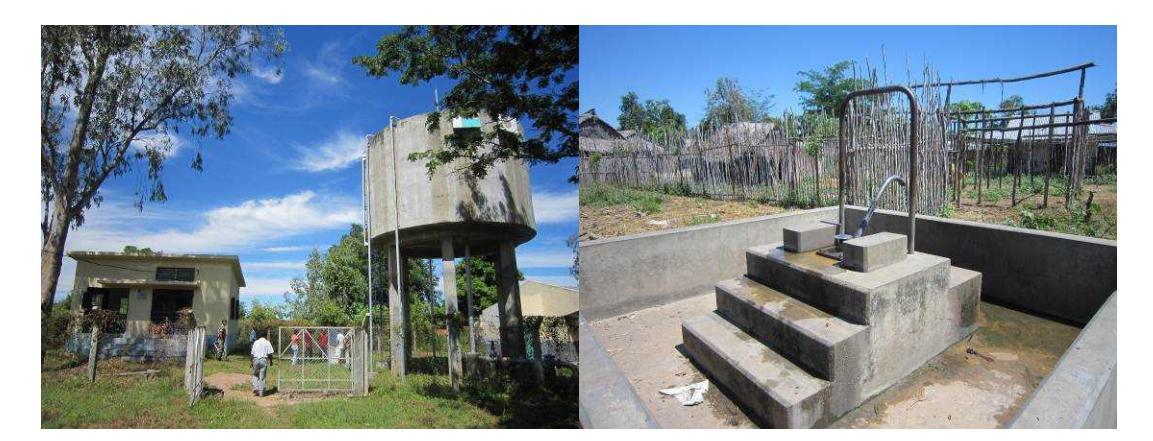
Photo 1: Public fountain type Water supply facility

Photo 2: Foot pump type Water supply facility

For foot pump type water supply facilities, even though the part of the excavation site was changed because of unsuccessful exploratory drilling and high salinity, etc, the planned number of the water supply facilities was eventually constructed. On public fountain type water supply facilities, the number of actual excavations was two below of the planned number. This was due to the unsuccessful exploratory drilling in Ankirizato and it was also found that the possibility of new underwater development there was extremely low; and the plan was changed through the proper procedures. According to the consultant who was in charge of designing the Project, even after conducting a detailed study and several exploratory drillings in advance at the cancelled site, it was difficult to find good water source. Therefore it was an unavoidable cancellation. For public fountain type water supply facilities, it seems that it was difficult to change the site to neighbouring villages because the scale of the facility was big and they couldn't find good water source; and it was hard to find an alternative site.
