Country Name	Project for Improvement of Equipment and Facilities on Mateorological and Hydrological
Lao People's Democratic Republic	Services

## I. Project Outline

# II. Result of the Evaluation

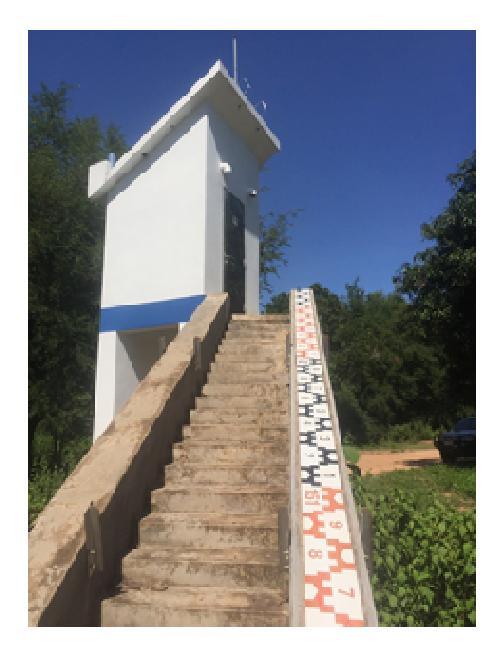
Hydrological station in Songkhone village, Lamam District, Sekong Province Meteorological station in Seno, Savannakhet Province
