Country Name		the Project for Improvement of Equipment for Disaster Risk Management						
Republic of Fiji								
I. Project Outline		•						
Background	The F as th Meteo but a Pacifi region The of dis and in	The Fiji Meteorological Service (FMS), which oversees meteorological-related operations in Fiji, was designated as the Regional Meteorological Center for Tropical Cyclone Programme (RSMC for TCP) by the World Meteorological Organization (WMO) in 1995. It had played a vital role in forecasting cyclones not only in Fiji but also in the southwestern Pacific region issuing warning, as well as performing weather forecasting in the Pacific region. It also played a central role in developing human resources in the weather area of the Pacific region. The FMS observation network was not sufficiently developed, and there were rooms for improvement in terms of disaster risk management such as high accuracy forecasting for tide levels and cyclones, information analysis, and information Transmission systems.

II. Result of the Evaluation

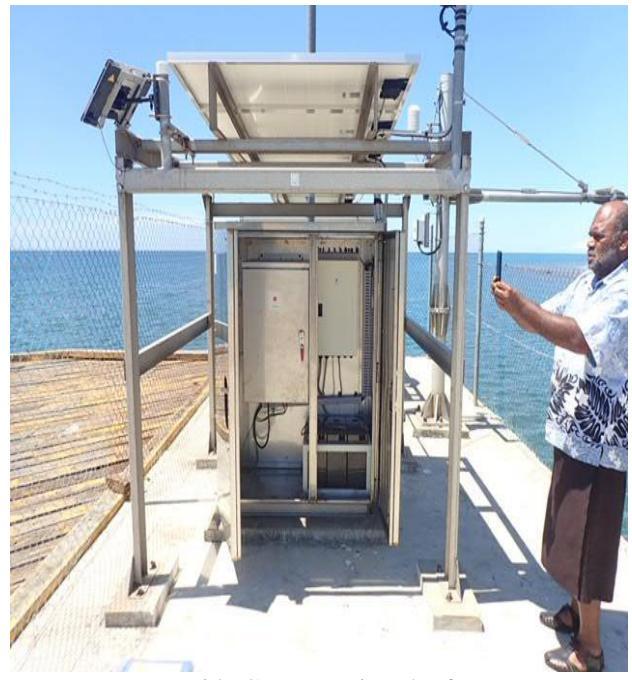
Tide Gauge, Vatia Wharf

The project partially achieved the objective of "to observe abnormal tide levels and collect observation data to FMS in near real time". As for the tide observation interval (Indicator 1), the gauge procured under the project in Vatia, Viti Levu transmitted data at 10 minute intervals. During Tropical Cyclone (TC) Winston (February 2016), the system was very robust and continued its services hence there was no damage to the system where the eye of the cyclone crossed.

However, some observations were made on the equipment which is not in operational now, especially due to the damage from massive Tropical Cyclone in 2019. In April 2020 during TC Harold with the maximum Category 5 did some damages to the equipment. The tide observation sustained damages during this Cyclone thus it became nonfunctional. The other equipment that was damaged was the tidal gauge wind profiler (air cooling system), 1 lighting detector and 1 lighting sensor and server for disaster recovery site. FMS has been liaising with Japan Meteorological Agency (JMA) to assist with the repairs of these equipment therefore it could continue with the services it provides. <Technical Aspect>

No planned maintenance has been scheduled for the tidal gauge nor the wind profiler. The equipment under the project was procured from Japan therefore no dealers in Fiji are selling spare parts of the equipment provided under the project. Technical skills and knowledge which is required for the repairs of such system configuration for AWS, Lighting Detector, Wind Profiler and Tide Gauge is not available as the FMS staff trained under the project are no longer employed. Therefore the newly assigned staff needs to be trained to be able to identify parts required and the repair works which needs to be undertaken.

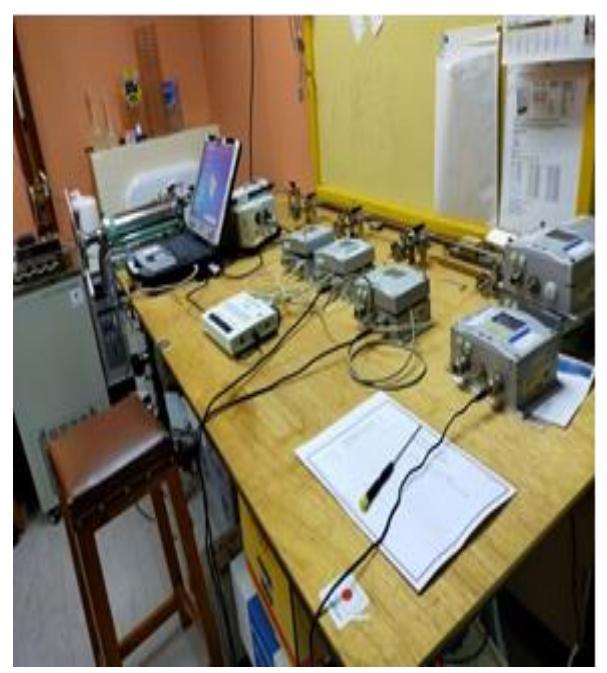
Digital barometer calibration namely (PTB series) JICA provided Tough Book HP laptop and calibration equipment.
