Country Name	
Lao People's Democratic	< The Project for the Reconstruction of the Bridges on National Road No.9>
Republic

I. Project Outline								
Background	National Road N crosses the Indoa and is an import as a whole. How No. 9 developed and Xe Tha Moo Czechoslovak R and other factors difficulty of ens bridges is deemo	to.9 in Laos, a land-locked country, is par china Peninsula and connects Laobao on the ant international trunk road for socioecom ever, at the time of planning of the Project 1 in the 1980s were showing signs of det uak Bridge, the target bridges of this proj epublic over 30 years ago. The main girde s. Both bridges were temporarily reinforce uring adequate safety through permanent ed necessary, leading to the implementation	t of the East-West Eco ne Vietnamese border to nomic development not t, it became obvious that erioration. In particula ject, were constructed ers had significant defle- ted with temporary given t repairs, the urgent reco on of this project.	nomic Corridor (EWEC), which o Savannakhet on the Thai border, only in Laos but also in ASEAN at many bridges on National Road r, both the Xe Kum Kam Bridge with the support from the former ection due t

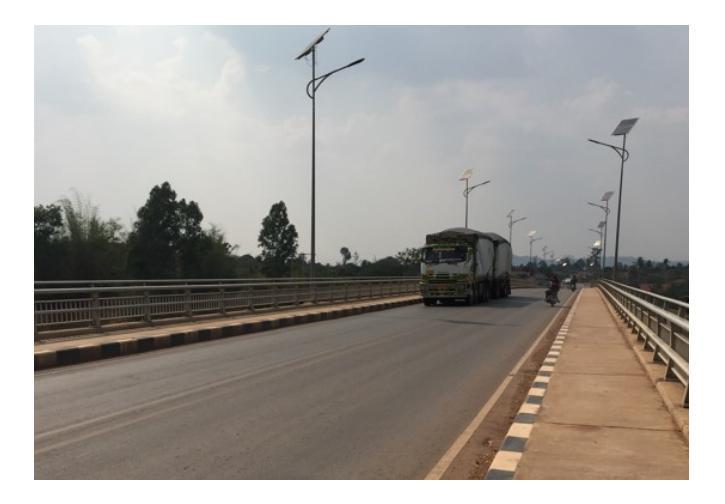
Xe Tha Mouak Bridge

Before the bridge was replaced, the road surface of the Xe Tha Mouak bridge had large undulations in several places, making it unsafe for drivers to drive on. After the bridge was replaced, the bridge road was flattened and improved to make it easier and safer to drive on it. - Installation of sidewalks with adequate width

Several communities are located near the Xe Tha Mouak bridge, and significant number of pedestrians use the bridge daily. Before the bridge was replaced, the sidewalks were narrow and unsafe for both pedestrians and drivers. The sidewalks were widened when the bridge was replaced, allowing pedestrians to cross the bridge safely.

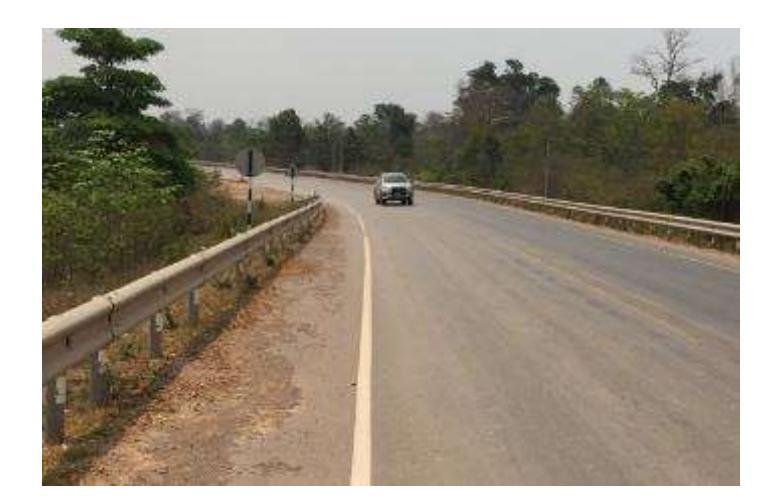
Before the project was implemented, there was a sharp curve in the approach road leading to the Xe Kum Kam Bridge, which was considered an accident-prone area. When the bridge was replaced, the curve in the approach road was changed to a more gradual alignment, allowing drivers to drive from the approach road to the bridge more safely.

Approach Road to Xe Kum Kam Bridge

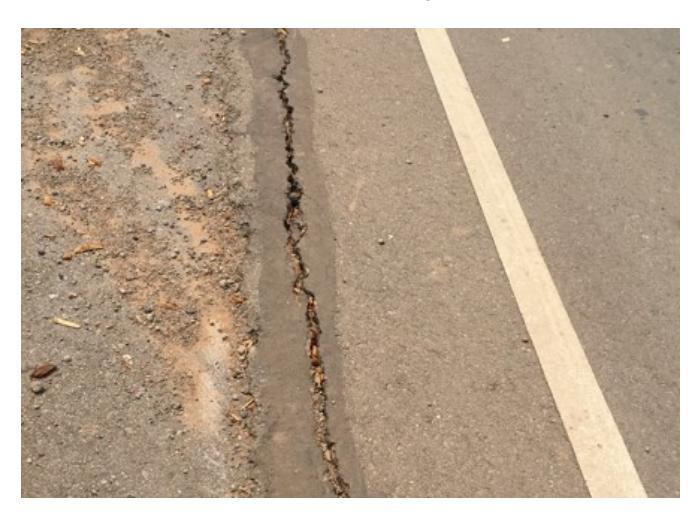
- Xe Kum Kam bridge: Cracks in the approach road, malfunctioning of nighttime lights (2 out of 5 lights), theft of drain covers (5 covers).
- Xe Tha Mouak bridge: Cracks in the approach road, malfunctioning of nighttime lights (5 out of 14 lights), theft of rubber parts from the expansion joints on the sidewalk.

The cracks in the approach road are considered to be caused by the passage of overloaded vehicles. As for the failure of the nighttime light, the electrical connection is thought to be the problem, and DPWT Savannakhet has not been able to ascertain the details and will need to confirm and address this issue in the future. Drain covers have been repeatedly stolen after restoration. Thefts of rubber parts have not been addressed since it was pointed out during the defect inspection. According to the DPWT Savannakhet, it is highly likely that the drain covers and rubber parts were stolen by local residents. To prevent such incidents from repeating in the future, it will be necessary to take measures such as engaging with the gaining the understanding of the local residents through communication and outreach efforts. Materials and parts required for maintenance and management can are available, but they may not be able to obtain them due to budget shortfalls<sup>11</sup>. On the other hand, technology for bridges that can efficiently reduce life cycle costs was introduced in the project, in consideration of the burden of maintenance and management costs, where bridges were generally built using concrete girders due to the country's weak maintenance and management system. For example, the bottom and side plates are made of weather-resistant steel suitable for bridge materials that require semi-permanent strength characteristics. Furthermore, in a country where securing the budget for maintenance is challenging, it is also difficult to allocate funds for road lighting electricity costs. Therefore, solar-powered LED lighting has been installed for nighttime use.

The Crack of Approach Road (Xe Tha Mouak Bridge)

the target bridges. DOR should promptly address equipment repairs and take measures to enforce overloading regulations, striving to prevent deterioration of the bridges and approach roads.

- While the maintenance conditions of the two target bridges are generally good, there have been issues identified such as cracks in the approach roads, malfunctioning of nighttime lights, theft of drain covers, and theft of rubber parts from the expansion joints on the sidewalk. The thefts of drain covers and rubber parts have continued to occur even after repairs were made. It is highly likely that local residents, including young people, are involved in theses thefts. Therefore, it is advisable for DPWT and OPWT to arrange meetings to explain to the local residents and seek their cooperation to prevent similar thefts from recurring in the future.
- Recommendations to JICA
   None
- Lessons Learned

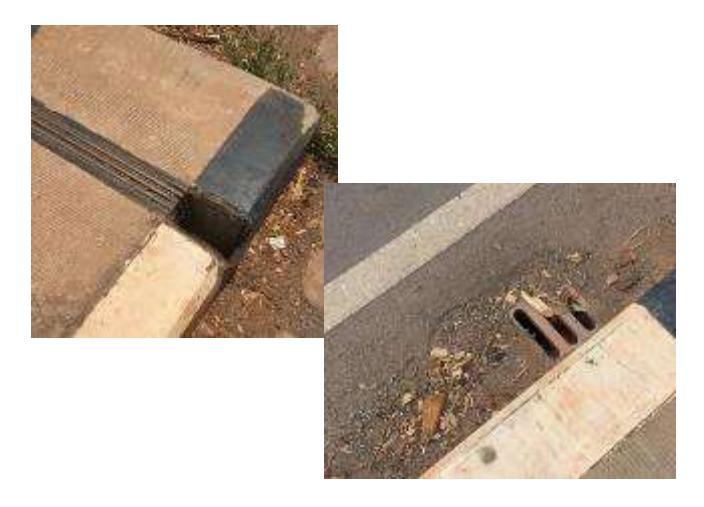
Stolen rubber parts of from the expansion joints on the sidewalk Drainage covers (Xe Tha Mouak Bridge)
