Pinatubo Hazard Urgent Mitigation Project - Phase II

Evaluator: Shinichi Mizuta,
Mitsubishi Research Institute, Inc.

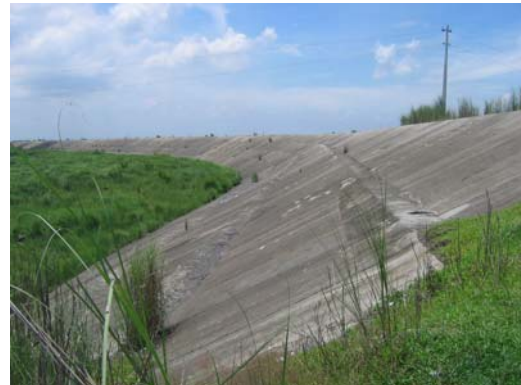
Southwest Mega Dike renovated by the project

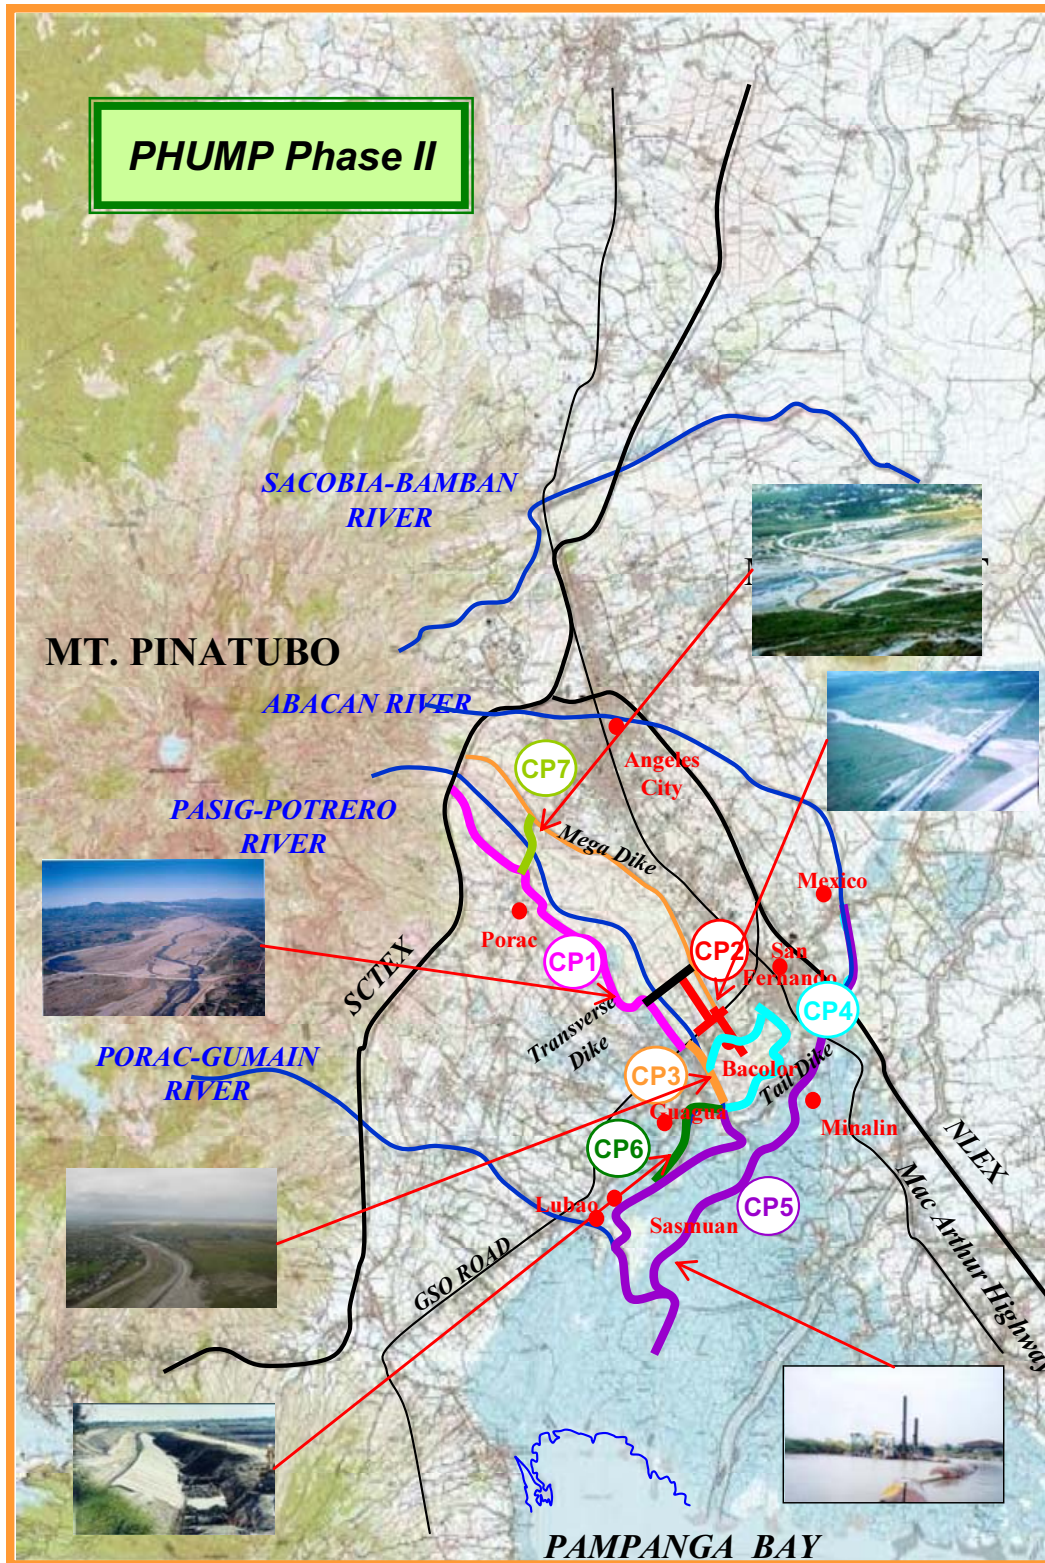
Figure1 Implementation sites of civil engineering works

Civil engineering works, the outputs of the project, consisted of seven contract packages (CP). Although the project was made up from CP1 through CP6 in the initial plan, CP7 was added during the implementation period of the project, in order to conduct required civil engineering work to accomplish the objectives of the project within the budget. The contents of civil work at the initial plan of each CP and major changes are as shown in Table 1. Also, the implementation sites from CP1 through CP7 are shown in Figure 1.
