Ex-Post Evaluation of Japanese Grant Aid Project

**“Project for the Construction of Classrooms for the Primary and Secondary Schools in  
Nouakchott and Nouadhibou in the Islamic Republic of Mauritania”**

External Evaluator: Tetsuya Ishii, KRI International Corp.

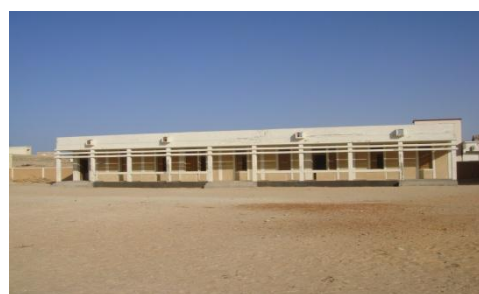
(One of the target primary school)

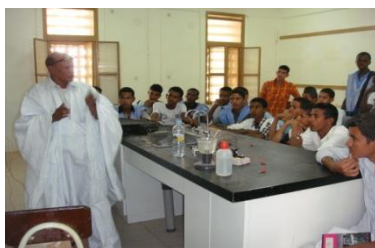
- **Laboratory**  
Having received the laboratory equipment in 2012, the five target schools are able to provide classes in science, chemistry, and physics in the laboratory in accordance with the prescribed curriculum.

(Experiment in the laboratory)

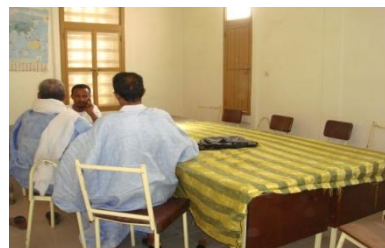
The administrative bloc that is composed of the director's room, study directors' room, teachers' room/meeting room, accounting room, and boarding master's room was expected to reinforce teaching and management system and to promote communication among teachers and staff. According to the answers to the questionnaires, interviews, and site visits, teachers' room was used for the preparation of classes by teachers, and meetings and documents are kept appropriately in the accounting room.

(Meeting in a teachers' meeting room)

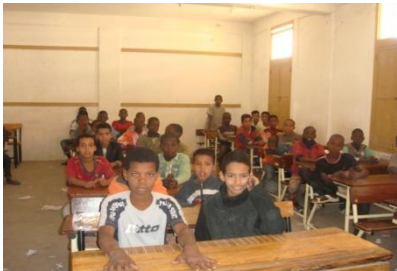
Sitting at their desks, students can concentrate on their lessons more than before
