Country Name	The Project for Rehabilitation of Floating Pump Stations in Upper Egypt (Phase IV)
Arab Republic of Egypt

**I. Project Outline**

**II. Result of the Evaluation**

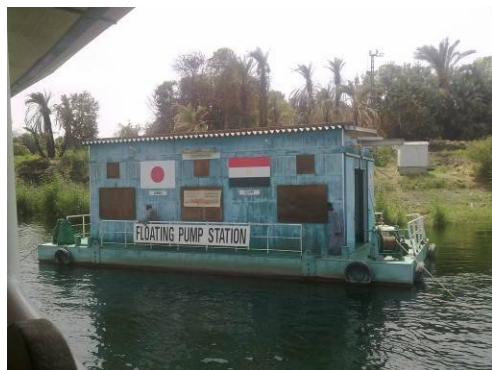
Floating Pump Station

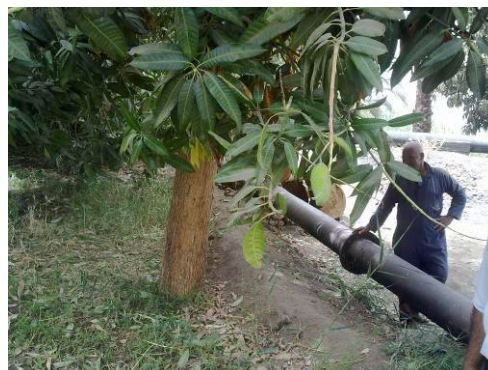
Discharge Pipe
