Ex-Post Monitoring of Japanese ODA Loan Project

Zimbabwe

Matabeleland Telecommunications Network Development Project

External Monitoring Consultant: Katsumi Matsuyama, Nakamoto&Associates Co., Ltd.

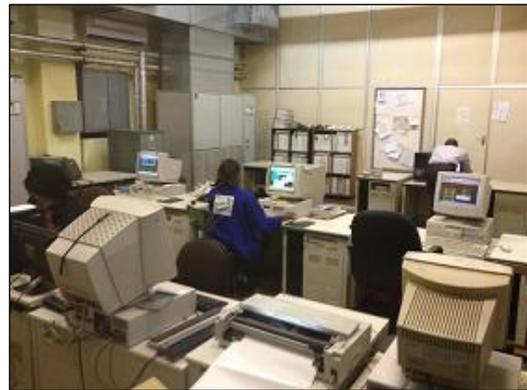
Central Management and Operations Center
(Bulawayo)

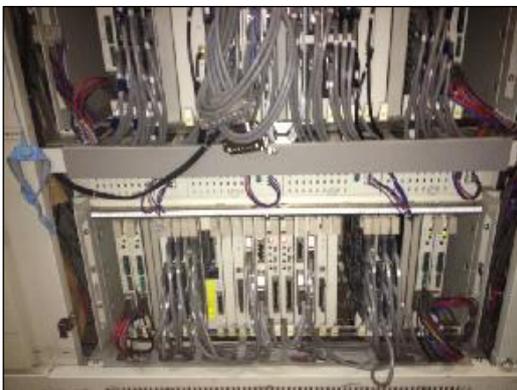
Switchboards: empty slots can be seen

Switchboards installed by this project consist of the main component and the backup component, which operates in case of the failure of the main component. However, backup component is currently not functioning due to the lack of spare parts. This would mean that if the main component fails, telephone of the region covered by the switchboard will go down. The lack of spare parts is the result of Fujitsu closing its Zimbabwe office in 2004. The local manufacturer for the switchboard has also stopped its production. Problem with obtaining spare parts has persisted since 2005. Also, since there are also difficulties in obtaining other spare parts, the operating capacity of the facility has decreased to 70%.

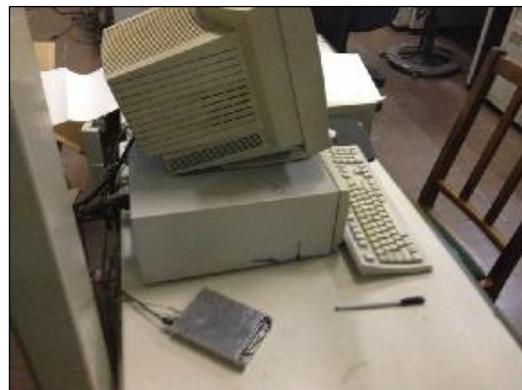
Mini-disc drive used as storage medium

At nighttime, CMOC uses computers to conduct centralized management of operation and maintenance. However, operating system and hardware of computer management system installed by this project has become obsolete. Storage medium for the hardware are no longer in production and new storage medium cannot be obtained. Since new storage mediums are unavailable, CMOC is constantly reusing the existing mediums. In addition, new computer applications cannot be used due to the obsolete operating system. These factors cause problems which obstruct business performance.
