Country Name	The Project of Development for Grand Water in Rural Areas
Republic of Paraguay

I. Project Outline

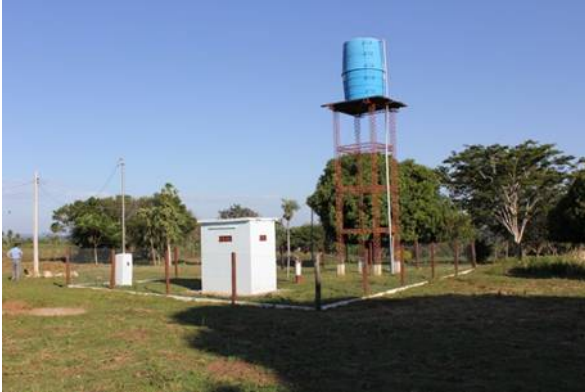
Ñuahi Village, Achay Municipality, Paraguari Province
(One of the 25 prioritized villages)
Completed deep well drilling and water supply facilities

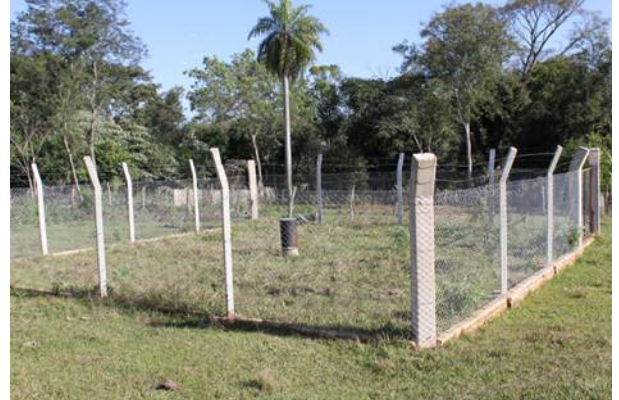
Yvaroty, La Colmena Municipality, Paraguari Province
(One of the 25 prioritized villages)
Construction of deep well: drilling of well and setting of casing
(not setting of submersible motor pump)
