Plurinational State of Bolivia

Ex-Post Evaluation of Japanese Technical Cooperation Project  
“The Project for Capacity Development of Road Disaster Prevention  
and Bridge Management and Maintenance”

External evaluator: Takeshi Yoshida, Global Group21 Japan, Inc.

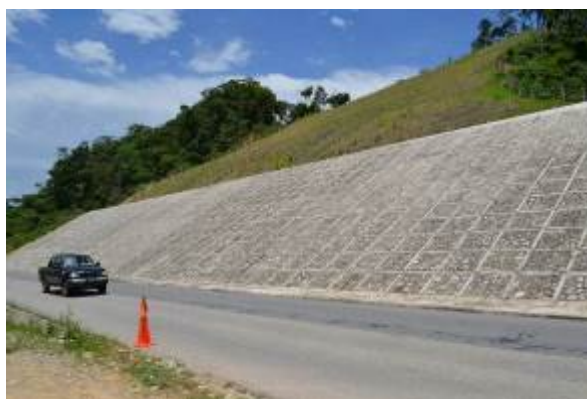
Slope Protection Works on National Road 1  
in Variante, Tarija Department (Pilot Project)

In addition to various indoor training and on-site training for the UPD, pilot works were implemented under the ABC budget at two locations, making it possible to conduct practical training on a wide range of tasks from the planning and design of bridge disaster prevention works to procurement, execution management, and handover.

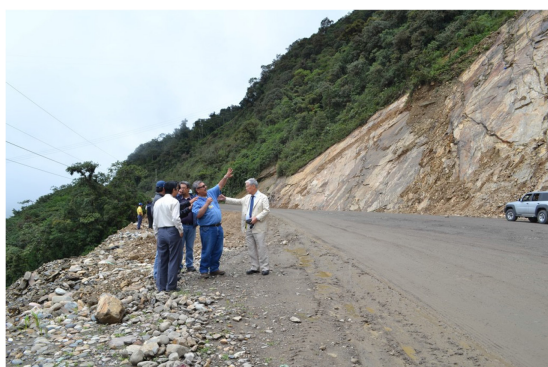
Site of slope failure on National Road 4  
Due to the extensive slope failure, the road width is much larger than usual.

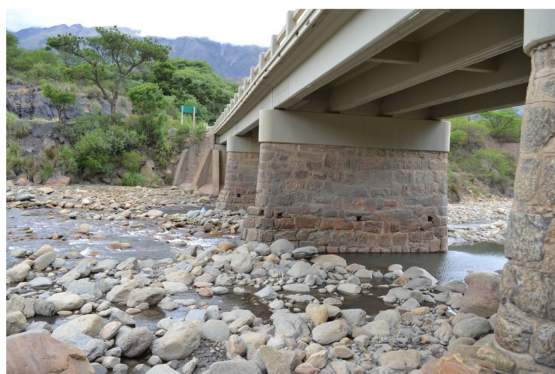
Repair of Popo Bridge on National Road 7  
Cracks in the main girders and floor plates were repaired, giving the bridge the strength to withstand the weight of large vehicles. (Pilot project)
